## Section 3.1

# CHATHAM COUNTY RECOMMENDATIONS

# US 15-501 over Pokeberry Creek

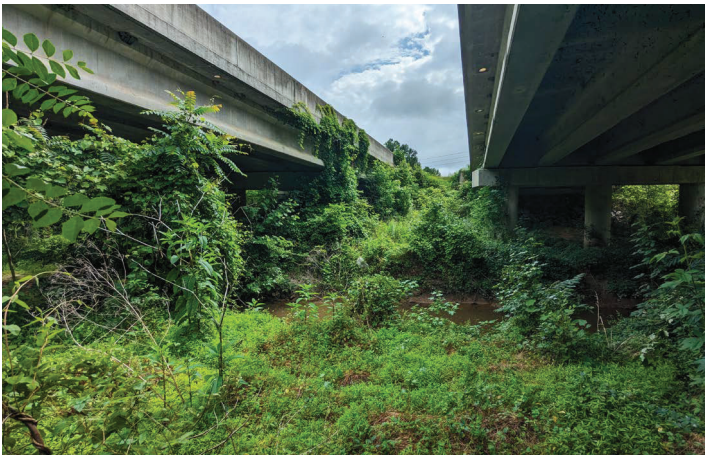
This site has an existing good, dry bench on both sides of the stream when not flooded. The width of the spans and the cross section of the ground surface under the spans already provide adequate space and geometry for wildlife passage on dry banks on both sides of the creek. However, barriers to wildlife travel exist along this corridor and under the bridges, which encourages wildlife travel on the roadway and results in conflicts with motorists. There are areas of exposed riprap with shallow to no sediment/soil (i.e., large voids) that are creating an uneven surface that likely makes it difficult for some wildlife species to traverse. The exposed riprap areas along the streambanks (and possibly in the adjacent toe ditches running parallel to the road) should be filled with material such as fines, soil, screenings, or aggregate to make the surface more even and traversable for wildlife.

Facing east, under US 15-501 bridge at Pokeberry Creek. DCHC MPO.

Fill voids in the exposed riprap under and adjacent to the spans on both sides of the creek with fine aggregate to provide a smooth natural surface for wildlife passage on the existing benches. Thin vegetation and remove invasives within the ROW immediately downstream of the bridge to increase permeability into the adjacent undisturbed habitat to allow wildlife passage. Install fencing to guide wildlife under the bridge.

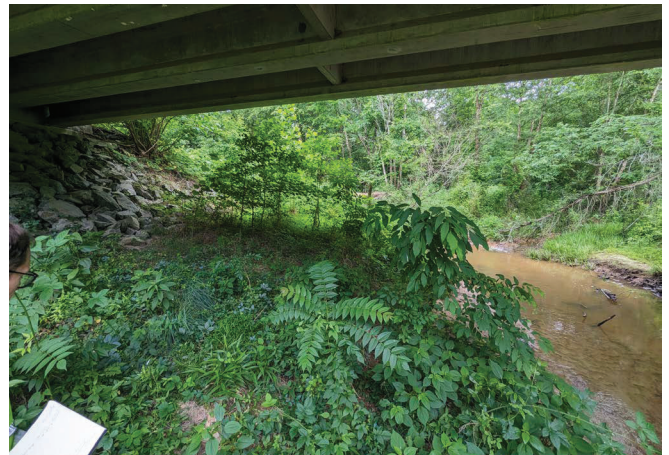
Vegetation under the bridge does not appear to be an obstacle, but vegetation downstream along the streambanks is dense, brushy, and thorny. There are also abundant invasive woody species present which should be removed, as they significantly degrade the habitat value of the corridor through the ROW. Vegetation management in at least the downstream riparian area should be explored to determine if it would help guide or attract wildlife to the riparian corridor and the crossing under the bridge. If these aspects are addressed, this crossing site may be a good candidate for fencing, depending on parcel ownership, fencing design factors, etc.

Facing west, under US 15-501 bridge at Pokeberry Creek. DCHC MPO.

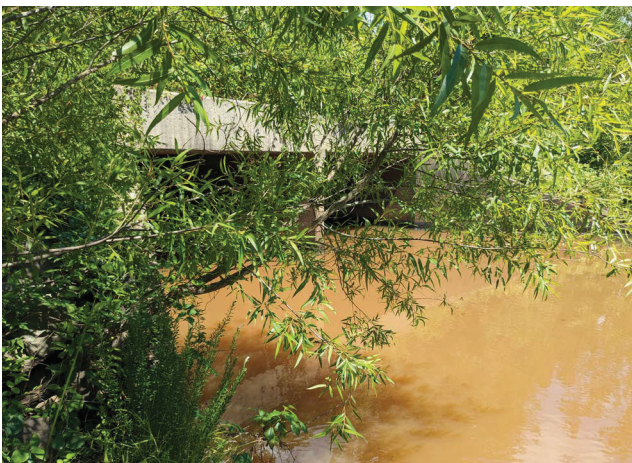
Barriers to wildlife travel exist along this corridor and through the culvert, which encourages wildlife travel on the roadway and results in conflicts with motorists. Barriers include standing water through the double box / two-bay culvert, and the placement of riprap. There are areas of suitable dry habitat approaching the underpass area on both sides of the road, even though there are also flooded wetland areas. However, there is no dry passage because both cells of the culvert are flooded to their full width, and because the riprap slope protection on the roadway embankment (causeway) extends into the standing water both up and downstream of the culvert.

Facing East from west side of Big Woods Road culvert. Pete Schubert.

Replace the existing culverts and adjacent earthen embankments with a single span bridge of sufficient roadway length to provide both hydrologic function plus a minimum width of 8 feet at and above floodplain elevation on both sides of the creek for dry wildlife passage. Extend these dry passages on both side of the bridge up and downstream into adjacent dry habitat areas. All dry passages must be natural surface, free of open riprap.

Construct new dry culverts through the causeway as wildlife underpasses on both sides of the existing culvert, placed so that wildlife can move from dry habitat areas on either side of the road, through these new dry culverts, to dry habitat areas on the other side of the road. These two new culverts should be at least 8 feet high and 12 feet wide, with a natural surface floor that is not normally flooded and should be straight with no offset or skew. If sufficient causeway height is not present to achieve the required height of the new dry culverts, the profile of the roadway may need to be raised in the section between the new culverts.

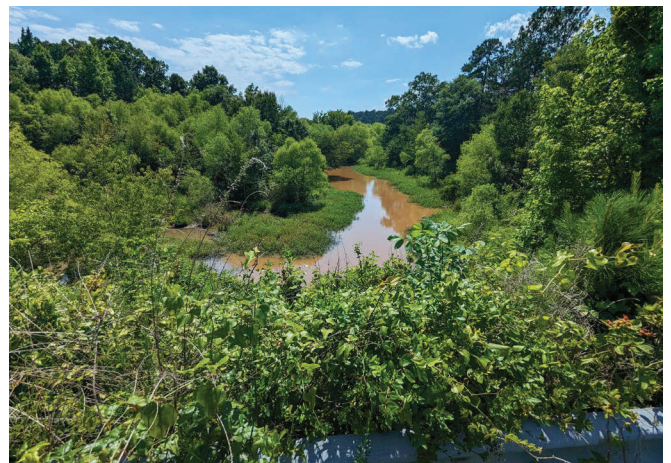
Several elements of the roadway embankment (causeway) and stream culvert construction present challenges for the potential of dry passage through the culvert except potentially in times of extremely low water levels when no standing water is present. First, the culverts are not wide enough to accommodate dry wildlife passage and hydrology. Further, the placement of embankment riprap slope protection to the toe of the embankment at the adjacent floodplain elevation, cuts off dry passage from the floodplain when it is flooded. In addition, the uniform steep slope of the riprap on the embankments and the concrete wingwalls does not include a level bench that could be tied into the culvert if dry passage through them were provided.

Facing west from above Big Woods Road culvert. Pete Schubert.

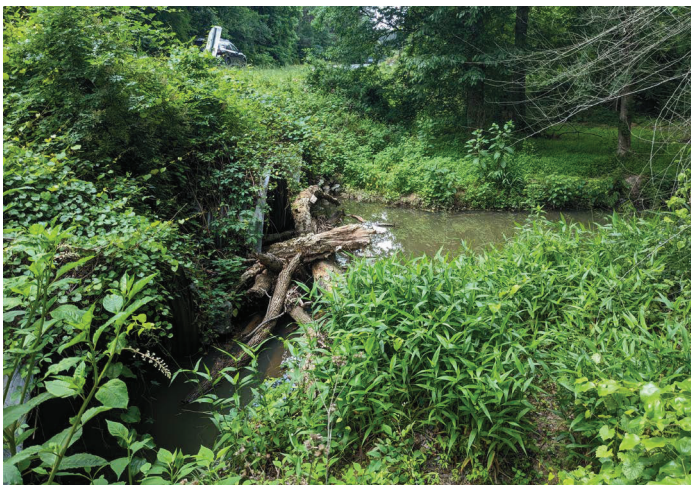
Barriers to wildlife travel exist along this corridor and through the culvert, which encourages wildlife travel on the roadway and results in conflicts with motorists. This site offers no dry passage for wildlife through the existing triple pipe culvert. During the relatively low water conditions on the date of site assessment, all pipe culverts were flooded with water, and debris was blocking the central culvert pipe. The three identical pipe culverts are round corrugated galvanized steel (pipe appears to be bituminous-coated on bottom) and are aging. Given the less than 6 feet of elevation difference between the road profile and the adjacent floodplain, there is no opportunity for any modification to the pipe culverts or installation of dry passage culverts adjacent to the existing culverts away from the stream channel.

East side of Manns Chapel Road culvert over Wilkinson Creek. DCHC MPO.

The triple pipe culverts should be replaced with a single bridge of sufficient span to provide dry passage for wildlife on both sides of the stream at or above floodplain elevation. The road causeway profile should be raised to provide at least 8 feet of vertical clearance between dry passages and the bottom of the bridge structure.

The existing triple pipe culvert could be replaced with a 5-bay box culvert that provides outer cells with higher, dry passage for wildlife on both sides of the stream, with these dry passages connected to habitat up and down stream; or, a relatively short, full open-span bridge wide enough and high enough for dry passage on both sides of stream. The road causeway profile should be raised sufficiently to provide at least 8 feet of vertical clearance between the natural surface bottoms and the box culvert ceilings within dry passage bays.

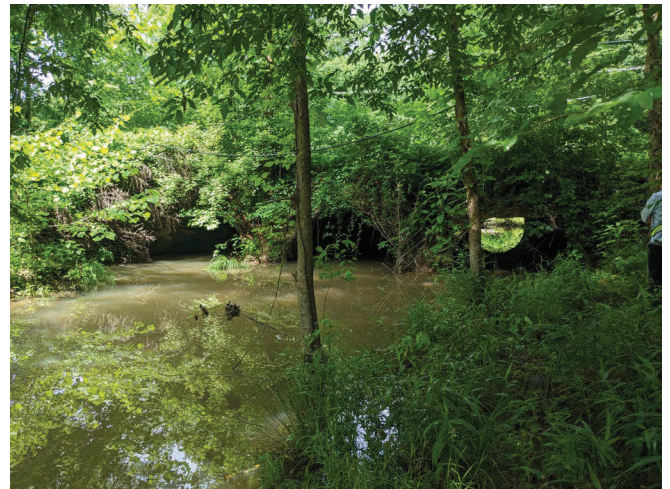
West side of Manns Chapel Road culvert over Wilkinson Creek. DCHC MPO.

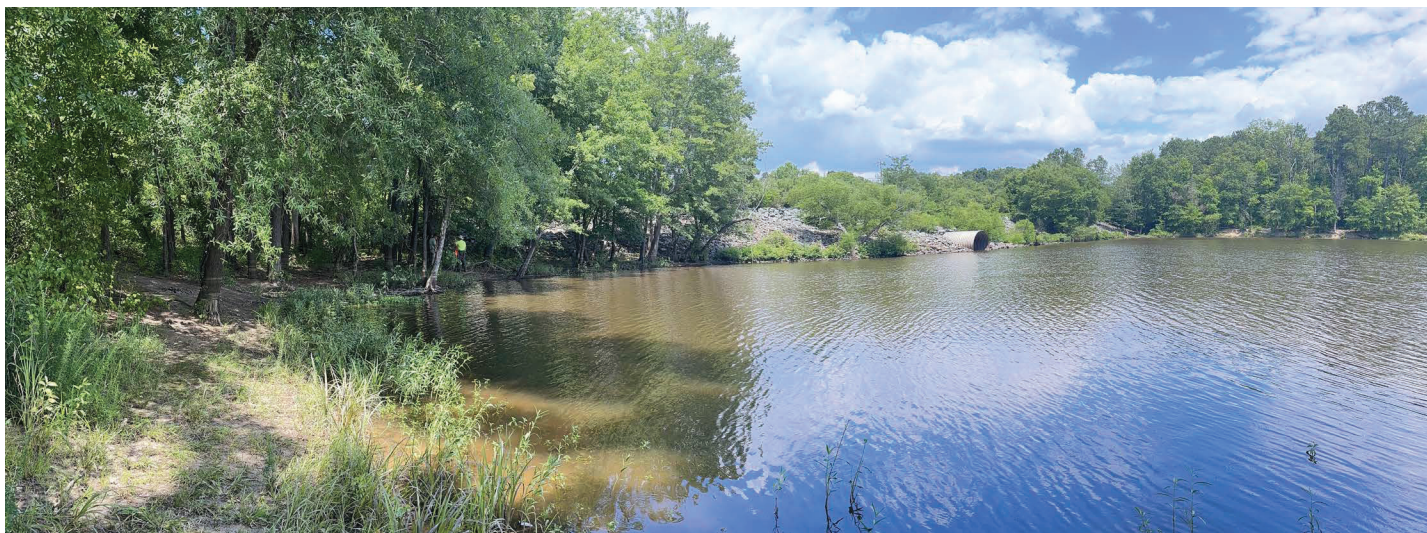
Barriers to wildlife travel exist along this corridor and through the pipe, which encourages wildlife travel on the roadway and results in conflicts with motorists. The road at this site crosses the lake on a raised causeway with steep riprap slopes from the road down to the floodplain and lake. The land around this crossing has existing trails currently used by the public that are conducive to wildlife travel. However, due to the pipe's location in the middle of Overcup Creek, and the wide body of water surrounding it, the structure is not conducive for wildlife passage through a retrofit.

View of pipe from north side of Lystra Road over Overcup Creek / Jordan Lake. DCHC MPO.

Construct dry culverts through the causeway on both sides of the lake to connect the high-quality lakeside habitat on both sides of the road. Dry culverts should be at least 12 feet wide and 8 feet high. The existing approach for wildlife to a potential underpass in these areas (visibility, slopes, etc.) is already good. This solution would also require fencing to guide wildlife to the dry culverts.

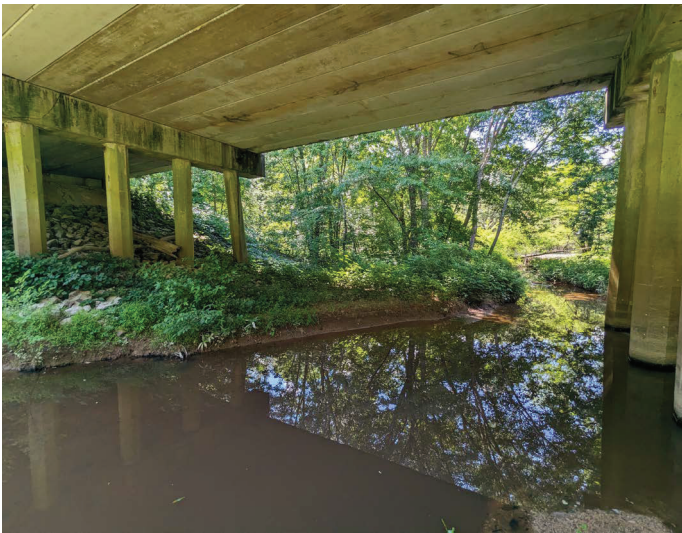
Barriers to wildlife travel exist along this corridor and under the bridge, which encourages wildlife travel on the roadway and results in conflicts with motorists. The continuous riprap slope protection along the causeway/roadway embankments and under the bridge is a major barrier to wildlife passage through the underpass and connection to habitat areas up and downstream. This riprap extends from about 10 feet below shoulder grade down to the toe of the slopes at the floodplain without a bench that could function as dry passage above the floodplain elevation. Though low water dry passage exists on the east side, none exists on the west side, and neither functions at high creek levels. A 30 feet wide partially dry natural surface floodplain exists on the north bank under the bridge, beyond the toe of the riprap slope protection that has good connectivity to adjacent up and downstream habitat, but only at low water levels. No dry passage is present on the south bank as the riprap slope protection extends to the top of the creek bank.

Under bridge at Jack Bennett Road over Herndon Creek, facing northwest. Pete Schubert.

If the length of the bridge span between abutments is sufficient, grade 8 feet wide benches into the embankment/causeway slopes across the entire width of the creek floodplain on both sides of the road to create dry passages for wildlife at high water. Connect the benches under the bridge on each end, and tie them into dry habitat up and downstream. Benches should be natural surface or, if riprap is used, it must have all voids filled to provide a smooth surface.

Construct new dry culverts through the causeway to serve as wildlife underpasses on both sides of the existing bridge span, placed so that wildlife can move from dry habitat areas on either side of the road, through these new dry culverts, to dry habitat areas on the other side of the road. These two new culverts should be at least 8 feet high and 12 feet wide, with a natural surface floor that is not normally flooded, and be straight with no offset or skew. If sufficient causeway height is not present to achieve the required height of the new dry culverts, the profile of the roadway may need to be raised in the section between the new culverts.

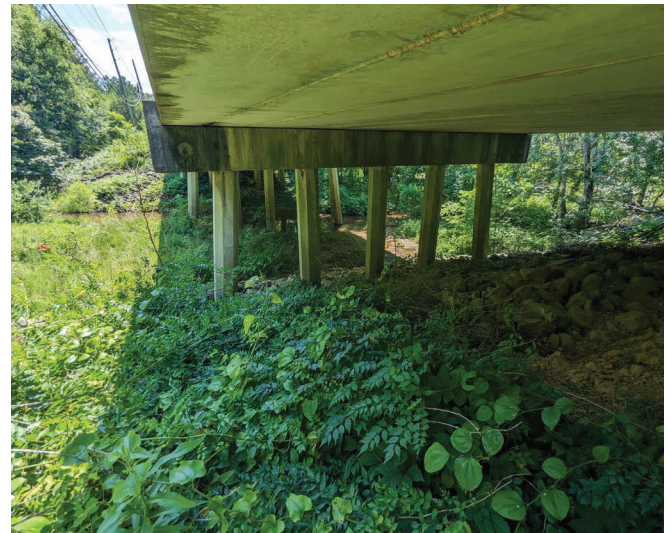
Under bridge at Jack Bennett Road over Herndon Creek, facing southwest. Pete Schubert.
