# **WILDLIFE CROSSINGS PLAN**

**DURHAM-CHAPEL HILL-CARRBORO  
METROPOLITAN PLANNING ORGANIZATION**

**Adopted November 19, 2024**

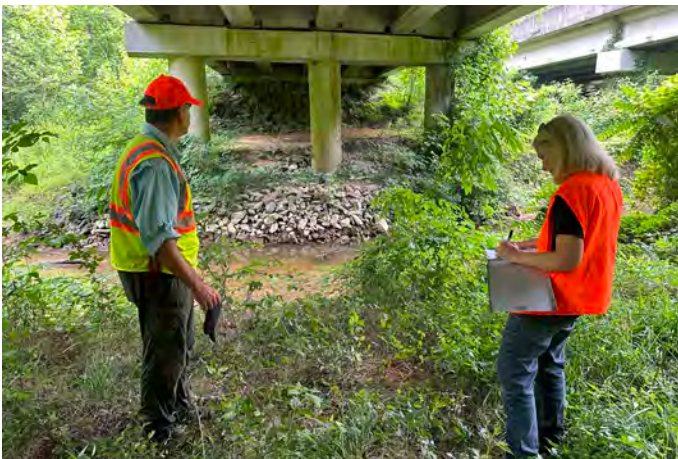
Figure 2.2.1: Photograph of site assessment at US 15-501 bridge over Pokeberry Creek. DCHC MPO.

The TCCTW partnered with the NCWRC to develop a site assessment form. The site assessment form was used as a guide (Appendix D), which included elements such as analyzing the existing structure (bridge, culvert, etc.), evaluating the site for roadkill, and identifying obstacles for wildlife connectivity. Based on each site's assessment, countermeasures were developed to help improve wildlife connectivity and reduce WVCs.

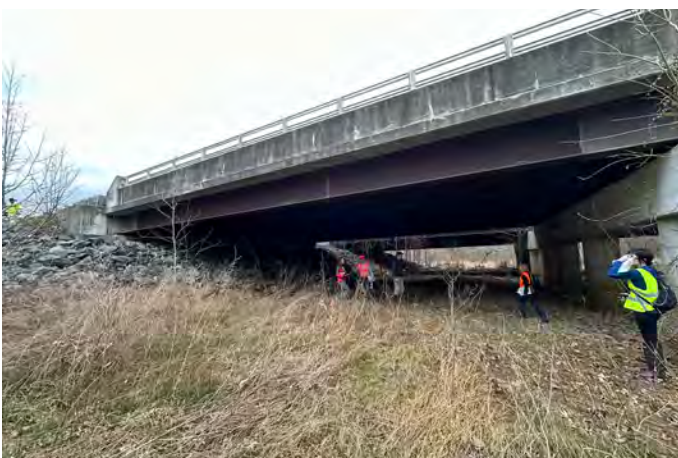
Figure 2.2.2: Photograph of site assessment at US 15-501 bridge over New Hope Creek. DCHC MPO.

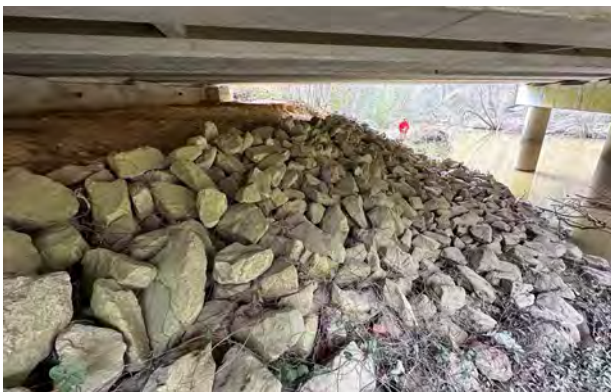
Figure 2.3.1.1 Photograph of site assessment at Old Chapel Hill Road bridge over New Hope Creek. DCHC MPO.

A passage bench is a gravel-surface path built under a bridge that is along a waterway intended to provide wildlife with continued travel and to reduce the likelihood of wildlife traveling across roadways and into vehicular traffic.<sup>22</sup> This countermeasure is often incorporated into bridge riprap. Riprap is a layer of large stone that protects soil from erosion in areas of high or concentrated water flows. It is especially useful for armoring channel and ditch banks, and protecting the integrity of a bridge abutment and prevent scour.<sup>23</sup> However, since riprap can be a challenge for wildlife to pass over, remediation has been done that repositions riprap along embankments and hills to create a wildlife bench - an example of this is the US 15-501 bridge over New Hope Creek in Durham County (Figure 2.3.3.1). The Old Chapel Hill Road bridge over New Hope Creek (Figure 2.3.1.1) is an example of riprap placement that poses such an obstacle. Wildlife that encounters this obstacle may choose to use the roadway to continue travel, putting the safety of themselves and drivers at risk.

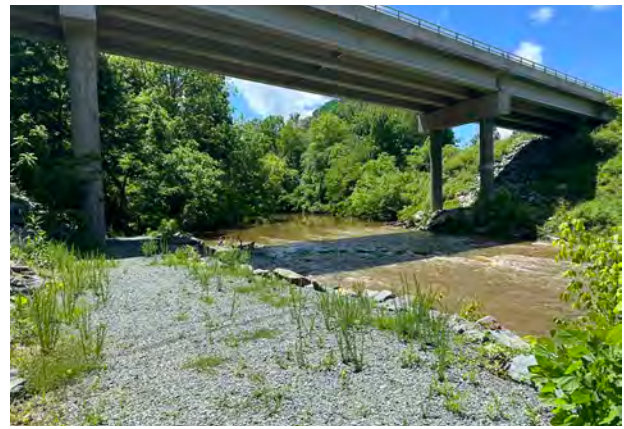
Figure 2.3.1.2: Photograph of US 70 bridge over the Eno River. DCHC MPO.

The wildlife crossing along US 70 over the Eno River in Orange County (Figure 2.3.1.2) is an example of a transportation project in the MPO's planning area that eliminated this type of obstacle by repositioning riprap to create a wildlife bench. When this type of mitigation measure is implemented in new projects such

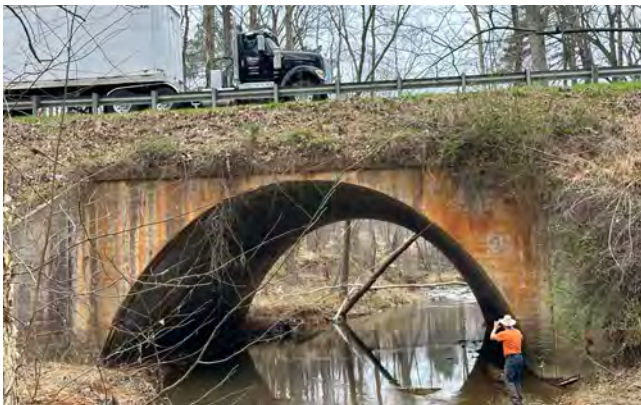
Figure 2.3.1.3: Bottomless culvert at US 70 over Stony Creek. DCHC MPO.

Culverts and pipes are structures used as a drainage management solution, as they guide water and sediment flow through a transportation network with minimal impact. While commonly used for the same purpose, the term used (culvert or pipe) often depends on the size of the structure; culverts are large structures, while pipes are smaller. Figure 2.3.1.3 is an example of a bottomless culvert, while Figure 2.3.1.4 is an example of a pipe.

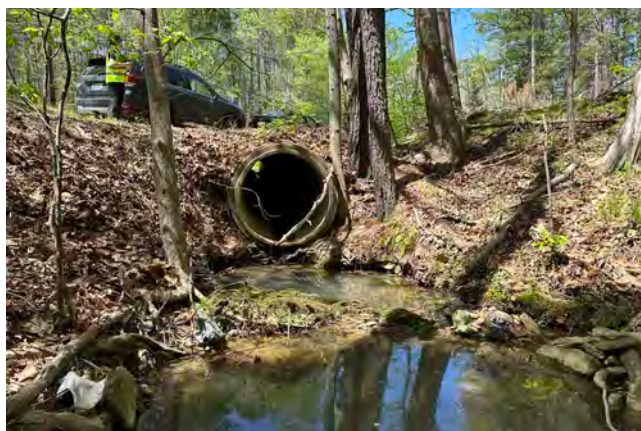
Figure 2.3.1.4: Pipe at Cole Mill Road at Eno River. DCHC MPO.

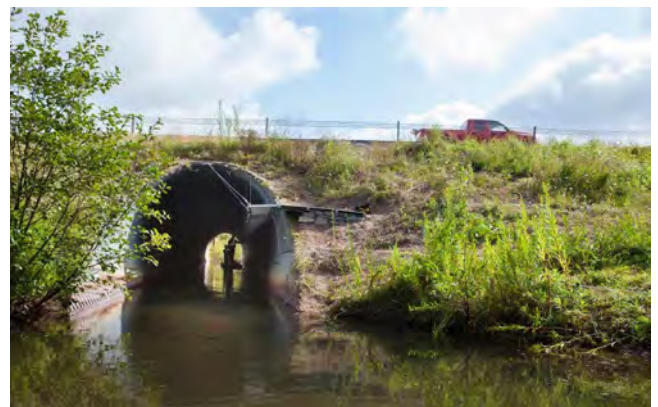
Figure 2.3.1.5: Wildlife shelf is installed in a culvert near Boonville, N.Y. Kurt Gardner/The Nature Conservancy via AP.

First, corrugated pipe could be installed along the culvert’s floor with enough concrete to prevent inhibiting the hydrologic or geomorphic (sediment-moving) function of the culvert.<sup>27</sup> Second, ledges – or dry shelves – could be considered in some cases as a retrofit on one or both sides of the culvert’s interior to allow wildlife to traverse safely, above the water. Figure 2.3.1.5 shows an image of a ledge retrofit for a project administered by the New York Department of Transportation and The Nature Conservancy.<sup>28</sup>

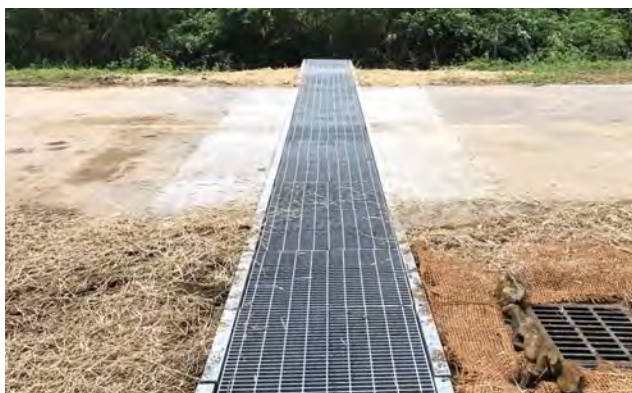
Many wildlife crossing solutions are aimed at reducing the likelihood of large animals traversing roadways due to the significant damage they can inflict in a WVC. While small animals may not necessarily cause vehicle damage or human injury, they greatly outnumber the large wildlife in the MPO's planning area, and their survival is as equally important as their larger counterparts. A solution to be considered for small wildlife passage – such as for turtles and snakes – is a wildlife tunnel.

Figure 2.3.1.6: Wildlife tunnel in western North Carolina. Kevin Hining/NCDOT.

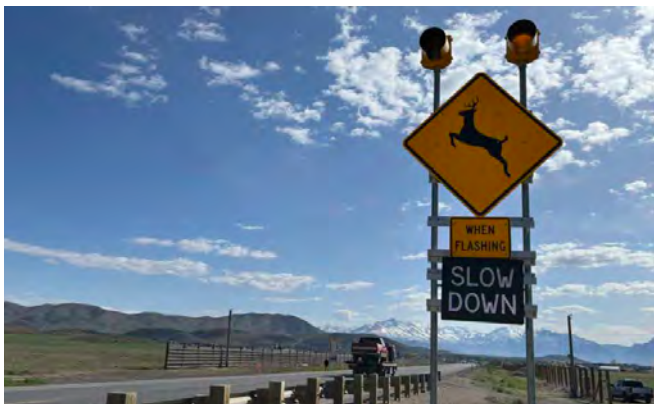
*Flashing beacons* have been proven to be more effective at gaining drivers’ attention and reducing vehicular speed. These activated wildlife crossing signs are typically installed during seasonal migration periods and are equipped with flashing lights to attract driver’s

Figure 2.3.1.8: Flashing beacon for wildlife crossings in Utah. Adam Small, KSL NewsRadio.

attention. Activated signs can use infrared technology to detect approaching wildlife, which will trigger the flashing lights,<sup>36</sup> or the lights can be set to remain flashing for a set period of time. A study conducted by the Insurance Institute for Highway Safety found that flashing beacon signs reduced speed by 8 mph, and that DVCs were reduced by 70% during migration.<sup>37</sup> The NCDOT Division Traffic Engineer should be contacted when requesting flashing beacons.

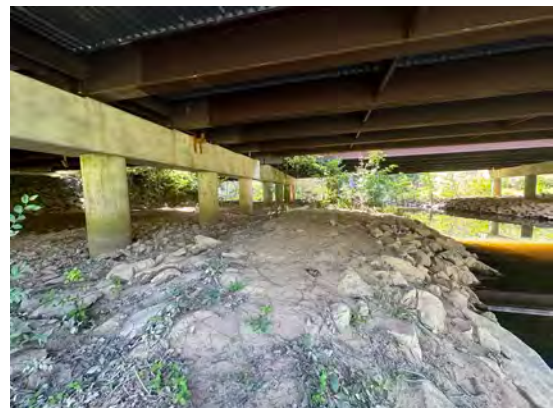
Figure 2.3.3.1: US 15-501 bridge over New Hope Creek in Durham County, NC. DCHC MPO.

The bridge on US 15-501 over New Hope Creek in Durham County (Figure 2.3.3.1) is a transportation project in partnership between NCDOT, NCWRC, and others that incorporated wildlife crossing countermeasures. The location of this site was identified as an important wildlife passage – particularly for white-tailed deer – because the natural and riparian areas associated with New Hope Creek create a wildlife corridor between Duke Forest to the north and B. Everett Jordan Lake to the south.<sup>39</sup> Completed in 2007, the bridge span was lengthened by approximately 160 feet. The lengthening created space on both sides of New Hope Creek to develop wildlife benches, which has improved wildlife connectivity and promotes movement underneath the bridge and along this corridor. While fencing is often incorporated as part of wildlife crossing bridge projects, the site's surrounding urban land use prevented fencing from being a viable option due to its relatively short range.<sup>40</sup> Since completion, evidence from camera trap data has shown that the new bridge has increased passage under US 15-501 for a variety of wildlife species.<sup>41</sup> To help ensure this site continues to promote wildlife connectivity under the bridge, land conservation efforts should be explored that include the acquisition of remaining natural lands adjacent to the site.

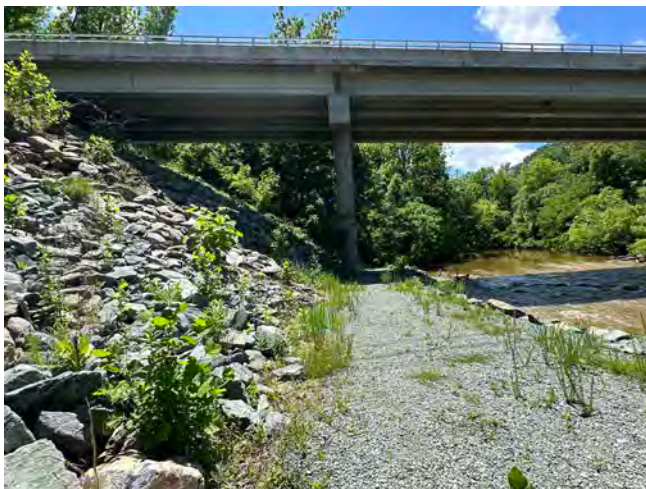
Figure 2.3.3.2: US 70 bridge over Eno River in Orange County, NC. Southeast side. DCHC MPO.

The bridge on US 70 over the Eno River, east of Hillsborough in Orange County (Figure 2.3.3.2) is a transportation project in partnership between NCDOT, NCWRC, and others that incorporated wildlife crossing countermeasures. This project was completed in 2022, which lengthened the span to 265 feet (27 feet longer than the original), installed guardrails, and was designed to accommodate the potential for a greenway to be developed underneath. To enhance wildlife connectivity underneath the bridge, a riprap remediation was completed in 2023 that constructed a wildlife passage benches on both sides of the Eno River.

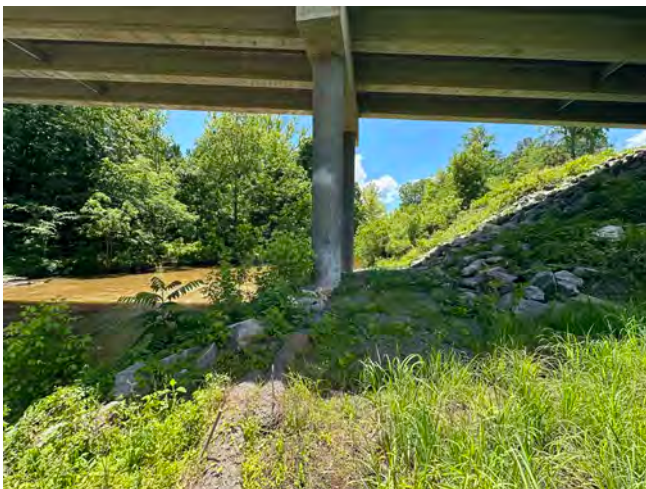
Figure 2.3.3.3: US 70 bridge over Eno River in Orange County, NC. Northwest side. DCHC MPO.

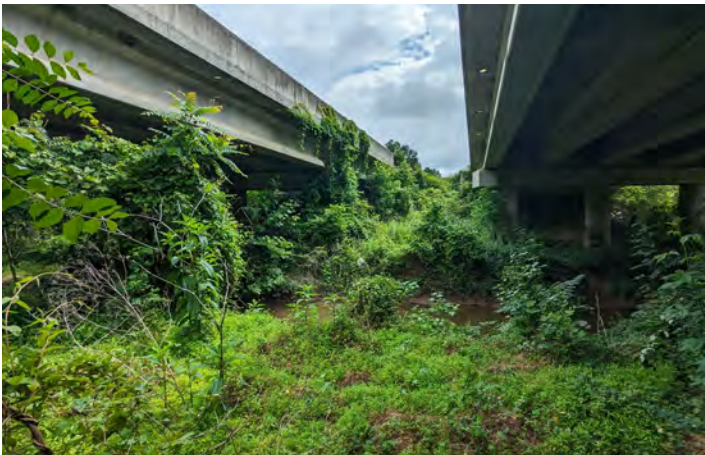
Vegetation under the bridge does not appear to be an obstacle, but vegetation downstream along the streambanks is dense, brushy, and thorny. There are also abundant invasive woody species present which should be removed, as they significantly degrade the habitat value of the corridor through the ROW. Vegetation management in at least the downstream riparian area should be explored to determine if it would help guide or attract wildlife to the riparian corridor and the crossing under the bridge. If these aspects are addressed, this crossing site may be a good candidate for fencing, depending on parcel ownership, fencing design factors, etc.

Facing east, under US 15-501 bridge at Pokeberry Creek. DCHC MPO.

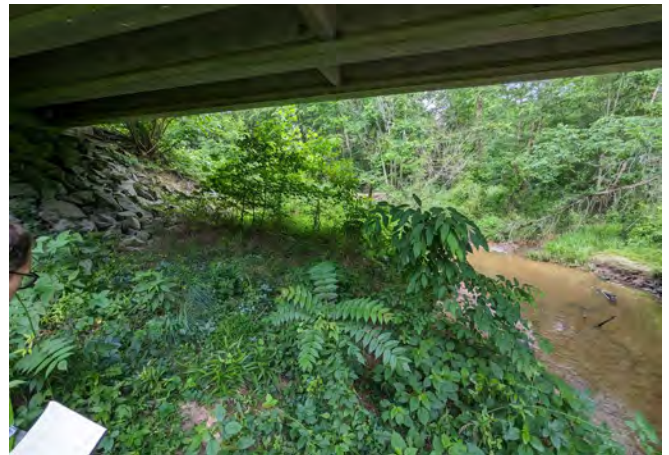
Facing west, under US 15-501 bridge at Pokeberry Creek. DCHC MPO.

The two bridges on US 15-501 S and N (Chapel Hill Road) over Pokeberry Creek have been identified as a priority wildlife crossing. This crossing resides within a wildlife corridor identified by Wildlands Network, and 20 WVCs have been reported within a one-mile buffer of this site. This roadway has two lanes running both north- and southbound divided by a 20-foot grass median; the divide continues through the bridge structure. The gap between the bridges provides good daylight and visibility to the creek banks below. This site has no bicycle and pedestrian facilities, has a posted speed limit of 55 mph, and garners 16,500 vehicles per day (2021 AADT).

Fill voids in the exposed riprap under and adjacent to the spans on both sides of the creek with fine aggregate to provide a smooth natural surface for wildlife passage on the existing benches. Thin vegetation and remove invasives within the ROW immediately downstream of the bridge to increase permeability into the adjacent undisturbed habitat to allow wildlife passage. Install fencing to guide wildlife under the bridge.

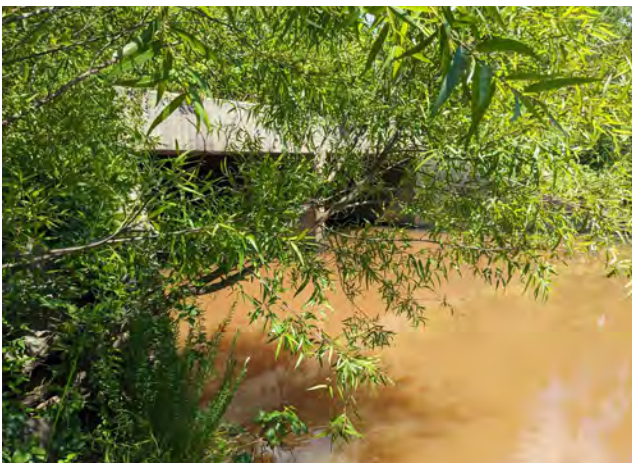
Several elements of the roadway embankment (causeway) and stream culvert construction present challenges for the potential of dry passage through the culvert except potentially in times of extremely low water levels when no standing water is present. First, the culverts are not wide enough to accommodate dry wildlife passage and hydrology. Further, the placement of embankment riprap slope protection to the toe of the embankment at the adjacent floodplain elevation, cuts off dry passage from the floodplain when it is flooded. In addition, the uniform steep slope of the riprap on the embankments and the concrete wingwalls does not include a level bench that could be tied into the culvert if dry passage through them were provided.

Facing East from west side of Big Woods Road culvert. Pete Schubert.

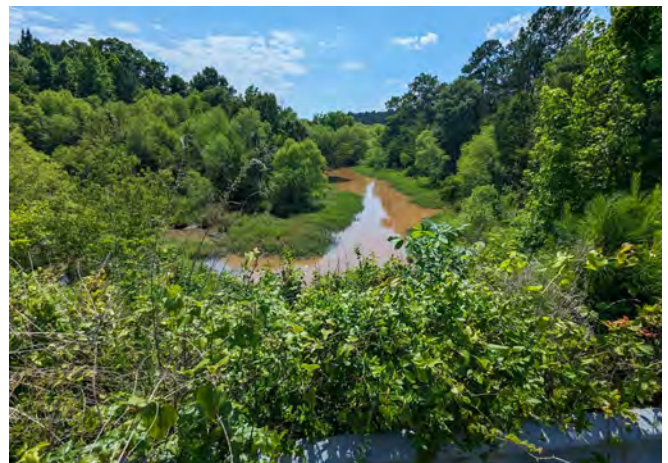
Facing west from above Big Woods Road culvert. Pete Schubert.

Barriers to wildlife travel exist along this corridor and through the culvert, which encourages wildlife travel on the roadway and results in conflicts with motorists. Barriers include standing water through the double box / two-bay culvert, and the placement of riprap. There are areas of suitable dry habitat approaching the underpass area on both sides of the road, even though there are also flooded wetland areas. However, there is no dry passage because both cells of the culvert are flooded to their full width, and because the riprap slope protection on the roadway embankment (causeway) extends into the standing water both up and downstream of the culvert.

Replace the existing culverts and adjacent earthen embankments with a single span bridge of sufficient roadway length to provide both hydrologic function plus a minimum width of 8 feet at and above floodplain elevation on both sides of the creek for dry wildlife passage. Extend these dry passages on both side of the bridge up and downstream into adjacent dry habitat areas. All dry passages must be natural surface, free of open riprap.

Construct new dry culverts through the causeway as wildlife underpasses on both sides of the existing culvert, placed so that wildlife can move from dry habitat areas on either side of the road, through these new dry culverts, to dry habitat areas on the other side of the road. These two new culverts should be at least 8 feet high and 12 feet wide, with a natural surface floor that is not normally flooded and should be straight with no offset or skew. If sufficient causeway height is not present to achieve the required height of the new dry culverts, the profile of the roadway may need to be raised in the section between the new culverts.

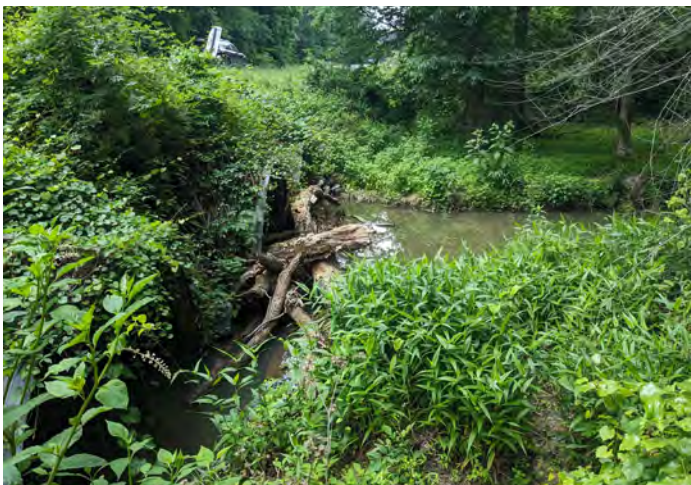
Barriers to wildlife travel exist along this corridor and through the culvert, which encourages wildlife travel on the roadway and results in conflicts with motorists. This site offers no dry passage for wildlife through the existing triple pipe culvert. During the relatively low water conditions on the date of site assessment, all pipe culverts were flooded with water, and debris was blocking the central culvert pipe. The three identical pipe culverts are round corrugated galvanized steel (pipe appears to be bituminous-coated on bottom) and are aging. Given the less than 6 feet of elevation difference between the road profile and the adjacent floodplain, there is no opportunity for any modification to the pipe culverts or installation of dry passage culverts adjacent to the existing culverts away from the stream channel.

East side of Manns Chapel Road culvert over Wilkinson Creek. DCHC MPO.

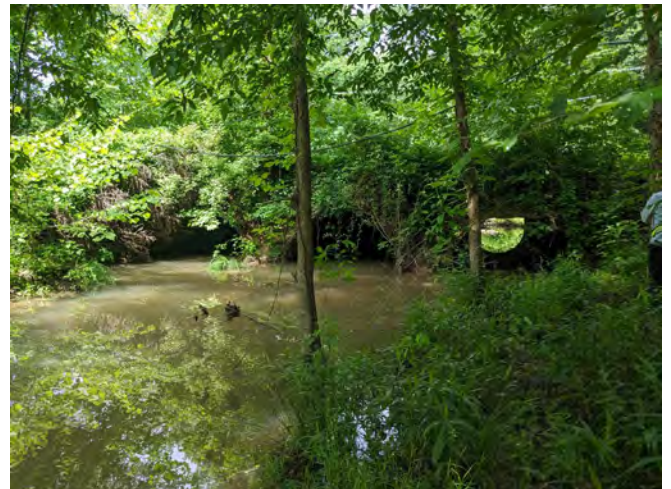
West side of Manns Chapel Road culvert over Wilkinson Creek. DCHC MPO.

The triple pipe culverts should be replaced with a single bridge of sufficient span to provide dry passage for wildlife on both sides of the stream at or above floodplain elevation. The road causeway profile should be raised to provide at least 8 feet of vertical clearance between dry passages and the bottom of the bridge structure.

The existing triple pipe culvert could be replaced with a 5-bay box culvert that provides outer cells with higher, dry passage for wildlife on both sides of the stream, with these dry passages connected to habitat up and down stream; or, a relatively short, full open-span bridge wide enough and high enough for dry passage on both sides of stream. The road causeway profile should be raised sufficiently to provide at least 8 feet of vertical clearance between the natural surface bottoms and the box culvert ceilings within dry passage bays.

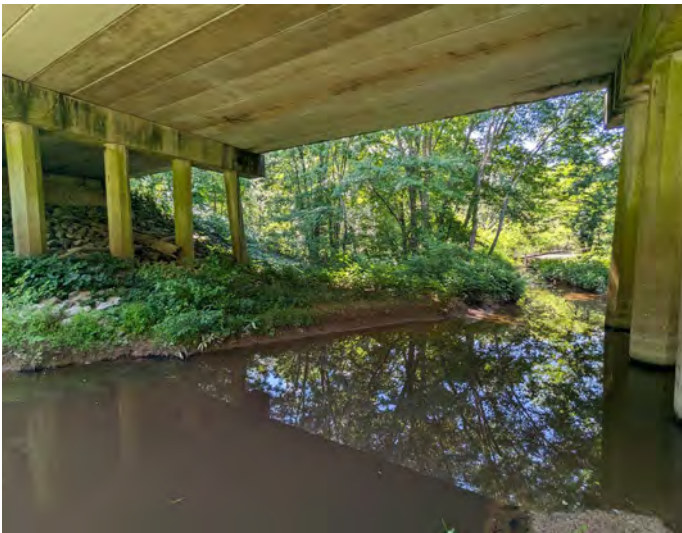
Barriers to wildlife travel exist along this corridor and under the bridge, which encourages wildlife travel on the roadway and results in conflicts with motorists. The continuous riprap slope protection along the causeway/roadway embankments and under the bridge is a major barrier to wildlife passage through the underpass and connection to habitat areas up and downstream. This riprap extends from about 10 feet below shoulder grade down to the toe of the slopes at the floodplain without a bench that could function as dry passage above the floodplain elevation. Though low water dry passage exists on the east side, none exists on the west side, and neither functions at high creek levels. A 30 feet wide partially dry natural surface floodplain exists on the north bank under the bridge, beyond the toe of the riprap slope protection that has good connectivity to adjacent up and downstream habitat, but only at low water levels. No dry passage is present on the south bank as the riprap slope protection extends to the top of the creek bank.

Under bridge at Jack Bennett Road over Herndon Creek, facing northwest. Pete Schubert.

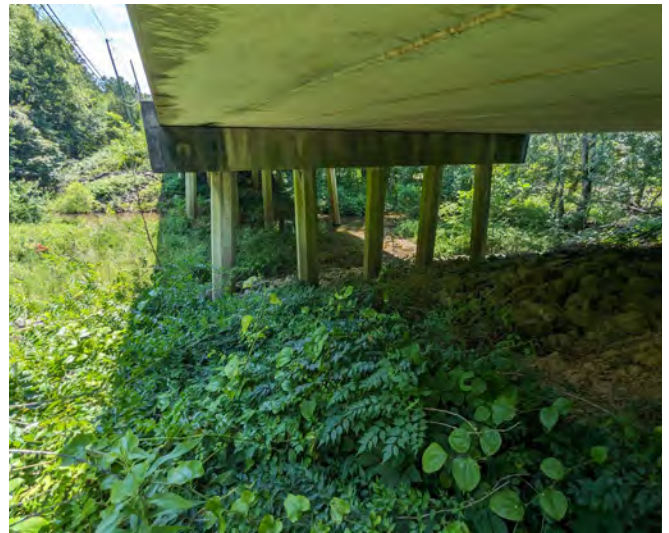
Under bridge at Jack Bennett Road over Herndon Creek, facing southwest. Pete Schubert.

If the length of the bridge span between abutments is sufficient, grade 8 feet wide benches into the embankment/causeway slopes across the entire width of the creek floodplain on both sides of the road to create dry passages for wildlife at high water. Connect the benches under the bridge on each end, and tie them into dry habitat up and downstream. Benches should be natural surface or, if riprap is used, it must have all voids filled to provide a smooth surface.

Construct new dry culverts through the causeway to serve as wildlife underpasses on both sides of the existing bridge span, placed so that wildlife can move from dry habitat areas on either side of the road, through these new dry culverts, to dry habitat areas on the other side of the road. These two new culverts should be at least 8 feet high and 12 feet wide, with a natural surface floor that is not normally flooded, and be straight with no offset or skew. If sufficient causeway height is not present to achieve the required height of the new dry culverts, the profile of the roadway may need to be raised in the section between the new culverts.

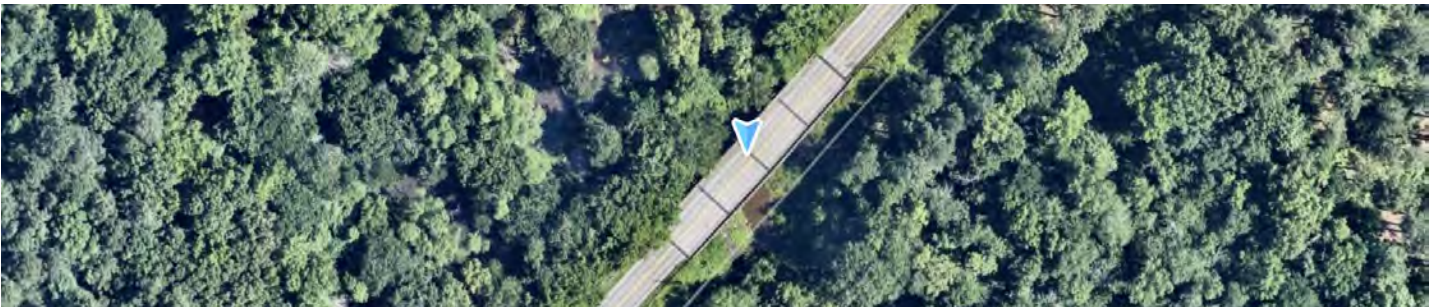
Aerial photograph of Jack Bennett Road bridge over Herndon Creek. Nearmap.

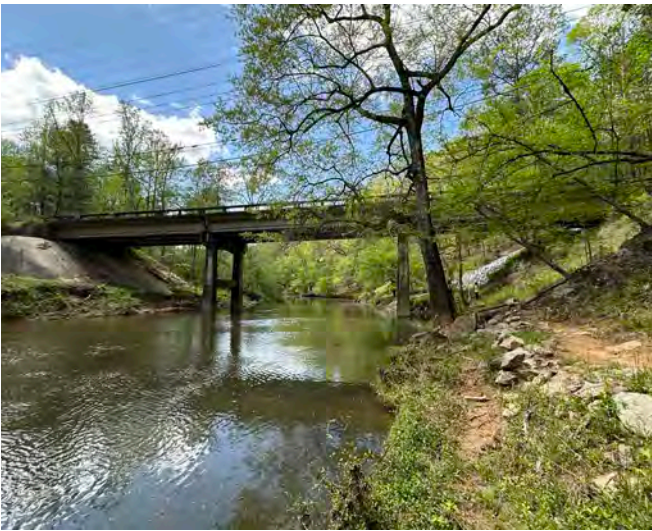
East side of Cole Mill Road bridge over Eno River, facing southwest. DCHC MPO.

Barriers to wildlife travel exist within this core and under the bridge, which encourages wildlife travel on the roadway and results in conflicts with motorists. Riprap placed on the east side of the bridge on the north bank from the top of the steep slope all the way into the river to the base of the incised bank prevents dry passage for wildlife at any elevation. A bench created midway up this riprap slope that has been choked with pea gravel has not been connected to the habitat up or downstream. The natural surface slope under the bridge is steeply sloping from abutment at the top to the riverbank. The remains of the eroded and abandoned Pea Creek Trail (wood boardwalk, steps) interfere with dry passage on the north bank from the east, and the entire north bank is steeply sloped with no benches for wildlife access or human foot traffic. On the south bank, scour has narrowed to the width of the dry passage between the toe of the steep concrete paved slope protection surrounding the abutment, and woody vegetation at the top of the eroding bank interferes with passage of both wildlife and foot traffic of the Mountains-to-Sea Trail (MST) along the south bank of the Eno River under the bridge. All replacement, repair, and/or remediation work should be closely coordinated between NCDOT staff, Eno River State Park (ERSP) staff (Pea Creek trail, ERSP lands), and NC Division of Parks and Recreation.

Replace the bridge with a longer span that provides sufficient room for dry wildlife and trail passage on both banks of the river. Vertical bents at the abutments are recommended to maximize low slope dry passages and provide additional high water flow capacity to minimize bank scour. Connect dry passages to habitat up and downstream on both sides of the river.

Bench into the north bank slope to provide a minimum of 8 feet of dry passage for wildlife and trail foot traffic. Similarly, bench into the paved slope protection on the south bank. Connect dry passages to habitat up and downstream on both sides of the river. Repair the scour around the bent piers that are eroding into both banks and potentially threatening the integrity of the piers.

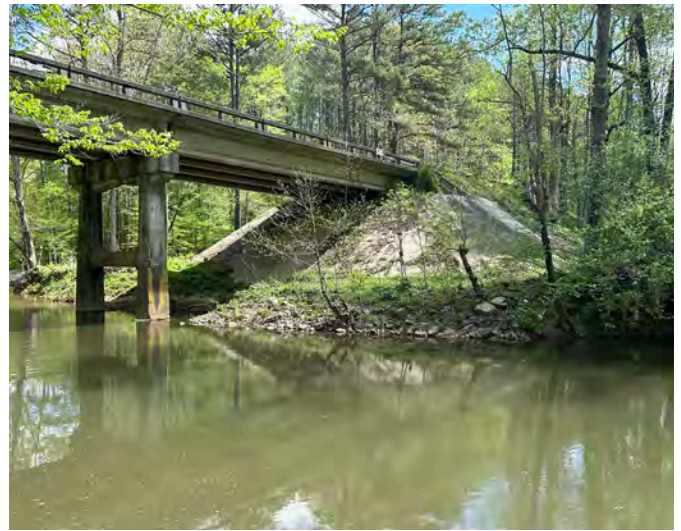
West side of Cole Mill Road bridge over Eno River, facing northeast. DCHC MPO.

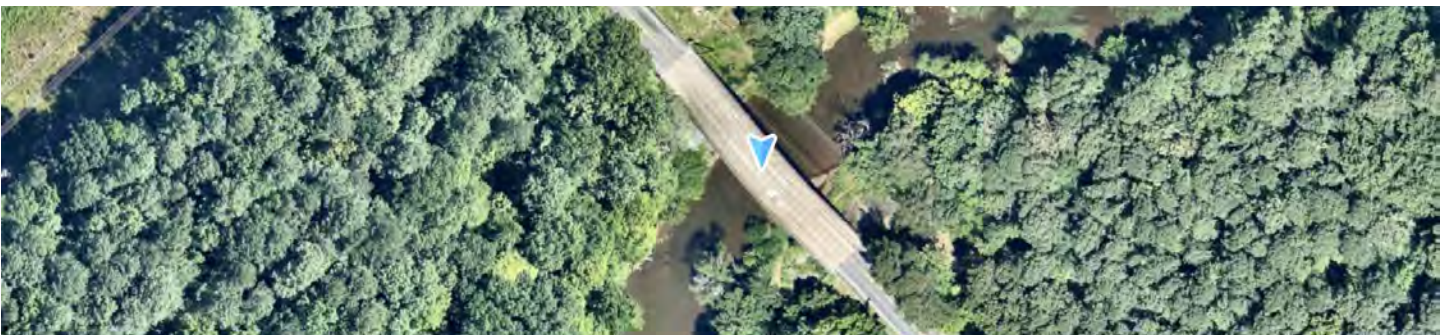
Aerial photograph of Cole Mill Road bridge over Eno River. Nearmap.

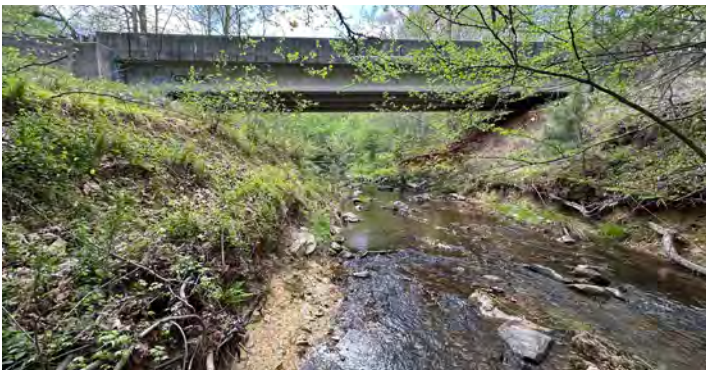
The slopes from the creek bank to the abutments appear to have been once covered by riprap slope protection, but all that remains is some riprap within a few feet of each abutment; the rest has been eroded away and the underlying subgrades have been significantly scoured away. These slopes should be rebuilt to provide natural surface dry passage benches, while also providing critical stabilization of the abutment slopes. The bridge appears to be a recent replacement span and of adequate span length to provide dry passage on both sides if the slopes are reconstructed and stabilized adequately.

Rivermont Road ridge over Nancy Rhodes Creek looking Southwest. DCHC MPO.

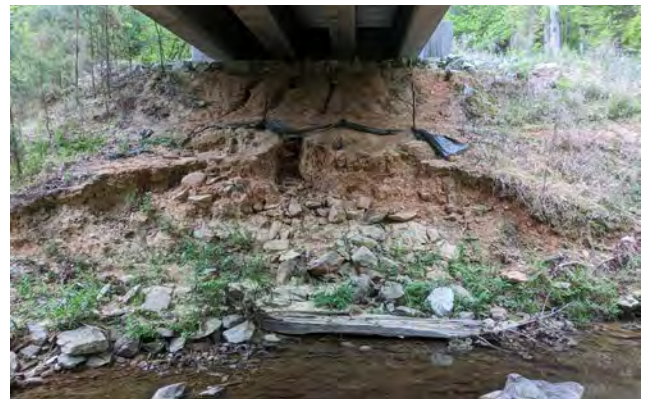
Rivermont Road bridge over Nancy Rhodes Creek looking East. Pete Schubert.

Rebuild the eroded abutment slopes with retaining walls to provide a natural surface dry wildlife passage on both sides of the creek. Ensure passages connect into habitat up and downstream.

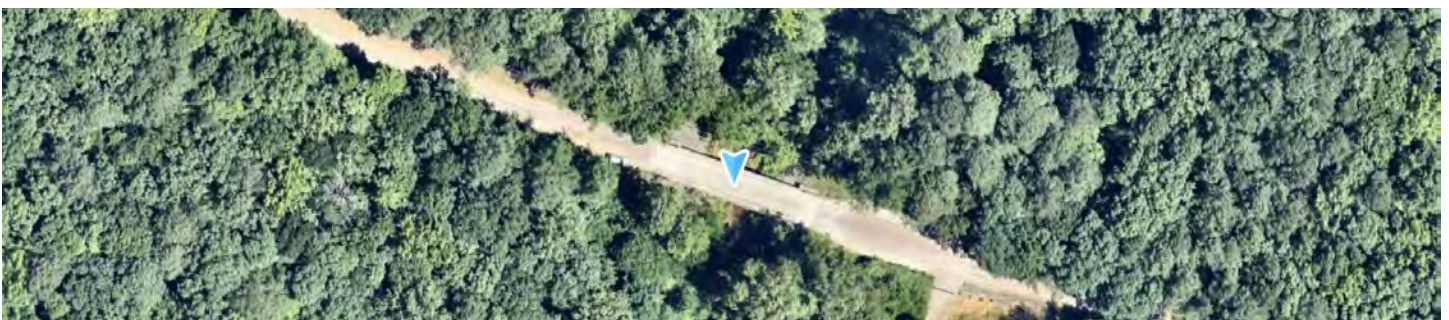
Aerial photograph of Rivermont Road bridge over Nancy Rhodes Creek. Nearman,

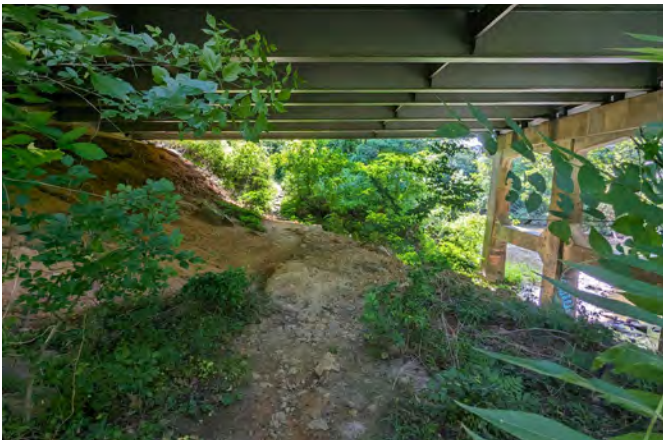
Under US 501 (Roxboro Road) bridge over Eno River, view upstream on the south bank. Pete Schubert.

While barriers to wildlife travel under the bridge exist, which encourages wildlife travel on the roadway and results in conflicts with motorists, the wildlife passage appears to be highly viable along this section of the river and corridor approaching and under the bridge, and the natural surface stream banks are overall excellent. No major remediation is needed except for the northeast and southeast slopes needing deep erosion/incision and voids backfilled and stabilized to prevent recurrence, and to allow full wildlife passage.

Evaluate and permanently repair deep erosion of banks due to stormwater flows coming from the roadway embankments and daylighting downstream of the bridge.

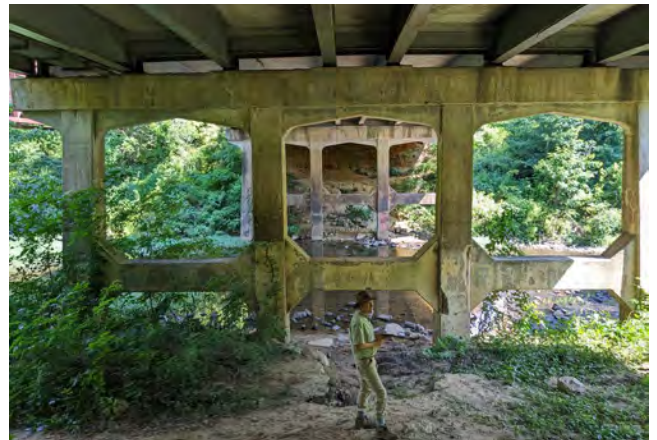
Under US 501 (Roxboro Road) bridge over Eno River, view downstream from the south bank to the north bank. Pete Schubert.

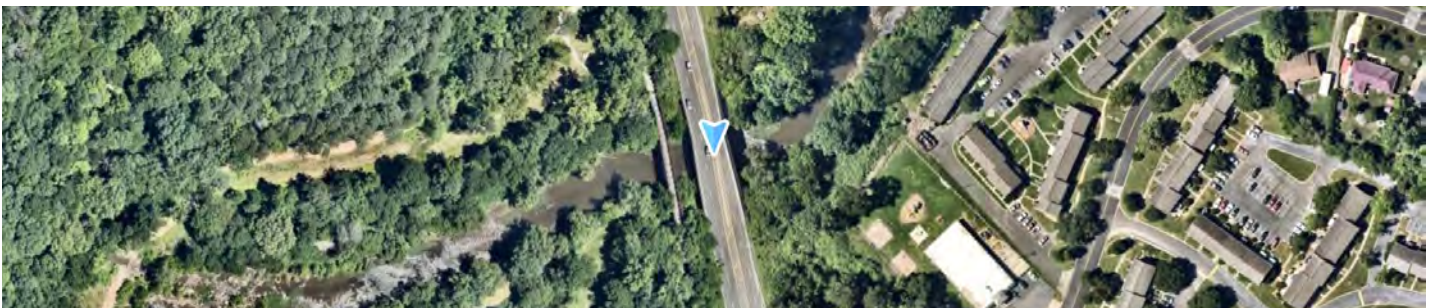
Aerial photograph of US 501 (Roxboro Road) bridge over Eno River. Nearmap.

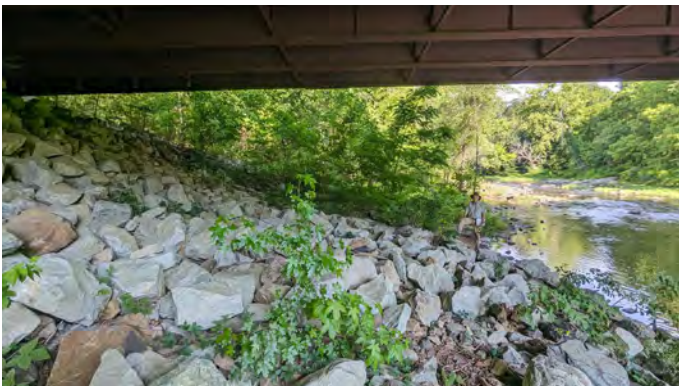
East side of Guess Road bridge over Eno River.  
Pete Schubert.

Barriers to wildlife travel under the bridge exist, which encourages wildlife travel on the roadway and results in conflicts with motorists. The substrate is a continuous rocky bottom throughout with large stones and some exposed bedrock. A low-profile concrete weir exists under the bridge perpendicular to the river water flow which may be a remnant from a former abutment. Large riprap covers the slope on both sides, beginning at the river's edge. Both riprap slopes have a shelf that could be remediated for wildlife passage. The south side has a 5-foot wide dry passage near the top of slope but it would be difficult for wildlife to negotiate. The north side has a 50-foot-wide dry passage for the Mountains-to-Sea Trail. All entryways to the bridge appear to be clear of obstructions including any dense vegetation. Wildlife passage is not possible on the south side due to the placement of exposed, oversize riprap. Riprap on existing shelves could be relocated or removed to expose a natural surface, or it could be left in place and the voids filled with fine aggregate and alluvial materials to create a natural surface.

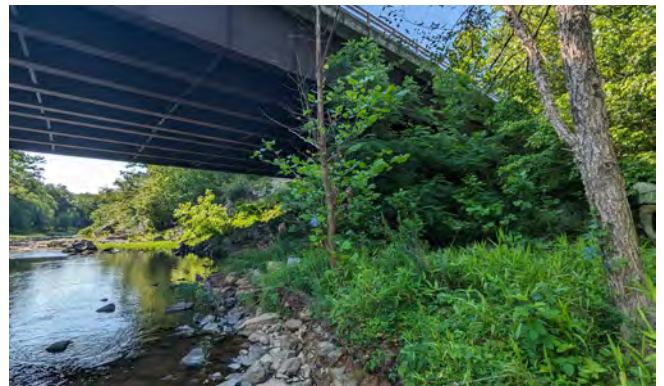
West side of Guess Road bridge over Eno River.  
Pete Schubert.

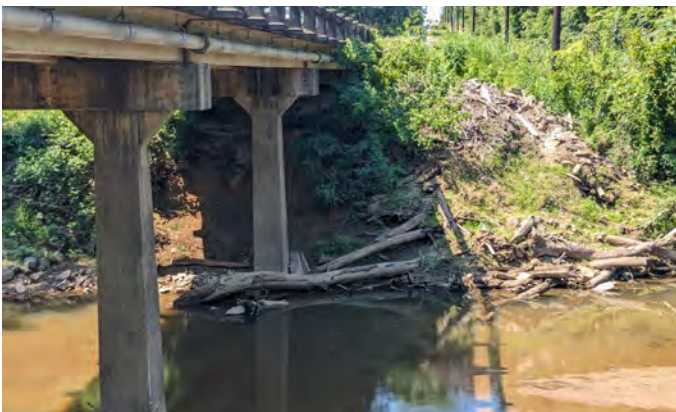
Old Oxford Road bridge over Eno River looking South. Pete Schubert.

Barriers to wildlife travel within this core and under the bridge exist, which encourages wildlife travel on the roadway and results in conflicts with motorists. Above the river there are steep slopes with little to no riprap. The north slope contains many stranded debris at a high bench with about 12 feet of clearance. The bench is impassible due to the debris, and the highest portion has some riprap. There is a narrow semi-dry passage (4-5 feet wide) along the river edge with some gravel substrate. The south slope above the abutment wall is dry natural substrate with concrete on portions of the upper slope. There is approximately 8-10 feet of dry upper passage. At the bottom of the slope there is 5-6 feet of semi-dry passage with 7 feet of clearance.

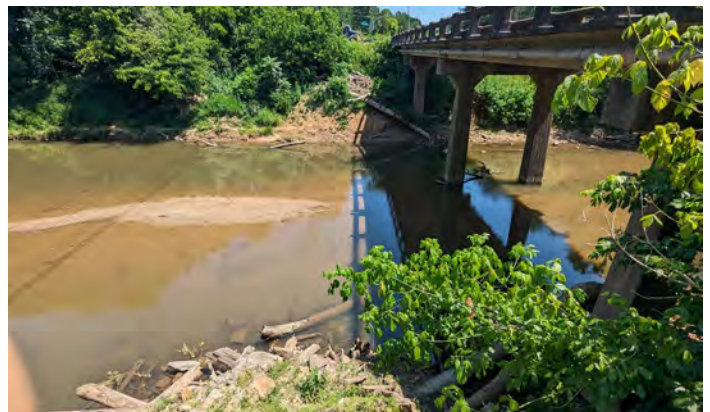
Old Oxford Road bridge over Eno River looking North. Pete Schubert.

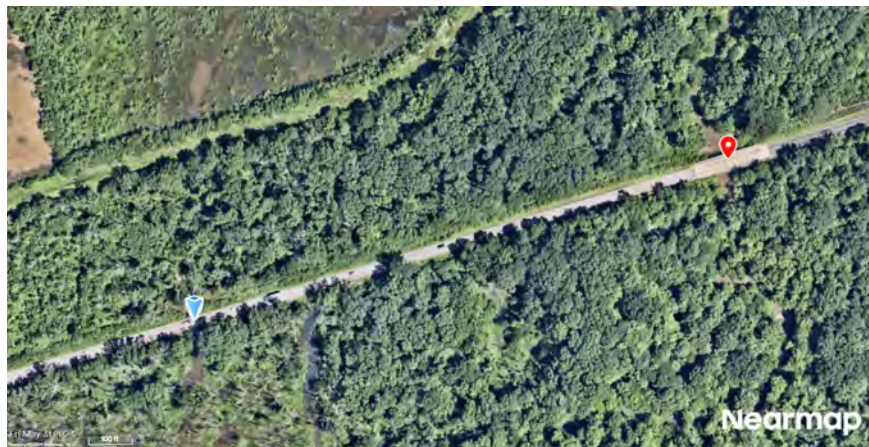
Approximately 500 feet upstream of NC 54 in the New Hope Creek floodplain is the New Hope Waterfowl Impoundment, which consists of two low (5-foot rise) earthen causeway/embankments (roughly 1,950 feet west and 250 feet east), connected by a 490-foot flat topped concrete spillway and a 2-bay stoplog control structure across the creek channel. Immediately downstream and parallel to the spillway and outlet structure is a 490-foot by 130-foot open water stilling basin, which provides a significant barrier to wildlife passage along the creek up and downstream, forcing movement away from the banks to cross the sub-impoundment structures, and then to return to the narrowed banks approaching the NC 54 bridge and causeway. Additionally, when seasonally impounded (fall/early winter), terrestrial wildlife passage is forced to the far edges of the inundated floodplain. Though the grassed, low slope sub-impoundment embankments are not significant barriers, the NC 54 embankment and motor vehicle traffic is. Additional dry culverts should be added to NC 54 at the causeway ends to allow for dry passage of wildlife when the impoundments above and/or below NC 54 are flooded.

Aerial photograph of NC 54 culvert (west) and bridge (east) over New Hope Creek. Nearmap.

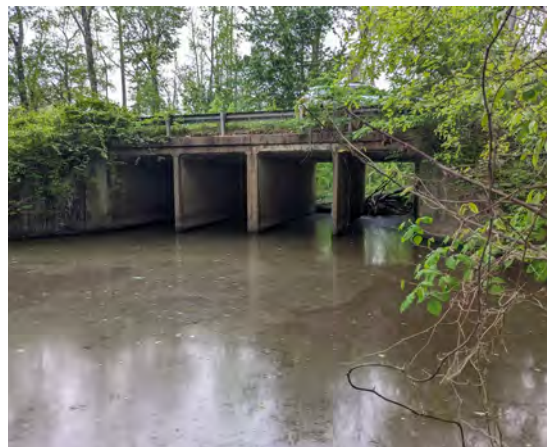
NC 54 culvert over New Hope Creek.  
Pete Schubert.  
DCHC MPO Wildlife Crossings Plan - 79

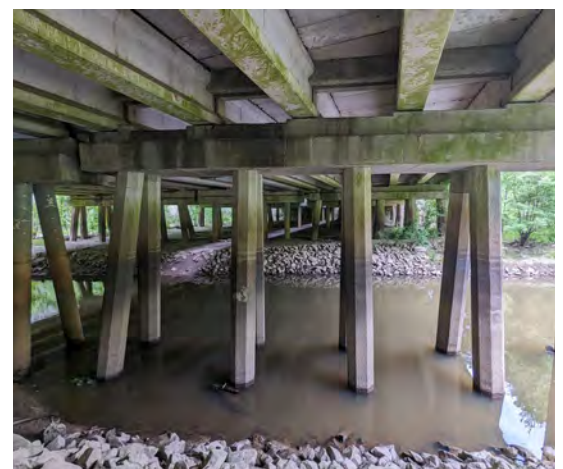
Under I 40 bridge facing east over New Hope Creek. Pete Schubert.

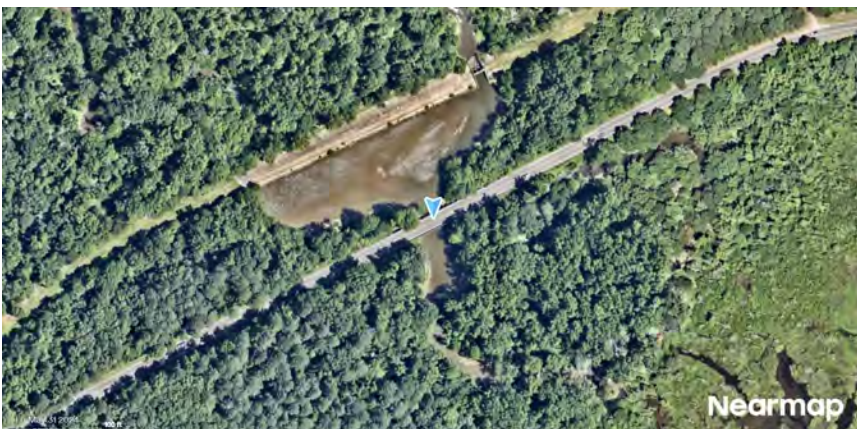
Approximately 270 feet upstream of Stagecoach Road in the New Hope Creek floodplain is the NCWRC's "Stagecoach Road Waterfowl Impoundment", which consists of two low (5-foot rise) earthen causeway/embankments (roughly 830 feet West and 500 feet East), connected by a 590-foot flat-topped concrete spillway and a 2-bay stoplog control structure across the creek channel. Immediately downstream and parallel to the spillway and outlet structure is a 620-foot by 150-foot open water stilling basin, which provides a significant barrier to wildlife passage along the creek up and downstream, forcing movement away from the banks to cross the sub impoundment structures, and then to return to the narrowed banks approaching the Stagecoach Road bridge and causeway. Additionally, when seasonally impounded (fall/early winter), terrestrial wildlife passage is forced to the far edges of the inundated floodplain. Though the grassed, low slope sub impoundment embankments are not significant barriers, the Stagecoach Road embankment and vehicle traffic is. Additional dry culverts should be added to Stagecoach Road at the causeway ends to allow for dry passage of wildlife when the impoundments above and/or below Stagecoach Road (including when Jordan lake rises) are flooded.

Aerial photograph of Stagecoach Road bridge over New Hope Creek. Nearmap.

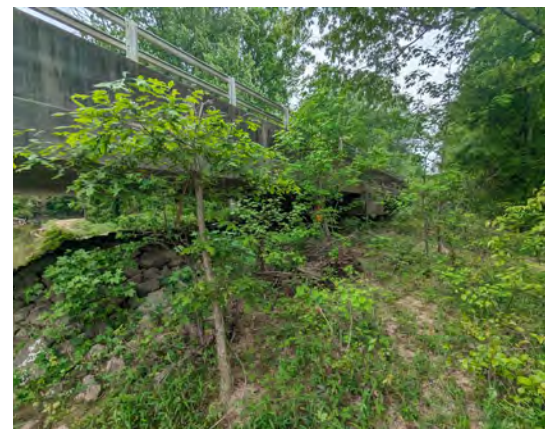
South side of Stagecoach Road bridge facing North over New Hope Creek. Pete Schubert.

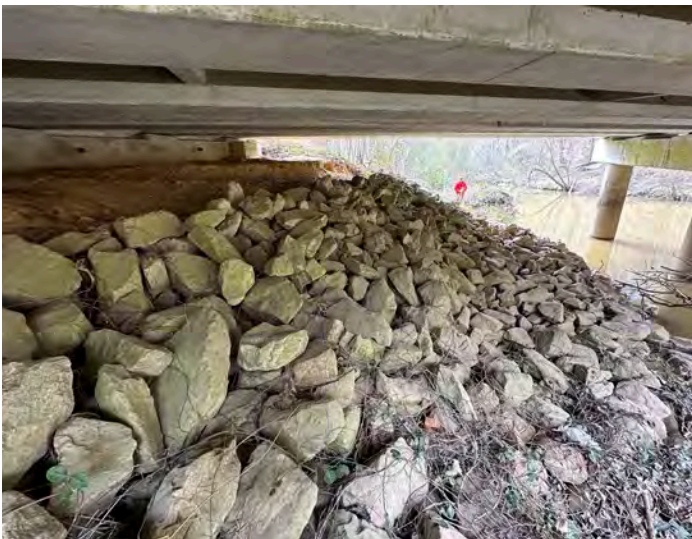
South side of Old Chapel Hill Road bridge over New Hope Creek looking north. DCHC MPO.

Barriers to wildlife travel along this corridor and under the bridge exist, which encourages wildlife travel on the roadway and results in conflicts with motorists. A significant obstacle to safe wildlife passage under the existing structure is the lack of bare ground between the riprap slope protection and the creek channel. While the lower portions of the riprap have trapped some interstitial sediment, there are many voids and a very uneven surface that would prevent smaller wildlife from crossing.

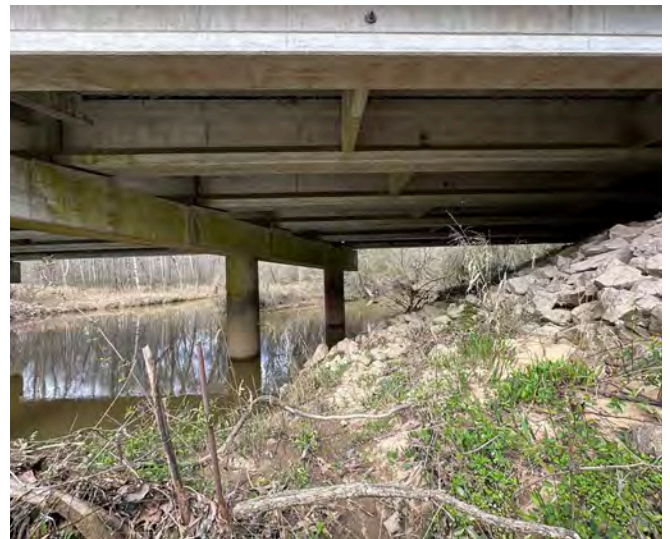
North side of Old Chapel Hill Road bridge over New Hope Creek looking south. DCHC MPO.

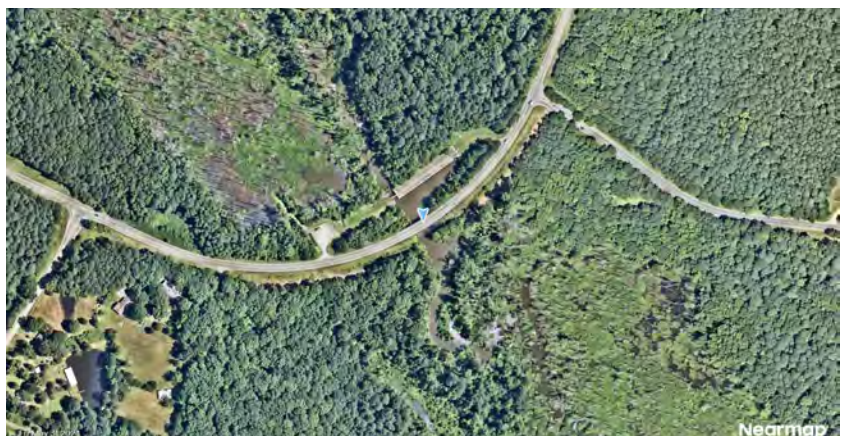
On the west side of the underpass, there exists a natural earth area above the riprap slope protection, approximately 12 feet wide and 7 feet high, that could function for wildlife passage, however, because it is entirely above the riprap and there is no path down the riprap to the floodplain habitat either upstream or downstream, it is not connected. Similarly, on the east side of the underpass, the potential dry area passage is about 12 to 15 feet wide and 7 to 8 feet high, but it is inaccessible to the up and downstream habitat by the continuous riprap slope protection on both the roadway embankment/causeway and the sub impoundment spillway and embankment. There is a 4 to 6 foot bench in the surface of the riprap near both outer bents, which could be connected to adjacent habitat if the benching was continued to the limits of the riprap and the voids were filled with small stone to provide a natural surface.

Aerial photograph of Farrington Road bridge over Little Creek. Nearmap.

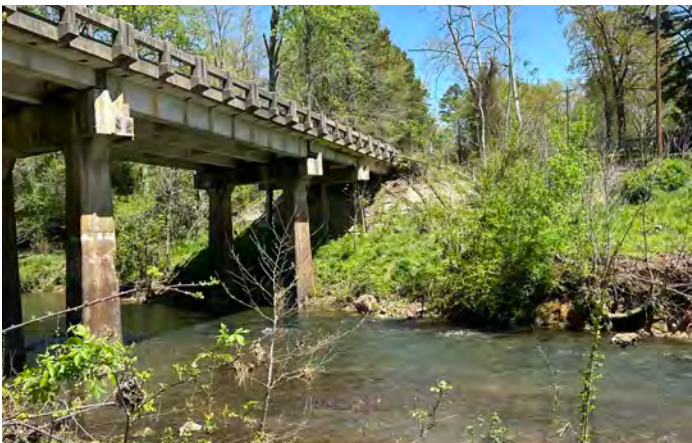
Barriers to wildlife travel within this core and under the bridge exist, which encourages wildlife travel on the roadway and results in conflicts with motorists. Current site conditions show that while the bench on the west side is serving as both wildlife passage and the MST alignment, the east side of the bridge is not conducive to wildlife movement due to the steep concrete slope and moderately steep natural surface embankment with no functional bench. Note that the master plan for continuation of the MST to the north (upstream) has the MST crossing the Eno River on or adjacent to the Pleasant Green Road bridge. As such, the new bridge must include enough new bend on the river's east side to accommodate wildlife passage and trail passage needed once the MST is open on the east side. The east side is presently used by fisherfolk to access bank fishing, which is likely to continue.

Pleasant Green Road bridge over Eno River facing East. DCHC MPO.

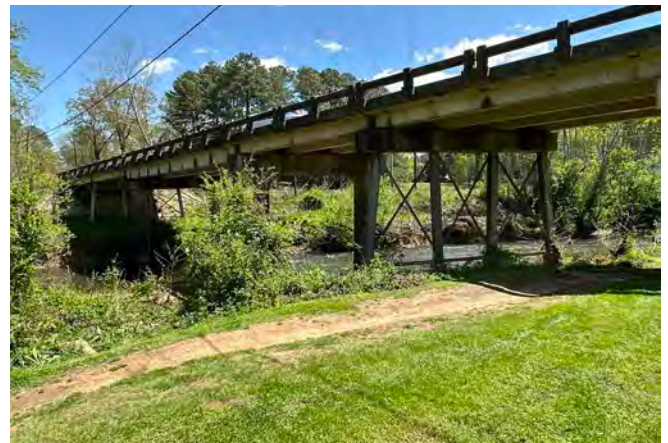
Pleasant Green Road bridge over Eno River looking southwest. DCHC MPO.

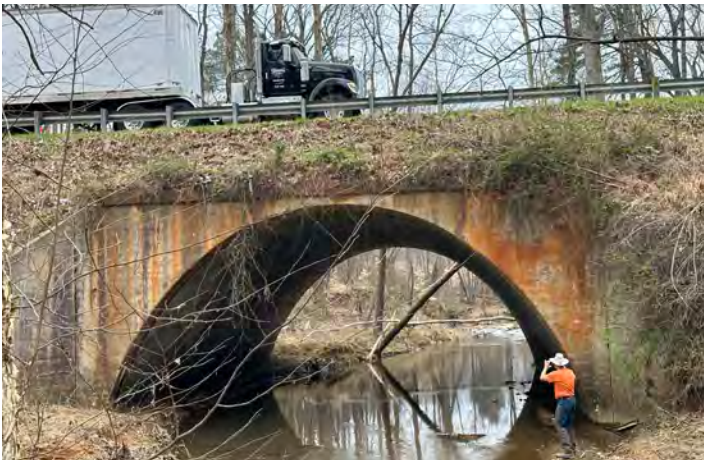
The structure at this site is a bottomless, single-cell culvert. The Stony Creek bed generally consists of sound bedrock, with varying depths, which continues through the culvert, providing a solid natural creek bottom within the culvert. Barriers to wildlife travel through the culvert exist, which encourages wildlife travel on the roadway and results in conflicts with motorists. The barriers include standing water in the channel, lack of continuous dry bank on one side, narrow and ephemeral dry banks on side, diminishing height of culvert at banks (sloping culvert walls), and steep embankments. The roadway has standard guardrail along both sides, which is porous to terrestrial wildlife.

US 70 culvert over Stony Creek, facing southwest upstream. DCHC MPO.
