# **WILDLIFE CROSSINGS PLAN**

**DURHAM-CHAPEL HILL-CARRBORO  
METROPOLITAN PLANNING ORGANIZATION**

**Adopted November 19, 2024**

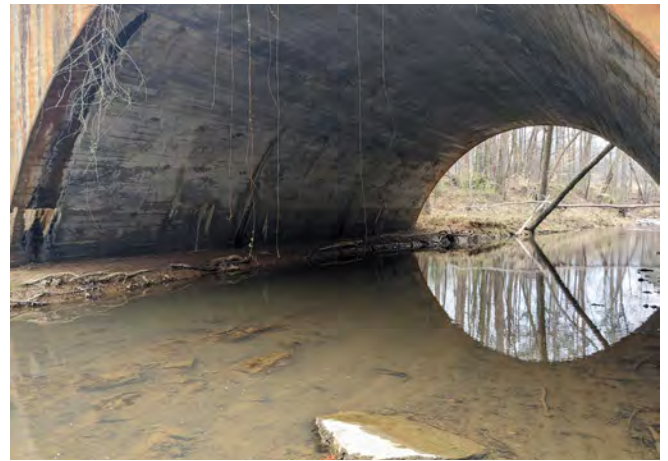
The structure at this site is a bottomless, single-cell culvert. The Stony Creek bed generally consists of sound bedrock, with varying depths, which continues through the culvert, providing a solid natural creek bottom within the culvert. Barriers to wildlife travel through the culvert exist, which encourages wildlife travel on the roadway and results in conflicts with motorists. The barriers include standing water in the channel, lack of continuous dry bank on one side, narrow and ephemeral dry banks on side, diminishing height of culvert at banks (sloping culvert walls), and steep embankments. The roadway has standard guardrail along both sides, which is porous to terrestrial wildlife.

US 70 culvert over Stony Creek, facing southwest upstream. Pete Schubert.

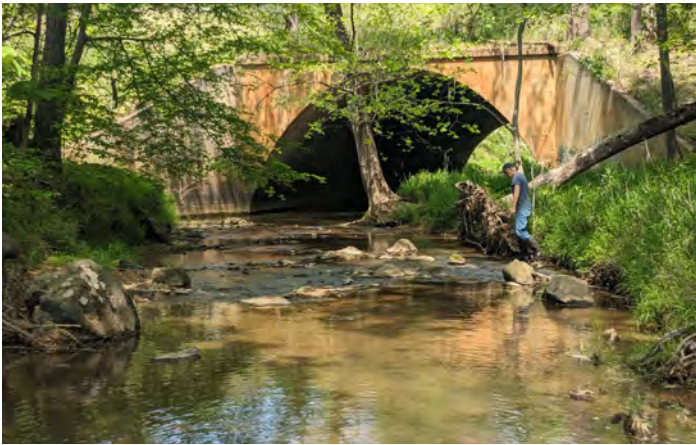
Barriers to wildlife travel through the culvert exist, which encourages wildlife travel on the roadway and results in conflicts with motorists. This site does provide dry passage (approximately 25 feet) on the east side of the stream during low water conditions. However, there is no dry passage on the west side of stream, and the stream bank leading up to the culvert on the west side is extremely steep. As a result, wildlife will be forced around the steep stream bank (and the concrete wingwall extending from the culvert inlet) and up the road embankment to the roadway. However, the stream channel itself is narrow, shallow, and slow enough (at least during the low water conditions) that many wildlife species would be able to cross the stream to dry passage on the east side. During times of high and fast water flow, wildlife would be prevented from crossing the stream and could attempt to cross on the roadway.

I-85 culvert over Stony Creek, facing north, downstream. Pete Schubert.

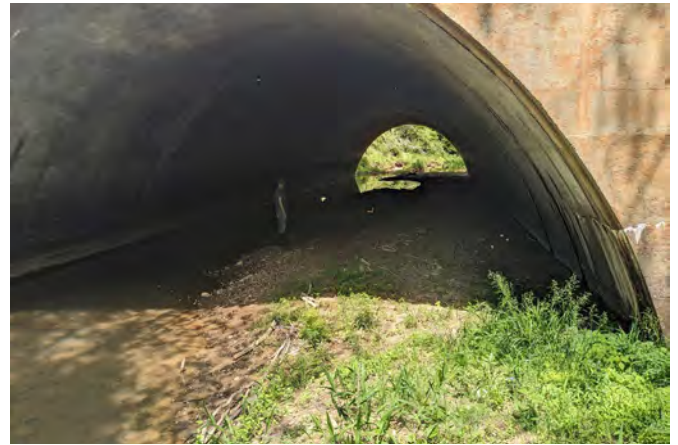
I-85 culvert over Stony Creek, facing north, downstream. Pete Schubert.

Replace the culvert with a bridge of sufficient span length to provide dry passage for wildlife on natural surfaces on atop both east and west stream banks, with such passage constructed continuous with habitat up and down stream. Provide two separate spans (eastbound and westbound) with a median gap to allow daylight to penetrate to the stream and banks below the bridge. Install fencing along the roadway ROW / toes of the embankment (both sides) of sufficient length to guide large wildlife through the culvert.

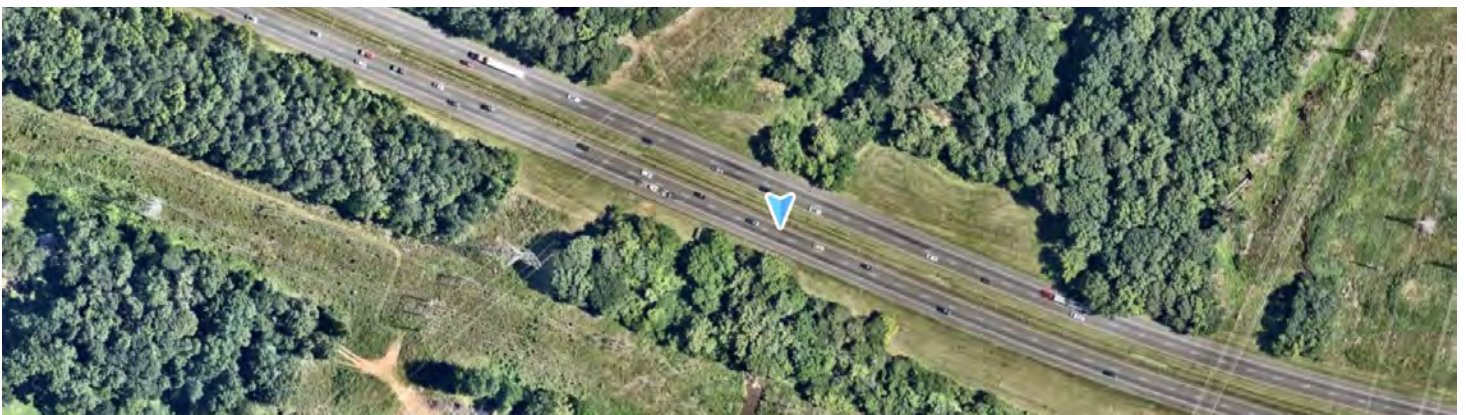
Aerial photograph of I-85 culvert over Stony Creek. Nearmap.

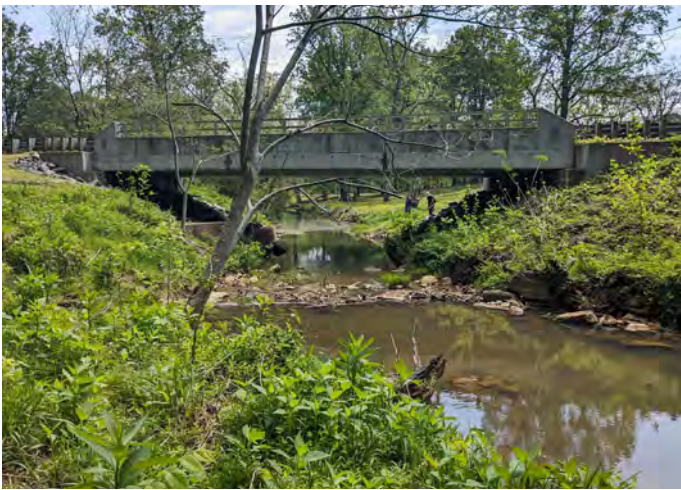
Barriers to wildlife travel under the bridge exist, which encourages wildlife travel on the roadway and results in conflicts with motorists. Identified barriers include concrete walls and steep, exposed riprap slopes that cover the entire area under the bridge. There is also a steep riprap slope on the northeast side extending from the streambank/underpass area up to the road. Stream fills the channel between concrete walls with no dry passage. Remnants of wooden piers are embedded in what are likely concrete footings for former bridge piers, now abandoned in place and confining the channel under the current bridge. Because these old structures confine the channel, the adjacent riprapped slopes could be benched / terraced and choked with fines to provide stabilized natural surface dry passages under the bridge. These could easily be connected to dry banks up and down stream. Due to the close proximity of driveways and private parcels, wildlife fencing may not be appropriate.

East side of University Road bridge over Stony Creek, facing northwest. Pete Schubert.

Create a bench in the existing riprap slope protection on each side of the creek under the bridge, and use small stones to fill the voids to create a natural surface wildlife passage that is connected upstream and downstream to existing habitat areas.

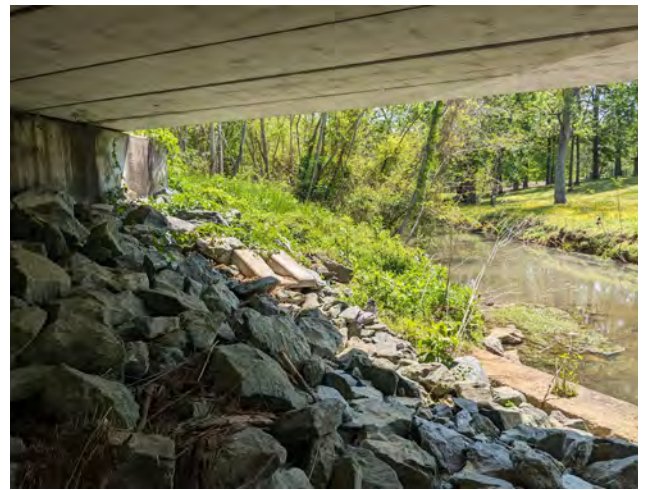
Underneath University Road bridge over Stony Creek, facing northwest. Pete Schubert.

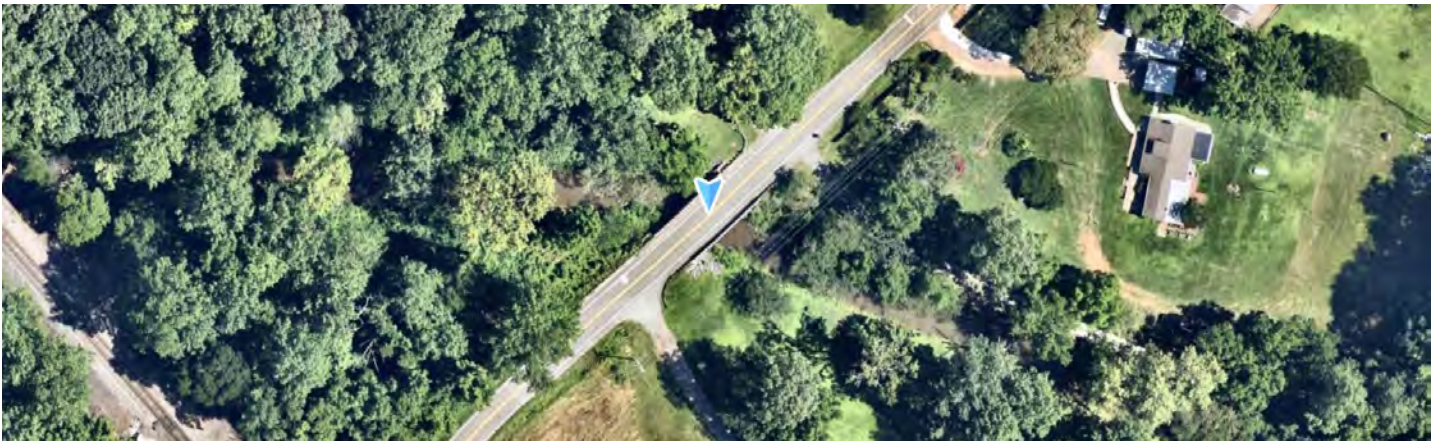
Aerial photograph of University Station Road. Nearmap.

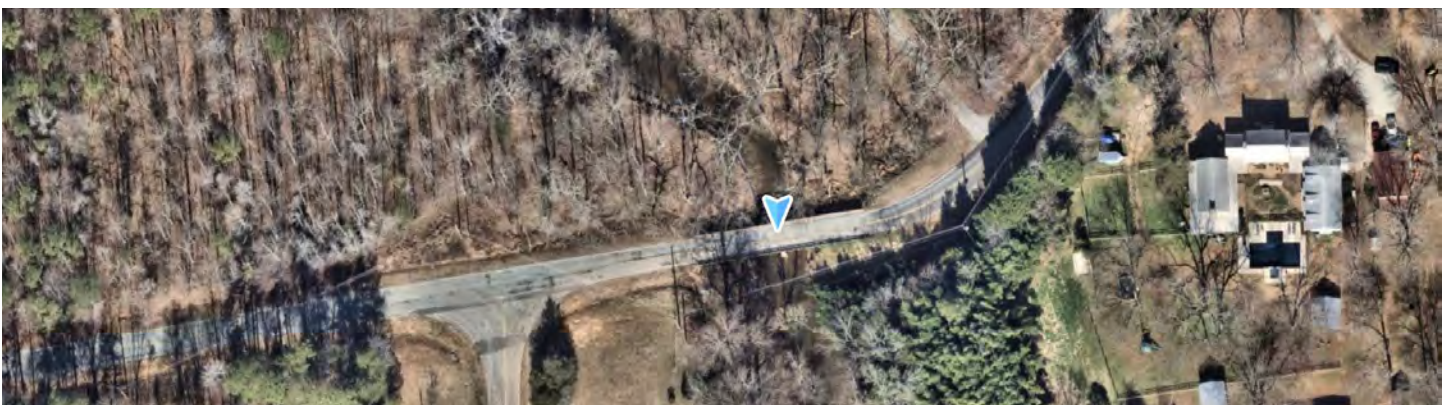
- Replacement bridge span has an increase of approximately 20 feet. This bridge lengthening allows greater opportunity to create dry passage underneath and along the embankments for wildlife to travel.
- Details for the shoulder berm gutter shows a mountable curb inside of a standard steel guardrail set on posts. This can contribute to adequate passage for smaller wildlife.
- The bridge profile depicts an increase in clear span height from a 13-foot average (existing) to 21.5-foot average (new/replacement), providing a clear span at the toe of the Class II Riprap slope protection of 13 feet on west end and 14 feet on east end. This increase can help create dry wildlife passage at low flow/discharge.

Aerial photograph of Halls Mill Road bridge over Eno River. Nearmap.

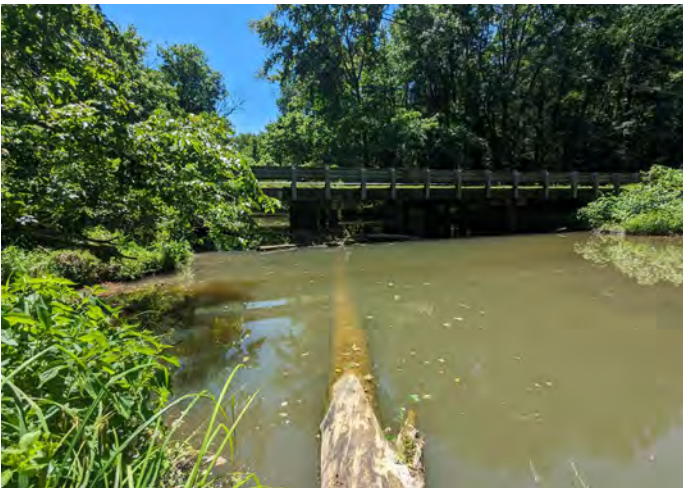
East side of Jones Ferry Road bridge over Neville Creek. Pete Schubert.

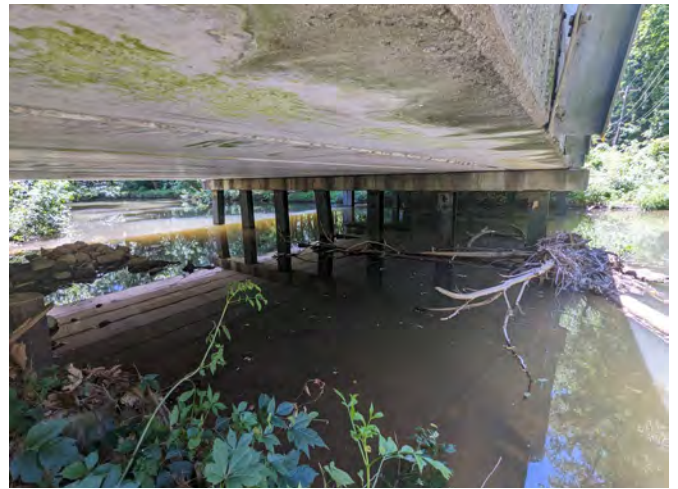
Barriers to wildlife travel along this corridor and under the bridge exist, which encourages wildlife travel on the roadway and results in conflicts with motorists. The barriers include standing water, riprap, and low visibility. Standing water is present just outside of the bridge underpass area and extends into habitat areas that are in the direct path for wildlife toward the dry underpass. The low visibility of the passage area under the bridge is caused by dense vegetation near openings and (possibly) the metal wings extending from the ends of bridge.

Underneath Jones Ferry Road bridge over Neville Creek, facing Northeast. Pete Schubert.

Replace the existing bridge and raise the road's approach to it to increase the height clearance for the dry passage areas. The bridge span should be long enough, and above flood level, to allow for dry passage on both sides of the creek. Fencing to guide wildlife into the underpass should then be installed.

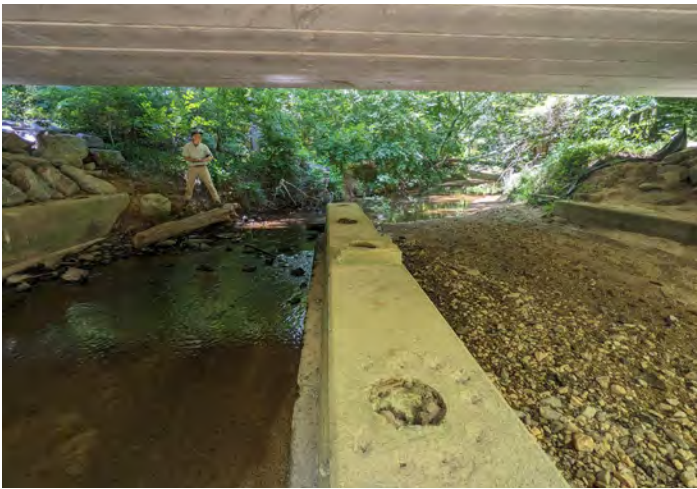
Under Neville Road bridge over Phil's Creek, facing East. Pete Schubert.

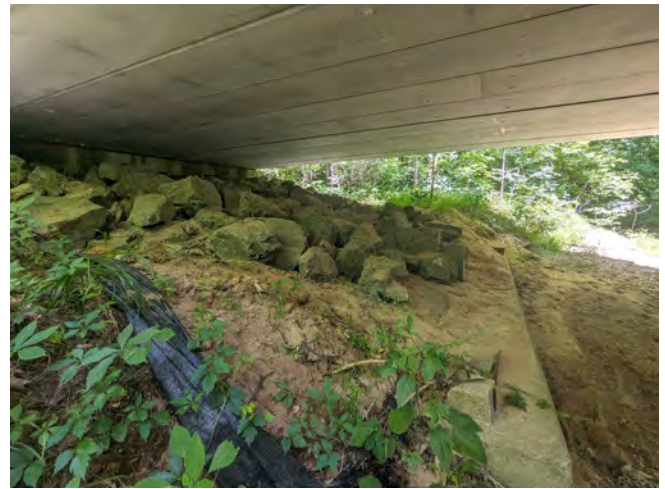
Barriers to wildlife travel along this corridor and under the bridge exist, which encourages wildlife travel on the roadway and results in conflicts with motorists. The bridge at this site was replaced within the past few years. While the footings for the previous bridge were left in place to minimize disturbance to the creek channel, they are constraining the flow and some wildlife access to the creek under the bridge. However, the outer footings stabilize the low-slope abutment embankment toes, providing considerable space for dry wildlife passage. But such passage is not possible due to the placement of exposed, oversize riprap. Given the low slope, the riprap could be removed, but the sheer size of the riprap and the low overhead clearance makes heavy equipment access difficult. If the riprap can be relocated or removed to expose a natural surface, it can be left in place with the voids filled with fine aggregate and alluvial materials to create a natural surface at all points with at least 4-feet of vertical clearance to the deck bottom above. Under the bridge, there is ephemeral dry passage through only the north channel, and only at low flow. At higher flows, both channels have standing water and there is no dry passage due to the riprap slope lining on both sides, except on the narrow (one-foot wide) flat footing tops.

Under Neville Road bridge over Phil's Creek, facing South. Pete Schubert.

Remove the riprap slope protection under the bridge on both sides up to within 4 feet of the underside of the deck, leaving a low-slope natural surface dry passage for wildlife on both sides of the creek.

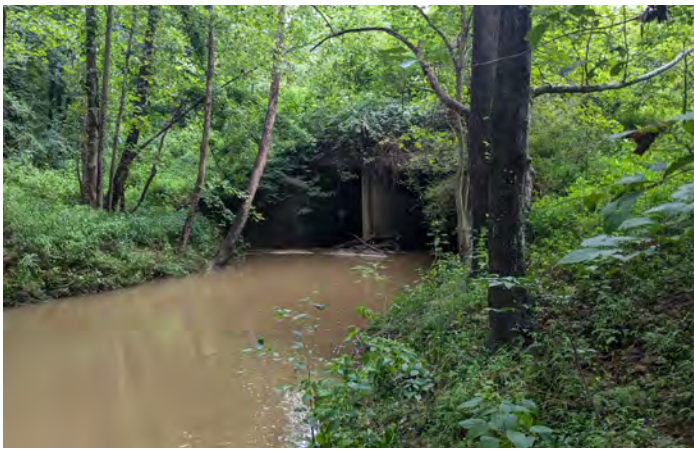
North side of NC 54 culvert, facing South.  
Pete Schubert.

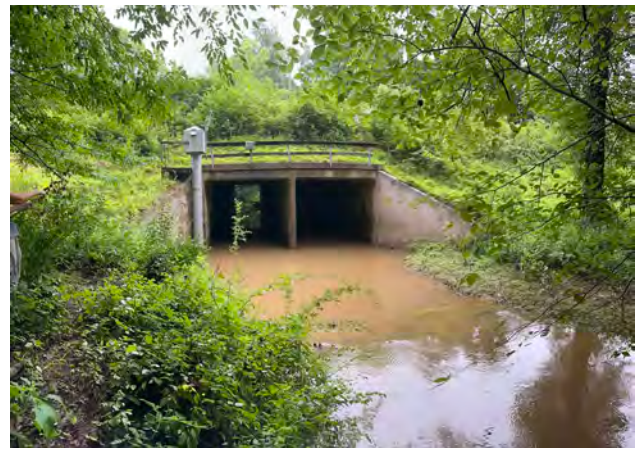
South side of NC 54 culvert, facing North.  
Pete Schubert.

Replace the flooded bottom box culvert with a single span bridge of adequate span length and height to provide dry passage for wildlife on both sides of the creek under the structure. Connect new dry passages to adjacent habitat up and downstream on both sides of the stream. Install fencing along the ROW approaching the bridge to guide wildlife into the dry crossings under the new bridge and deter crossing NC 54. Perform annual vegetation management in accordance with the NCDOT Vegetation Management Manual and standard practices.

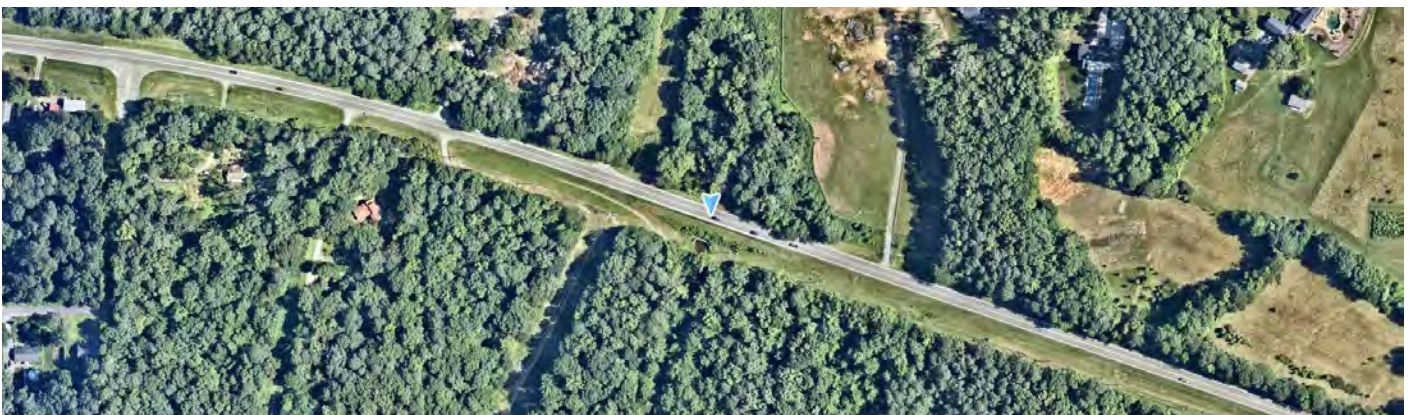
Aerial photograph of NC 54 culvert over Morgan Creek. Nearmap.

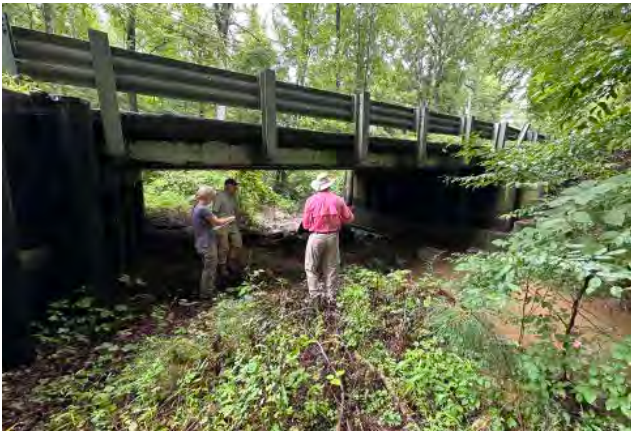
West side of Damascus Church Road bridge over Pritchard Mill Creek, facing east. DCHC MPO.

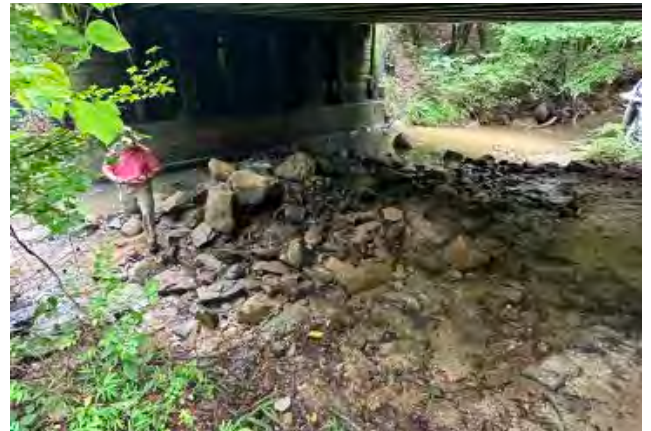
East side of Damascus Church Road bridge over Pritchard Mill Creek, facing west. DCHC MPO.

As part of this bridge replacement, ensure the replacement bridge is high and long enough to allow for dry passage on both sides of the creek, especially during times of high flood. It is recommended that the span be lengthened, especially to the south where there is currently no dry passage, and the creek channel is against the footing of the abutment wall. Connect new natural surface dry passages to up and downstream habitat on both sides of the creek.

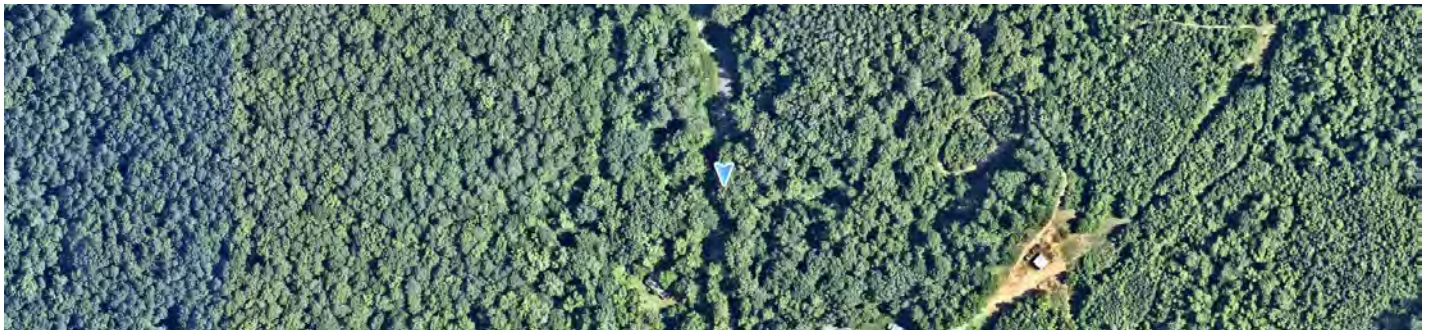
Aerial photograph of Damascus Church Road bridge over Pritchard Mill Creek. Nearmap.

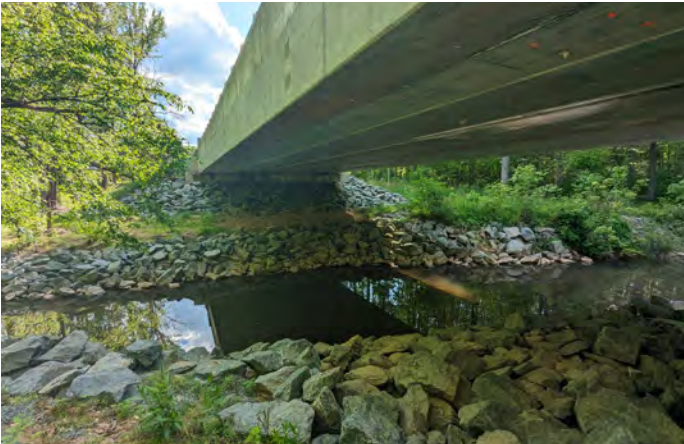
View of west bank, under New Hope Church Road bridge over New Hope Creek. Pete Schubert.

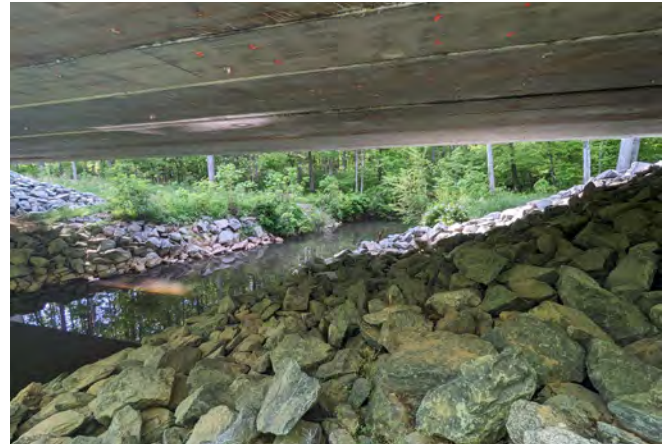
Barriers to wildlife travel along this corridor and under the bridge exist, which encourages wildlife travel on the roadway and results in conflicts with motorists. The east bank slope is completely covered with gently sloping riprap from the abutment 2 feet below the deck to the bottom of the bank, interfering with dry passage on this side only. However, the west bank has a level dry passage, but will not function at high water due to riprap covering the balance of the slope up to the 2 feet abutment under the deck. The bridge span is of adequate distance and has gentle dry slopes underneath to accommodate wildlife passage if the riprap placed above the top of the bank is choked with small stone to provide a natural surface to within 2 feet vertically of the underside of the bridge deck.

East bank, under New Hope Church Road bridge over New Hope Creek. Pete Schubert.

Create a natural, dry surface for wildlife passage by using small stones to choke/fill the voids within the portions of the existing riprap slope that is below 2 feet from the underside of the deck to the top of the creek bank.

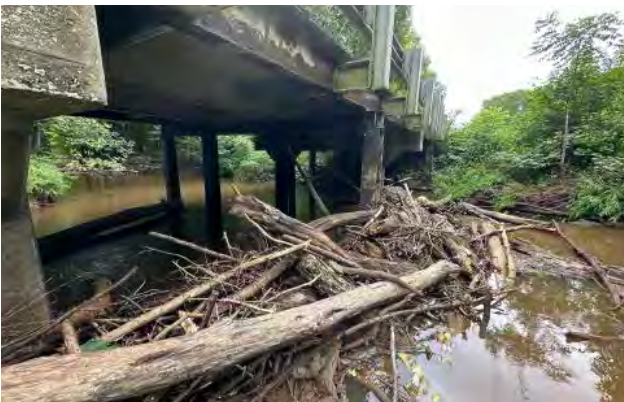
West side of NC 86 bridge over New Hope Creek, facing east. DCHC MPO.

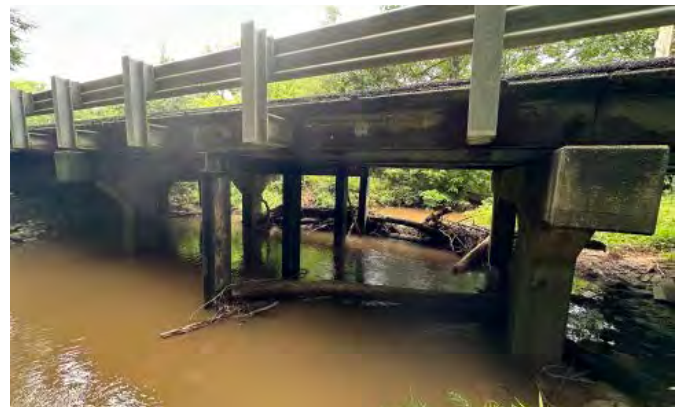
Barriers to wildlife travel along this corridor under the bridge exist, which encourages wildlife travel on the roadway and results in conflicts with motorists. Barriers include riprap on the entire south abutment slope, and old construction debris in the lower portion of the north slope and bank. The existing bridge span is of insufficient length to fully accommodate dry passage on both banks at high creek levels, as evidenced by stranded woody debris and flotsam. The existing bridge is low and narrow and appears to have been structurally repaired and augmented many times over the years, and a replacement bridge provides the opportunity to improve dry wildlife passage along both creek banks. Lengthening the bridge span as part of the replacement is the most critical, combined with replacing the multiple bents with a single span across the entire crossing.

East side of NC 86 bridge over New Hope Creek, facing west. DCHC MPO.

As part of the bridge replacement project, raise the NC 86 causeway profile through the entire New Hope Creek floodplain and install a replacement bridge with a span high and long enough to create a passage bench for wildlife on both sides of the creek, which must remain dry during times of high flood. Avoid placing riprap slope protection on abutment slopes, and provide dry connection to adjacent habitat up and downstream on both banks.

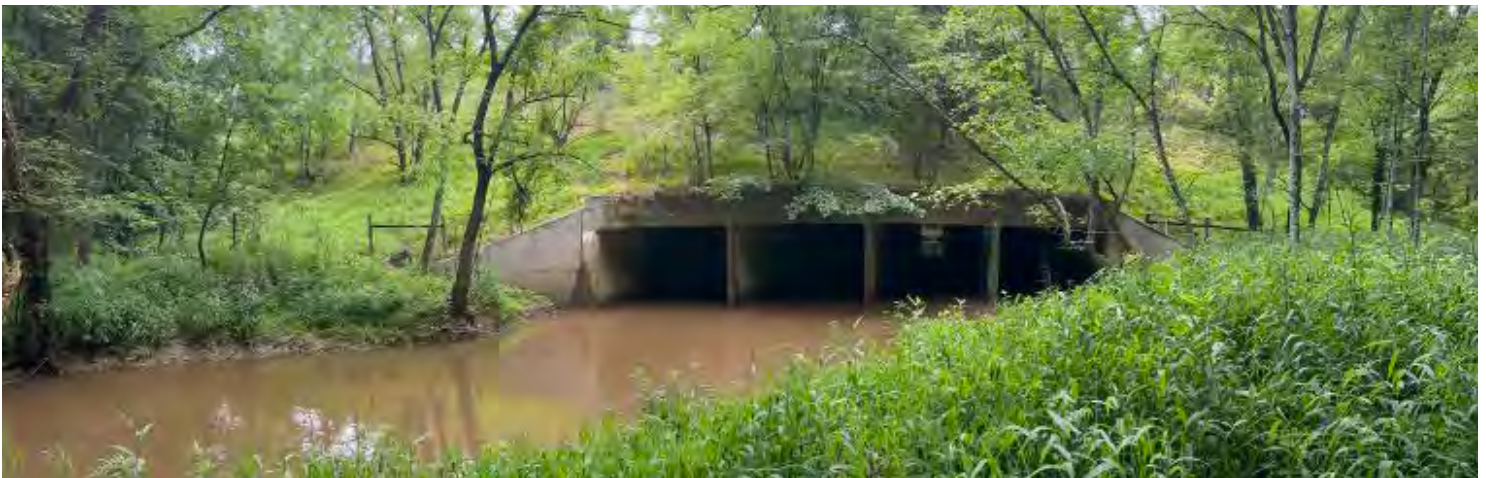
Barriers to wildlife travel along this corridor through the culvert exist. No dry passage for wildlife exists at this site due to continued standing water in the culvert. Combined with ROW fencing that was installed on both sides of the creek, this site creates an ecological dead end for wildlife. However, white-tailed deer have navigated through the existing ROW fence and onto the roadway as indicated by the reported WVCs.

East side of I-40 culvert over New Hope Creek, facing west. DCHC MPO.

Replace the existing 4-cell culvert with a multicell culvert which includes additional outer raised bottom elevation culverts to accommodate dry passage for both creek banks. Construct these new dry passage culverts with natural surface floors. Connect these new dry passages to adjacent habitat up and downstream.

Construct separate, new dry culverts through the I-40 embankment out from the existing flooded culvert to accommodate dry passage for both creek banks. These two new culverts should be at least 8 feet high and 12 feet wide, with a natural surface floor and be straight with no offset or skew. Replace existing ROW fencing with taller fencing to guide wildlife into the dry passes from the adjacent habitat areas and deter wildlife climbing the embankment to attempt to cross I-40.

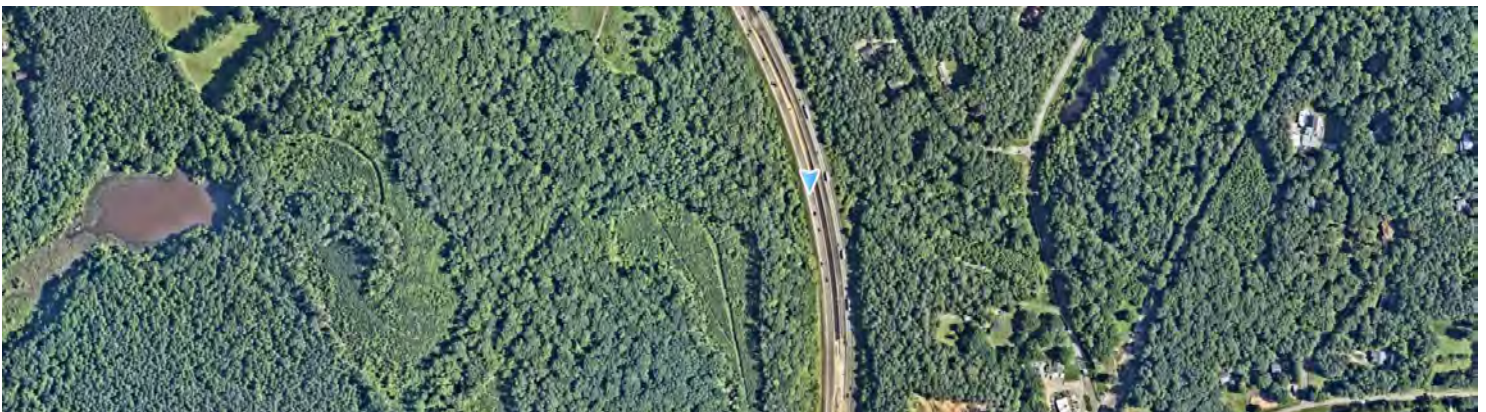
Aerial photograph of I-40 culvert over New Hope Creek. Nearmap.

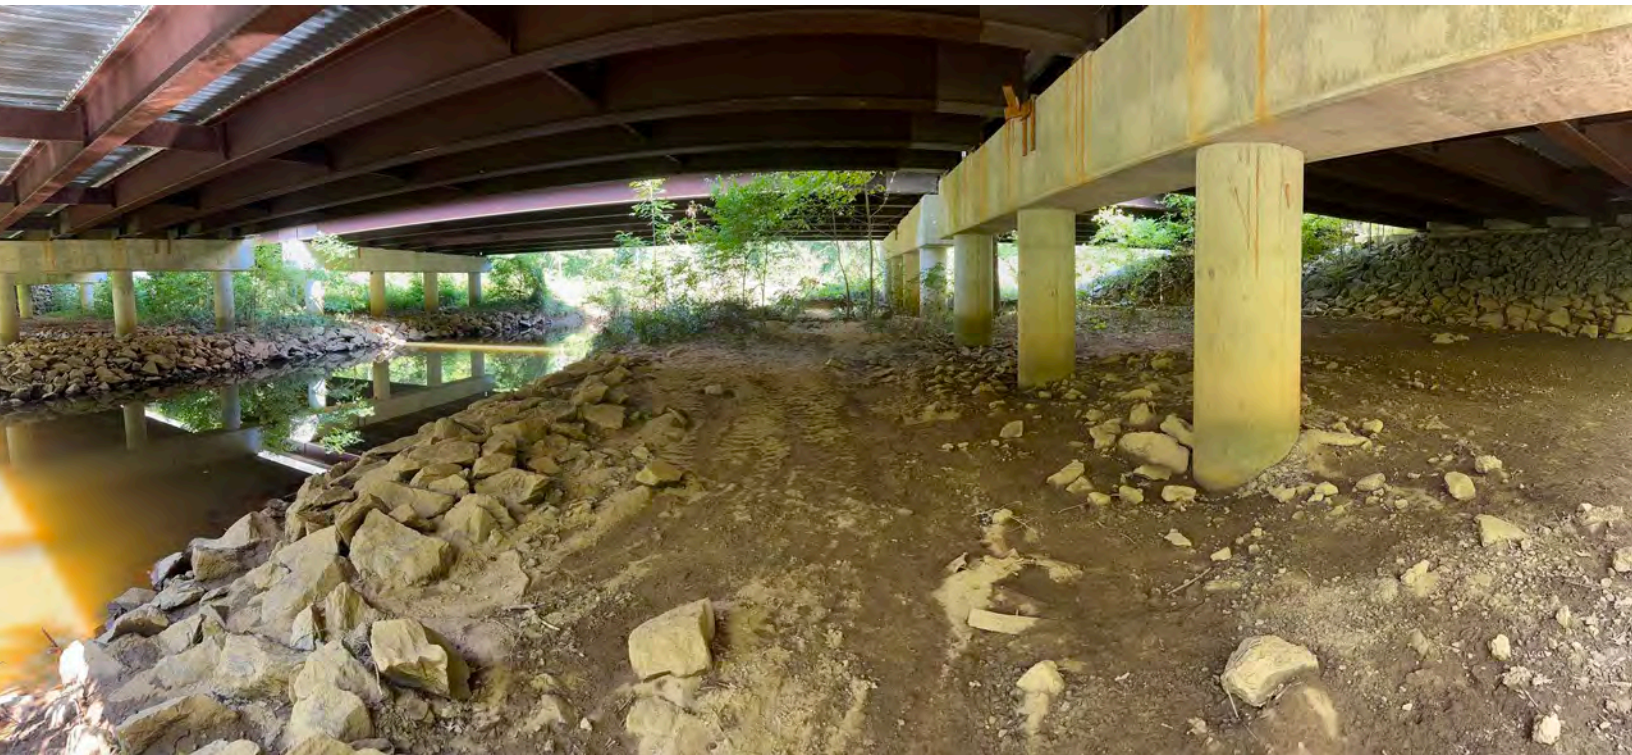
US 15-501 bridge over New Hope Creek in Durham County. DCHC MPO.
