Section 3.2

DURHAM COUNTY RECOMMENDATIONS

The DCHC MPO is recommending ten (10) projects for Durham County (two (2) reside in the City of Durham) as part of this plan. The list of projects can be found below in Table 3.2, and a map showing these sites are found in Figure 3.2: Map of complete list of wildlife crossing project recommendations in Durham County. Project recommendations assigned two project IDs signify two separate structures at the site.

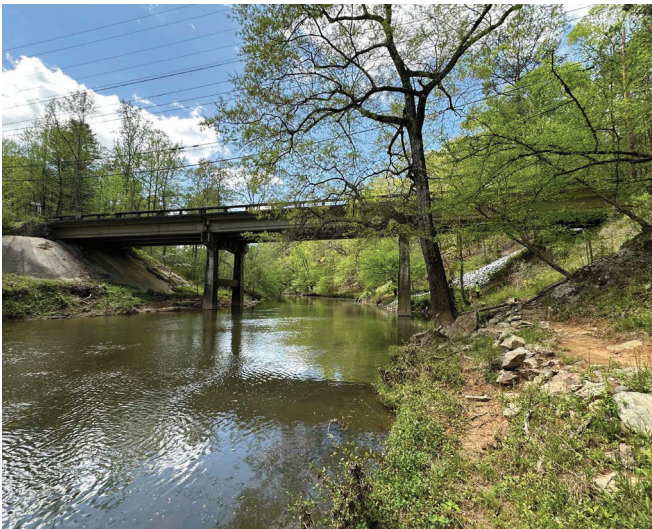
Barriers to wildlife travel exist within this core and under the bridge, which encourages wildlife travel on the roadway and results in conflicts with motorists. Riprap placed on the east side of the bridge on the north bank from the top of the steep slope all the way into the river to the base of the incised bank prevents dry passage for wildlife at any elevation. A bench created midway up this riprap slope that has been choked with pea gravel has not been connected to the habitat up or downstream. The natural surface slope under the bridge is steeply sloping from abutment at the top to the riverbank. The remains of the eroded and abandoned Pea Creek Trail (wood boardwalk, steps) interfere with dry passage on the north bank from the east, and the entire north bank is steeply sloped with no benches for wildlife access or human foot traffic. On the south bank, scour has narrowed to the width of the dry passage between the toe of the steep concrete paved slope protection surrounding the abutment, and woody vegetation at the top of the eroding bank interferes with passage of both wildlife and foot traffic of the Mountains-to-Sea Trail (MST) along the south bank of the Eno River under the bridge. All replacement, repair, and/or remediation work should be closely coordinated between NCDOT staff, Eno River State Park (ERSP) staff (Pea Creek trail, ERSP lands), and NC Division of Parks and Recreation.

East side of Cole Mill Road bridge over Eno River, facing southwest. DCHC MPO.

Replace the bridge with a longer span that provides sufficient room for dry wildlife and trail passage on both banks of the river. Vertical bents at the abutments are recommended to maximize low slope dry passages and provide additional high water flow capacity to minimize bank scour. Connect dry passages to habitat up and downstream on both sides of the river.

Bench into the north bank slope to provide a minimum of 8 feet of dry passage for wildlife and trail foot traffic. Similarly, bench into the paved slope protection on the south bank. Connect dry passages to habitat up and downstream on both sides of the river. Repair the scour around the bent piers that are eroding into both banks and potentially threatening the integrity of the piers.

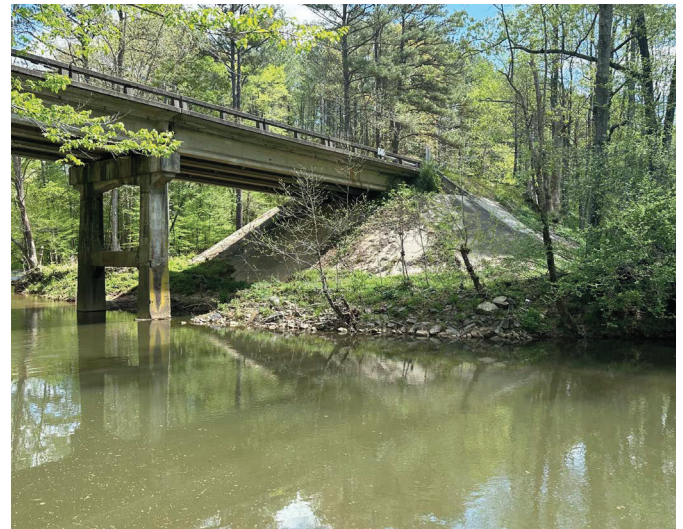
West side of Cole Mill Road bridge over Eno River, facing northeast. DCHC MPO.

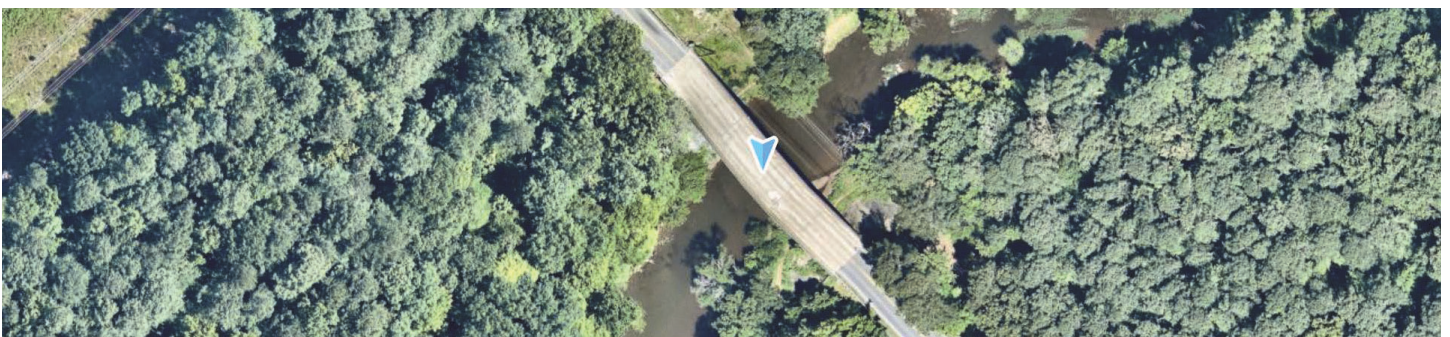
Aerial photograph of Cole Mill Road bridge over Eno River. Nearmap.

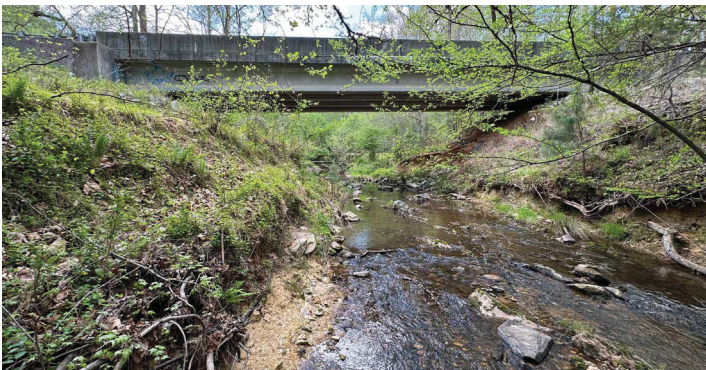
Barriers to wildlife travel exist within this core and under the bridge, which encourages wildlife travel on the roadway and results in conflicts with motorists. Barriers include scattered riprap, steep and actively eroding and undercut banks, and abandoned temporary silt fence and posts. The banks beneath the bridge appear to need immediate stabilization from creek bank erosion. The once uniformly steep, riprap slopes are now eroded, leaving hardpan and saprolite benches that are discontinuously present on both banks. Neither side provides continuous dry stream bank passage at any stream level.

The slopes from the creek bank to the abutments appear to have been once covered by riprap slope protection, but all that remains is some riprap within a few feet of each abutment; the rest has been eroded away and the underlying subgrades have been significantly scoured away. These slopes should be rebuilt to provide natural surface dry passage benches, while also providing critical stabilization of the abutment slopes. The bridge appears to be a recent replacement span and of adequate span length to provide dry passage on both sides if the slopes are reconstructed and stabilized adequately.

Rivermont Road ridge over Nancy Rhodes Creek looking Southwest. DCHC MPO.

Rebuild the eroded abutment slopes with retaining walls to provide a natural surface dry wildlife passage on both sides of the creek. Ensure passages connect into habitat up and downstream.

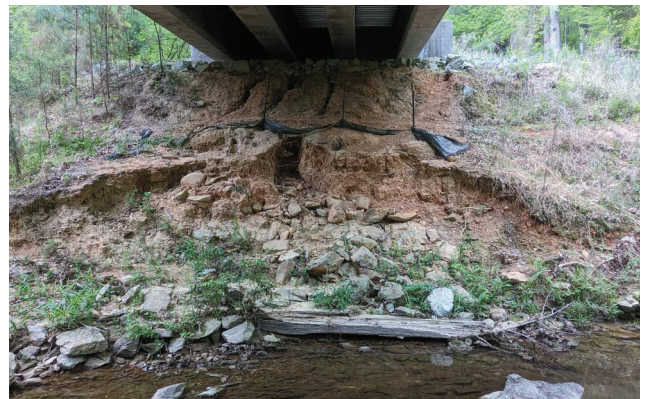
Rivermont Road bridge over Nancy Rhodes Creek looking East. Pete Schubert.

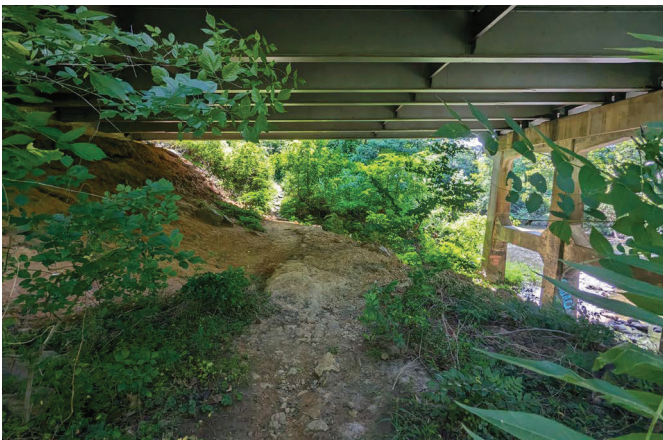
While barriers to wildlife travel under the bridge exist, which encourages wildlife travel on the roadway and results in conflicts with motorists, the wildlife passage appears to be highly viable along this section of the river and corridor approaching and under the bridge, and the natural surface stream banks are overall excellent. No major remediation is needed except for the northeast and southeast slopes needing deep erosion/incision and voids backfilled and stabilized to prevent recurrence, and to allow full wildlife passage.

Under US 501 (Roxboro Road) bridge over Eno River, view upstream on the south bank. Pete Schubert.

Evaluate and permanently repair deep erosion of banks due to stormwater flows coming from the roadway embankments and daylighting downstream of the bridge.

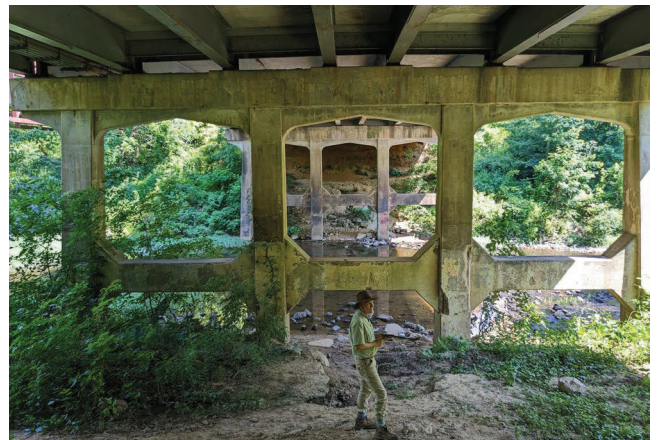
Under US 501 (Roxboro Road) bridge over Eno River, view downstream from the south bank to the north bank. Pete Schubert.

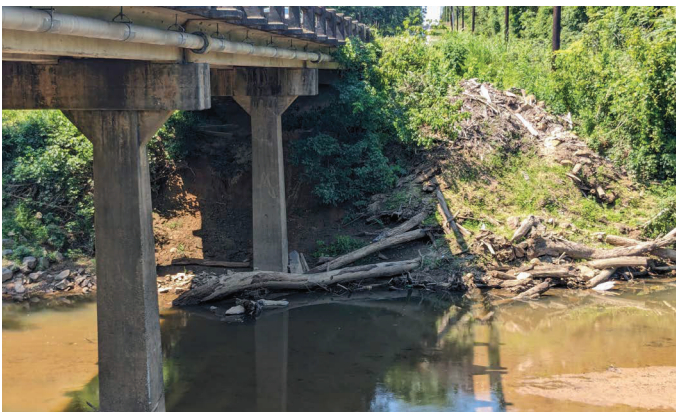
Barriers to wildlife travel within this core and under the bridge exist, which encourages wildlife travel on the roadway and results in conflicts with motorists. Above the river there are steep slopes with little to no riprap. The north slope contains many stranded debris at a high bench with about 12 feet of clearance. The bench is impassible due to the debris, and the highest portion has some riprap. There is a narrow semi-dry passage (4-5 feet wide) along the river edge with some gravel substrate. The south slope above the abutment wall is dry natural substrate with concrete on portions of the upper slope. There is approximately 8-10 feet of dry upper passage. At the bottom of the slope there is 5-6 feet of semi-dry passage with 7 feet of clearance.

Old Oxford Road bridge over Eno River looking South. Pete Schubert.

Replace the bridge and lengthen the span from the current hourglass-shaped causeway (and incised riverbank) that creates a choke point for wildlife (and fishers) and catches debris both at water's edge and up the slope.

Remove considerable large debris from the upper northern side slope and lower southern slope to enable wildlife passage, which is currently impassible.

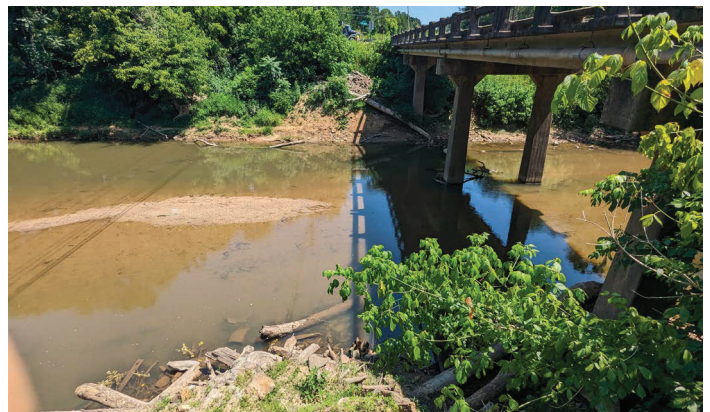
Old Oxford Road bridge over Eno River looking North. Pete Schubert.

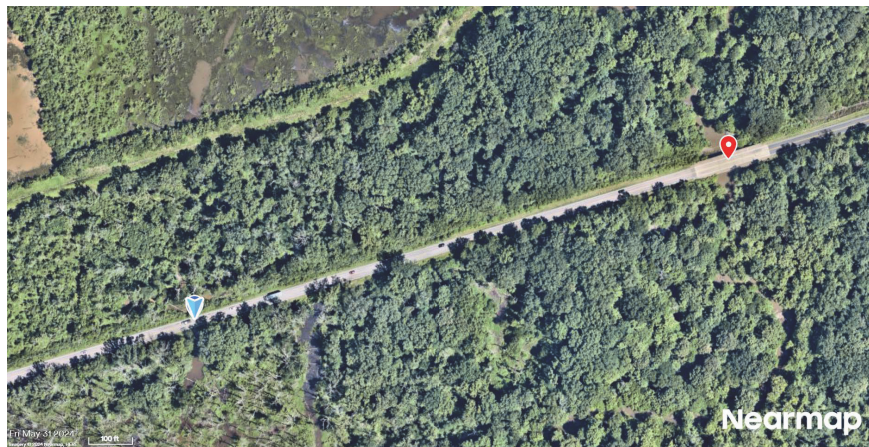
Barriers to wildlife travel along this corridor and under the bridge and through the culvert exist, which encourages wildlife travel on the roadway and results in conflicts with motorists. While the bridge span does have dry passage on both sides of the channel, it does not during flood stage. Though the overhead clearance is marginal at present, it may be possible to install stepped natural soil benches against each abutment slope to provide some high-water access. Additional dry culverts (with natural soil bottoms at adjacent floodplain level with at least one bay stepped up) should be considered on both the bridge structure, and the 4-bay box culvert.

Aerial photograph of NC 54 culvert (west) and bridge (east) over New Hope Creek. Nearmap.

Replace the bridge with a longer and higher span to allow for the construction of dry wildlife passages above the floodplain on both sides of the creek, with at least 8 feet of vertical clearance beneath the new structure. Elsewhere along the raised and widened NC 54 causeway, construct at least two multi-bay box culverts away from the active or any abandoned channels, to provide dry passage for wildlife within the wide New Hope Creek floodplain, aligned due south (downstream) of the ends of the upstream wildlife sub-impoundment structure (spillway and control structure including stilling basin). One of the bays should be floored above the floodplain elevation to provide dry passage during flood events. Similarly, replace the existing 4-bay box culvert with a single span bridge of sufficient length and height to provide dry passage for wildlife on both sides of the high-water channel.

Raise a section of the banks under the bridge against the abutment slopes on both sides of the creek to provide a high-water dry wildlife passage.

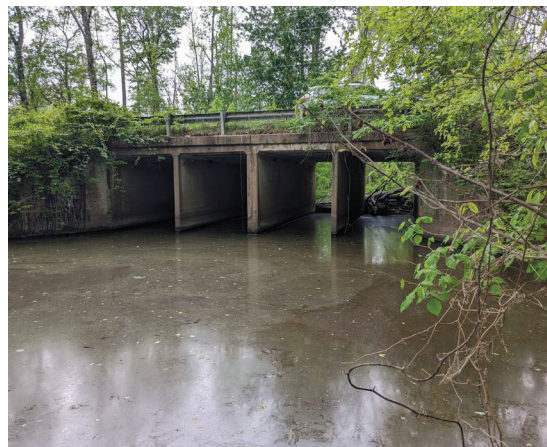
NC 54 culvert over New Hope Creek.
Pete Schubert.
DCHC MPO Wildlife Crossings Plan - 79

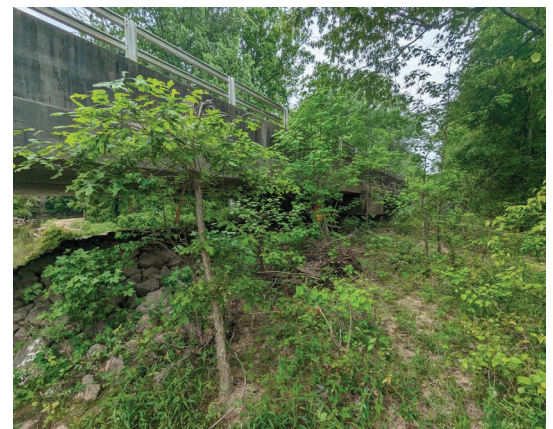
Barriers to wildlife travel along this corridor and under the bridge exist, which encourages wildlife travel on the roadway and results in conflicts with motorists. While the bridge span does have dry passage on both sides of the channel, the exposed riprap is an obstacle that could be alleviated by using small stone fill the voids and create a natural surface. Even with this surface improvement, there is no dry passage during flood stage. Though the overhead clearance of the bridge is marginal at present, it may be possible to install stepped natural soil benches against each abutment slope to provide some high-water access. Additional dry culverts (with natural soil bottoms at adjacent floodplain level with at least one bay stepped up) should be added if Stagecoach Road is widened in the future.

South side of Stagecoach Road bridge facing North over New Hope Creek. Pete Schubert.

Raise the approaches of the bridge and causeway to a minimum of 8 feet vertical clearance for wildlife along dry passages on both sides of the creek. Install two supplementary minimum 2-bay box culverts at points along the causeway downstream of the ends of the upstream wildlife sub impoundment structure (spillway, outlet/control bays, and stilling basin), to allow for dry passage of wildlife within the New Hope Creek floodplain away from the creek banks. All culvert bays shall have natural surface bottoms and at least 8 feet of vertical clearance, with one bay floored above the floodplain to enhance dry passage during flooding events.

Use fine aggregate to fill the voids among the exposed riprap under the existing bridge span to provide natural surface dry passage for wildlife. Build up the elevation of the dry passage nearer the abutments to provide dry passage during flooding events. Install additional, supplementary dry passage culverts to allow for dry passage of wildlife within the New Hope Creek floodplain away from

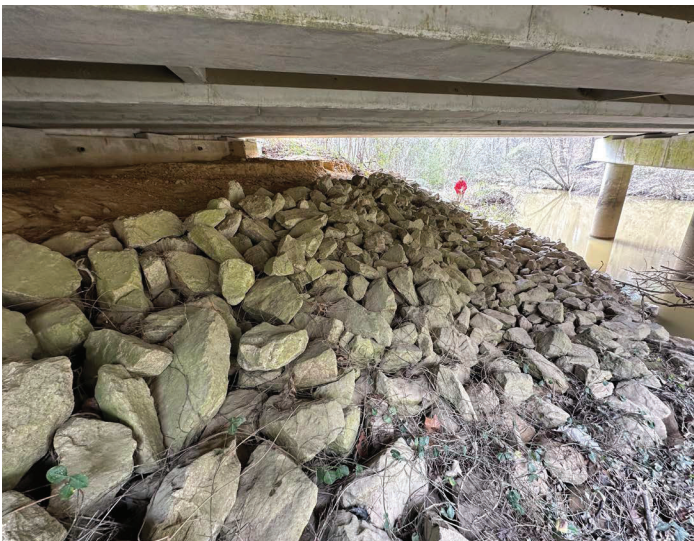
Barriers to wildlife travel along this corridor and under the bridge exist, which encourages wildlife travel on the roadway and results in conflicts with motorists. A significant obstacle to safe wildlife passage under the existing structure is the lack of bare ground between the riprap slope protection and the creek channel. While the lower portions of the riprap have trapped some interstitial sediment, there are many voids and a very uneven surface that would prevent smaller wildlife from crossing.

South side of Old Chapel Hill Road bridge over New Hope Creek looking north. DCHC MPO.

The preferred recommendation of this site includes lengthening the bridge span and removing approach embankment fills to leave room for continuous floodplain on both sides under the bridge; create benching into the riprap to provide a terrace parallel to the bank (on each side), which would then be choked and filled with gravel and rock fines; to suspend or otherwise support a shelf from the deck that wildlife could use; and then install quality fencing on both sides of the bridge to guide wildlife under the structure and off of the road. However, this crossing aligns with a TIP project (EB-4707B) completed in July 2019 – therefore, a new bridge (while preferred) may be unlikely.

Remove considerable large debris from the upper northern side slope and lower southern slope to conduct a riprap remediation to reposition existing riprap to create a wildlife bench on both sides of the creek. Once the benches are built, install fencing of sufficient length on both sides of the bridge to guide wildlife under the structure and off the road.

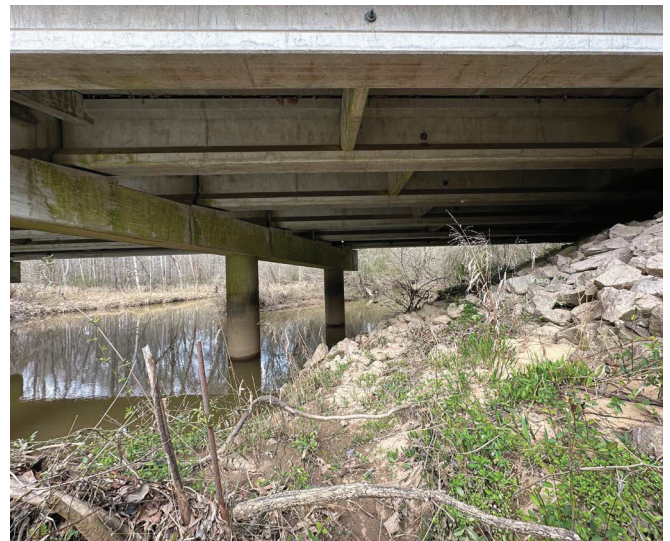
North side of Old Chapel Hill Road bridge over New Hope Creek looking south. DCHC MPO.

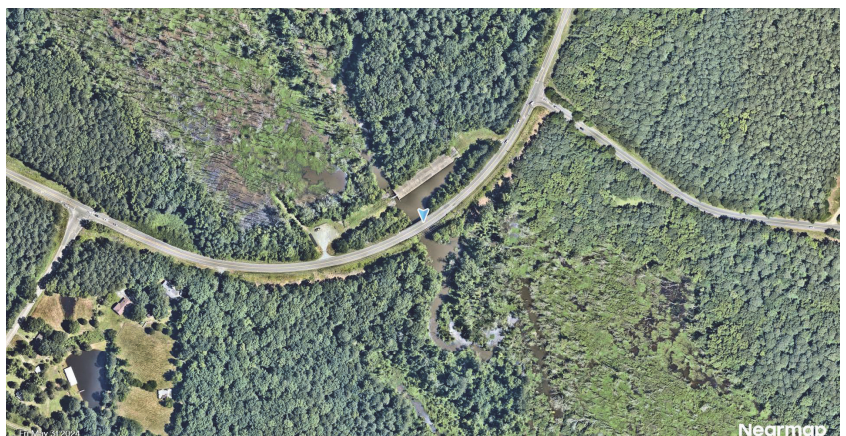
Barriers to wildlife travel along this corridor and under the bridge exist, which encourages wildlife travel on the roadway and results in conflicts with motorists. Barriers include standing water, riprap placement, and the upstream sub impoundment spillway, outlet structure, and earth embankments with steep riprapped slopes. There are areas of permanent flooding upstream and downstream of the crossing – the upstream flooding is due to the sub impoundment structure and was created to support waterfowl habitat for hunting. The cause of the downstream flooding is likely to be the result of backwater from Jordan reservoir, perhaps amplified by downstream beaver damming in the extensive floodplain. An earthen causeway extends from the ends of the spillway structure. Riprap slopes extend down the road causeway at the corners of the spillway structure and along the causeway slopes. There are also riprap slopes leading to the corners of the underpass opening, blocking the approach to the underpass. The riprap slopes wrap entirely around the causeway. All riprap slope protection so described and observed extends into standing water. Dense vegetation may block visibility of approach to the underpass area for wildlife. Wildlife has no path from floodplain to or through the underpass.

On the west side of the underpass, there exists a natural earth area above the riprap slope protection, approximately 12 feet wide and 7 feet high, that could function for wildlife passage, however, because it is entirely above the riprap and there is no path down the riprap to the floodplain habitat either upstream or downstream, it is not connected. Similarly, on the east side of the underpass, the potential dry area passage is about 12 to 15 feet wide and 7 to 8 feet high, but it is inaccessible to the up and downstream habitat by the continuous riprap slope protection on both the roadway embankment/causeway and the sub impoundment spillway and embankment. There is a 4 to 6 foot bench in the surface of the riprap near both outer bents, which could be connected to adjacent habitat if the benching was continued to the limits of the riprap and the voids were filled with small stone to provide a natural surface.

Aerial photograph of Farrington Road bridge over Little Creek. Nearmap.

Bench, choke (fill voids) with small stone, and flatten the slopes of riprap to tie the benches into adjacent habitat areas to provide natural surface wildlife pathways that cross under the bridge at the current top of the riprap slope protection. This must be done on both sides of the bridge and across the full length of the riprap until it can tie into undisturbed habitat up and down stream, including making natural surface connections across the grassed sub impoundment dikes.

In addition to the preferred recommendation, or as an alternative wildlife pathway, install dry culverts that are at least 8 feet high and 12 feet wide under the road at the floodplain elevation, on both sides of the bridge area, so that wildlife can move from non-flooded habitat directly to and through an underpass into non-flooded habitat on the other side of the road. These underpasses would then allow wildlife to bypass the now impenetrable obstacles in place along the streambanks. Fencing to guide wildlife to these passages and away from the road and riprap would be necessary.

Consider changing (flattening) the artificially steep slopes of the road berm and earthen causeway to gentler slopes, which could be a (re-)design principle that might also improve/reduce structural needs for riprap slope protection and to prevent fill collapse. Consideration should also be given to the need for the upstream sub impoundment in light of back flooding from Jordan Reservoir. The elimination/deconstruction of the frequently flooded spillway stilling basin, outlet structure channel, and removal of the no longer needed concrete spillway and embankment riprap slope protection would simplify the scope of the preferred scenario for the bridge and road causeways. Though the sub impoundment provides for seasonal waterfowl management upstream, it is a continuous wildlife passage impediment for all terrestrial species in the bottomlands.
