## Section 3.3

# ORANGE COUNTY RECOMMENDATIONS

The DCHC MPO is recommending thirteen (13) projects for Orange County as part of this plan. The list of projects can be found below in Table 3.3, and a map showing these sites are found in Figure 3.3: Map of complete list of wildlife crossing project recommendations in Orange County.

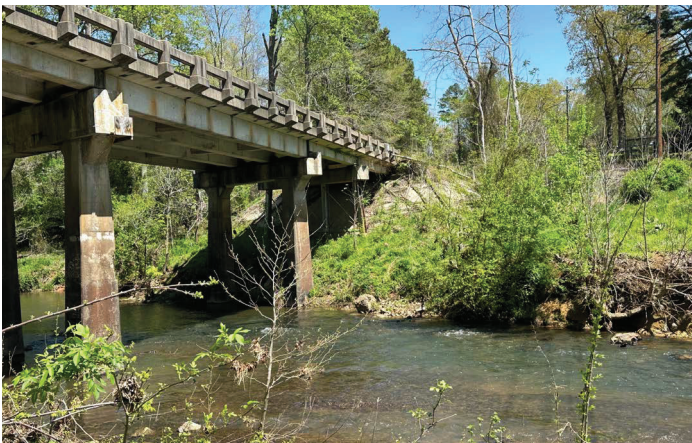
Barriers to wildlife travel within this core and under the bridge exist, which encourages wildlife travel on the roadway and results in conflicts with motorists. Current site conditions show that while the bench on the west side is serving as both wildlife passage and the MST alignment, the east side of the bridge is not conducive to wildlife movement due to the steep concrete slope and moderately steep natural surface embankment with no functional bench. Note that the master plan for continuation of the MST to the north (upstream) has the MST crossing the Eno River on or adjacent to the Pleasant Green Road bridge. As such, the new bridge must include enough new bend on the river's east side to accommodate wildlife passage and trail passage needed once the MST is open on the east side. The east side is presently used by fisherfolk to access bank fishing, which is likely to continue.

Pleasant Green Road bridge over Eno River facing East. DCHC MPO.

Provide a replacement bridge that maintains or extends the dry wildlife passage and MST footprint on natural benches on both sides of the river/ends of the bridge. Provide safe pedestrian crossing of the Eno River for the MST, either on the new bridge (preferably both sides) with connecting trails down to the benches below. Alternatively, pedestrian river crossing may be provided by a standalone pedestrian bridge upstream of the existing bridge if bridge sidewalks are not provided..

Until the new bridge is constructed, install a natural surface wildlife passage bench under the east side of the bridge in the 2nd bay from the abutment, including tie-ins to habitat up and downstream.

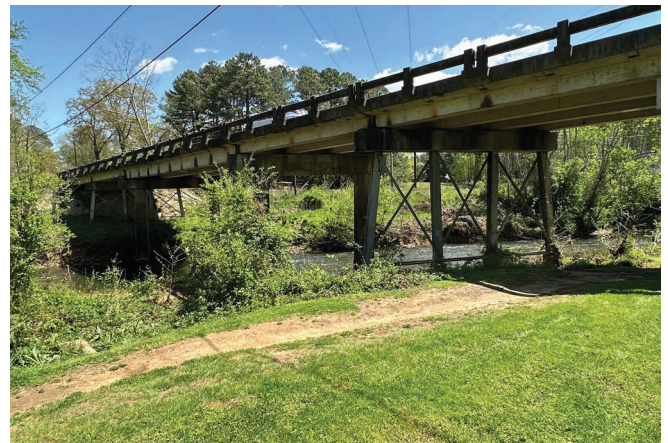
Pleasant Green Road bridge over Eno River looking southwest. DCHC MPO.

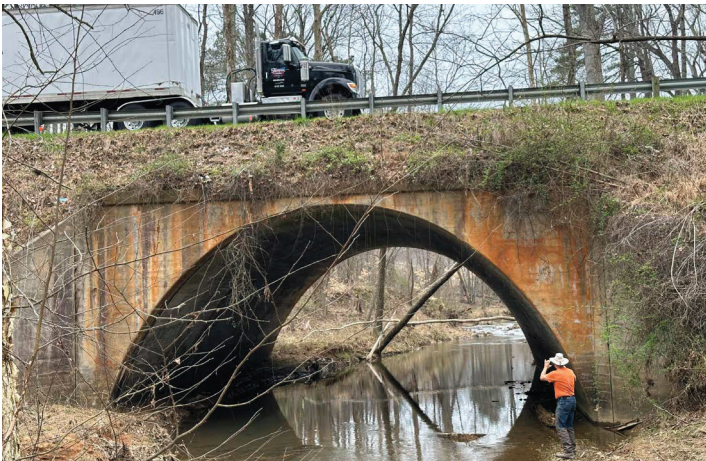
The structure at this site is a bottomless, single-cell culvert. The Stony Creek bed generally consists of sound bedrock, with varying depths, which continues through the culvert, providing a solid natural creek bottom within the culvert. Barriers to wildlife travel through the culvert exist, which encourages wildlife travel on the roadway and results in conflicts with motorists. The barriers include standing water in the channel, lack of continuous dry bank on one side, narrow and ephemeral dry banks on side, diminishing height of culvert at banks (sloping culvert walls), and steep embankments. The roadway has standard guardrail along both sides, which is porous to terrestrial wildlife.

US 70 culvert over Stony Creek, facing southwest upstream. DCHC MPO.

Provide a replacement bridge that maintains or extends the dry wildlife passage and MST footprint on natural benches on both sides of the river/ends of the bridge. Provide safe pedestrian crossing of the Eno River for the MST, either on the new bridge (preferably both sides) with connecting trails down to the benches below. Alternatively, pedestrian river crossing may be provided by a standalone pedestrian bridge upstream of the existing bridge if bridge sidewalks are not provided.

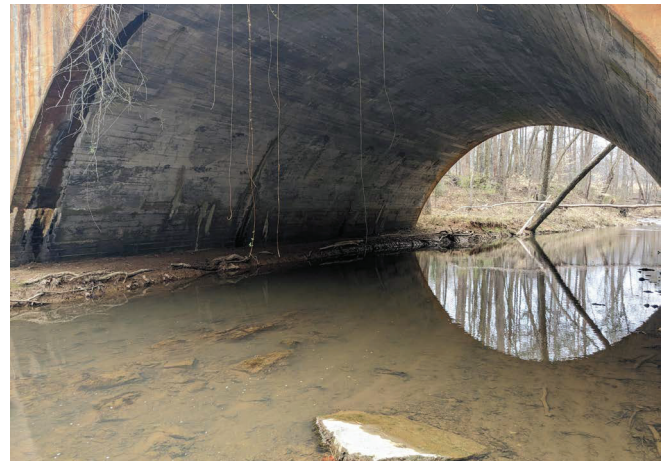
US 70 culvert over Stony Creek, facing southwest upstream. Pete Schubert.

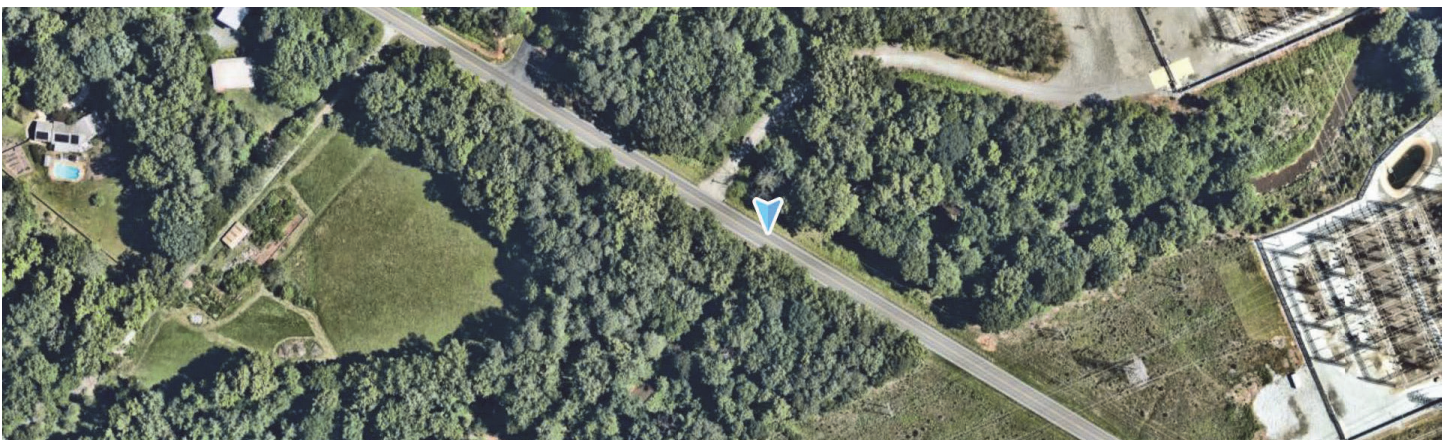
Aerial photograph of US 70 culvert over Stony Creek. Nearmap.

Until the new bridge is constructed, install a natural surface wildlife passage bench under the east side of the bridge in the 2nd bay from the abutment, including tie-ins to habitat up and downstream.

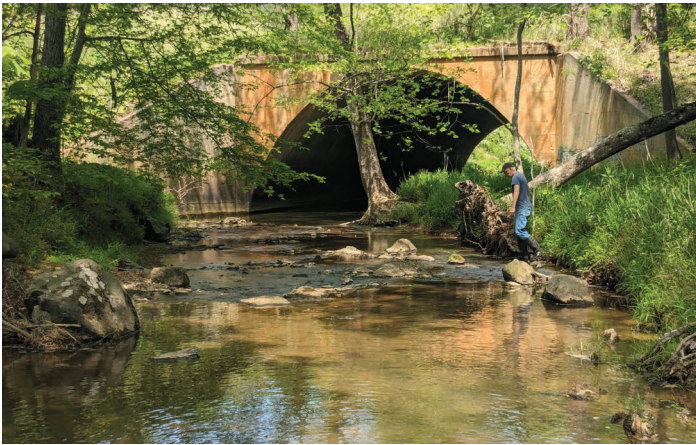
Barriers to wildlife travel through the culvert exist, which encourages wildlife travel on the roadway and results in conflicts with motorists. This site does provide dry passage (approximately 25 feet) on the east side of the stream during low water conditions. However, there is no dry passage on the west side of stream, and the stream bank leading up to the culvert on the west side is extremely steep. As a result, wildlife will be forced around the steep stream bank (and the concrete wingwall extending from the culvert inlet) and up the road embankment to the roadway. However, the stream channel itself is narrow, shallow, and slow enough (at least during the low water conditions) that many wildlife species would be able to cross the stream to dry passage on the east side. During times of high and fast water flow, wildlife would be prevented from crossing the stream and could attempt to cross on the roadway.

I-85 culvert over Stony Creek, facing north, downstream. Pete Schubert.

Replace the culvert with a bridge of sufficient span length to provide dry passage for wildlife on natural surfaces on atop both east and west stream banks, with such passage constructed continuous with habitat up and down stream. Provide two separate spans (eastbound and westbound) with a median gap to allow daylight to penetrate to the stream and banks below the bridge. Install fencing along the roadway ROW / toes of the embankment (both sides) of sufficient length to guide large wildlife through the culvert.

If hydraulic and hydrologic analyses allow, construct a permanent dry passage within the culvert on the west side, tied into the stream banks up and downstream.

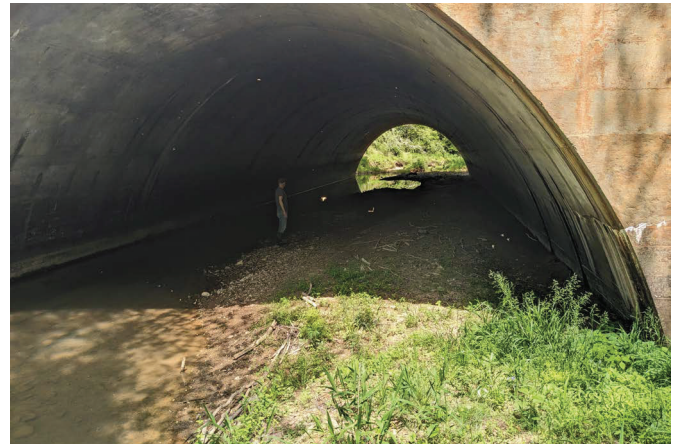
I-85 culvert over Stony Creek, facing north, downstream. Pete Schubert.

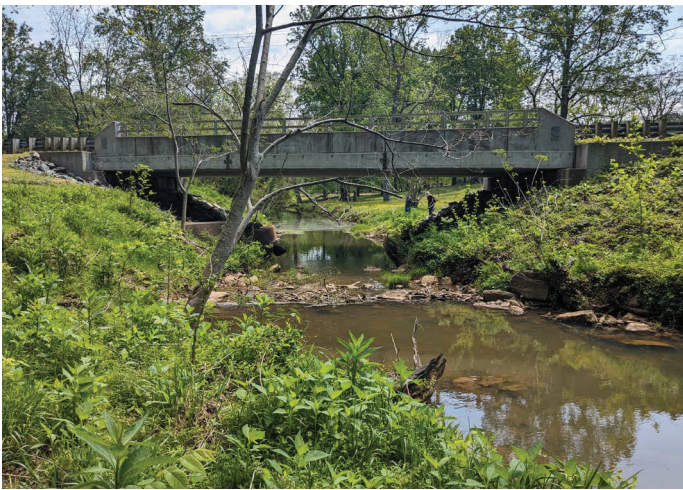
Barriers to wildlife travel under the bridge exist, which encourages wildlife travel on the roadway and results in conflicts with motorists. Identified barriers include concrete walls and steep, exposed riprap slopes that cover the entire area under the bridge. There is also a steep riprap slope on the northeast side extending from the streambank/underpass area up to the road. Stream fills the channel between concrete walls with no dry passage. Remnants of wooden piers are embedded in what are likely concrete footings for former bridge piers, now abandoned in place and confining the channel under the current bridge. Because these old structures confine the channel, the adjacent riprapped slopes could be benched / terraced and choked with fines to provide stabilized natural surface dry passages under the bridge. These could easily be connected to dry banks up and down stream. Due to the close proximity of driveways and private parcels, wildlife fencing may not be appropriate.

East side of University Road bridge over Stony Creek, facing northwest. Pete Schubert.

Create a bench in the existing riprap slope protection on each side of the creek under the bridge, and use small stones to fill the voids to create a natural surface wildlife passage that is connected upstream and downstream to existing habitat areas.

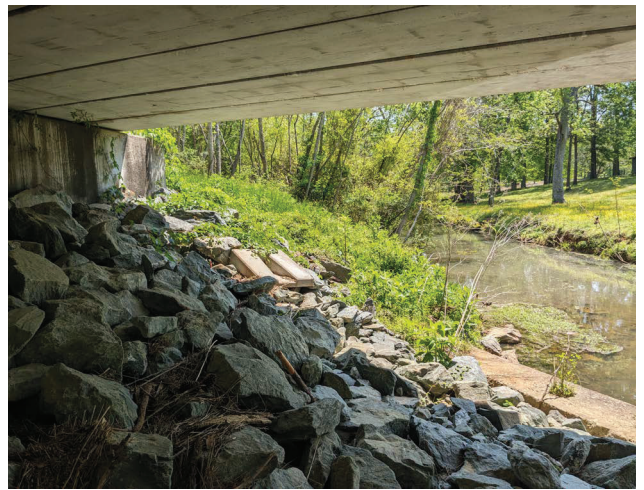
Underneath University Road bridge over Stony Creek, facing northwest. Pete Schubert.

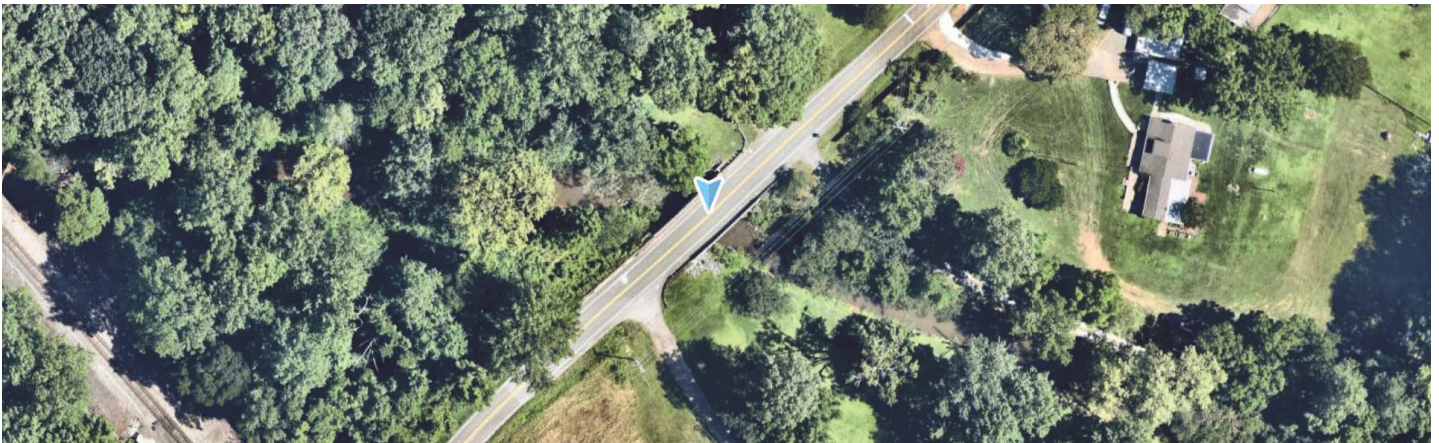
Aerial photograph of University Station Road. Nearmap.

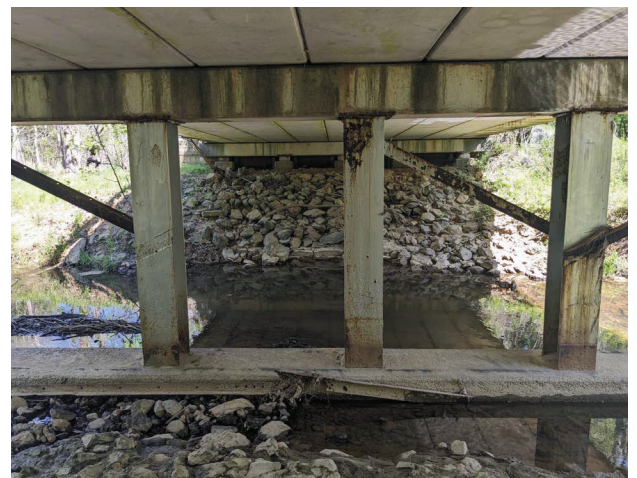
Underneath Old NC Highway 10 bridge over Stony Creek, facing west. Pete Schubert.

Raise the road and causeway profile and replace the existing narrow bridge with a single or multiple span of adequate length to provide for dry passage of wildlife on both sides of the creek and a minimum of eight feet vertical clearance. Install fencing of adequate length on both sides and approaches to channel wildlife movement under the improved bridge.

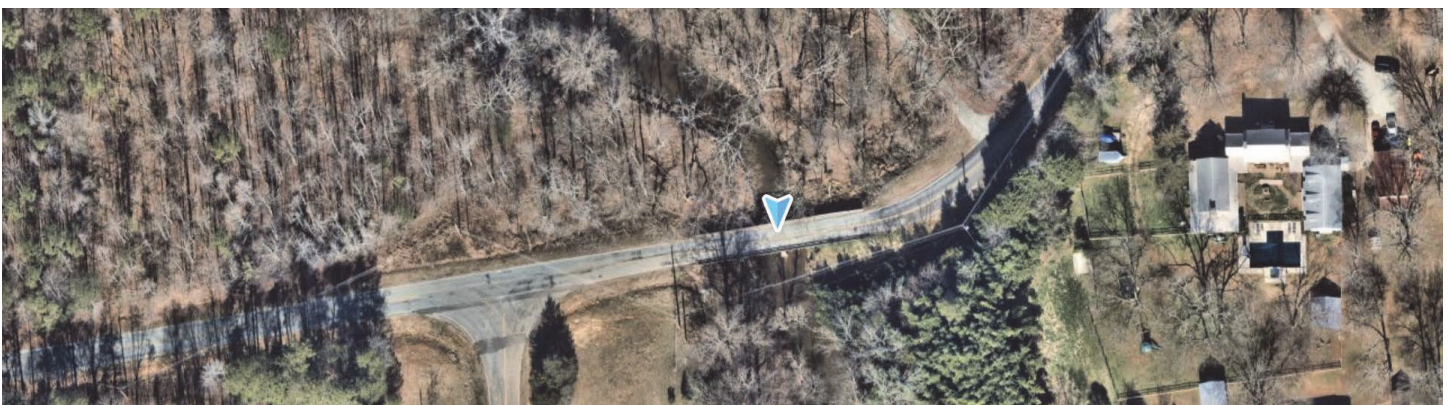
- Replacement bridge span has an increase of approximately 20 feet. This bridge lengthening allows greater opportunity to create dry passage underneath and along the embankments for wildlife to travel.
- Details for the shoulder berm gutter shows a mountable curb inside of a standard steel guardrail set on posts. This can contribute to adequate passage for smaller wildlife.
- The bridge profile depicts an increase in clear span height from a 13-foot average (existing) to 21.5-foot average (new/replacement), providing a clear span at the toe of the Class II Riprap slope protection of 13 feet on west end and 14 feet on east end. This increase can help create dry wildlife passage at low flow/discharge.

Aerial photograph of Halls Mill Road bridge over Eno River. Nearmap.

- The replacement bridge should have a span at least as long as the current span; longer if there will be a slope up to the abutments instead of a vertical end bent. The replacement bridge should provide no less capacity for wildlife to cross as is presently afforded, consisting of a range of elevations of dry passage on both sides of the bridge, tied into the habitat up and down stream.

- Once the bridge replacement has been completed, perform annual vegetation management in accordance with the NCDOT Vegetation Management Manual and standard practices to eradicate invasive bamboo, selectively clear other dense woody vegetation, and allow wildlife full access to the dry passages under the span.

If new riprap slope protection is incorporated, then natural surface (i.e., choked riprap) benches at least 6 feet below the new bridge deck are recommended. Until the bridge is replaced, perform annual vegetation management in accordance with the NCDOT Vegetation Management Manual and standard practices to eradicate invasive bamboo, selectively clear other dense woody vegetation, and allow wildlife full access to the dry passages under the span.

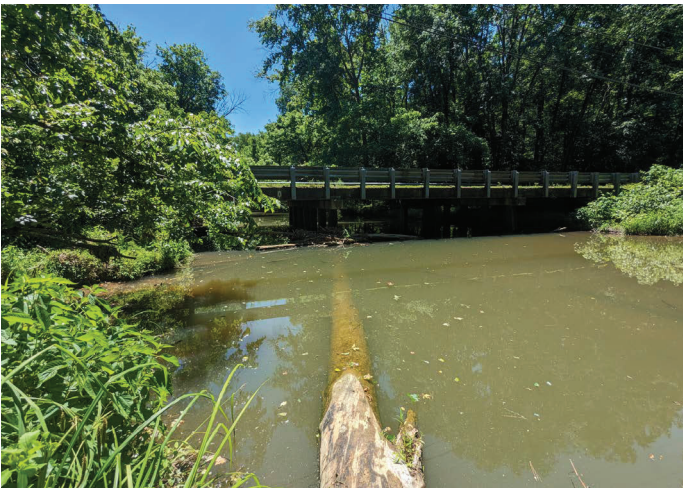
Barriers to wildlife travel along this corridor and under the bridge exist, which encourages wildlife travel on the roadway and results in conflicts with motorists. The barriers include standing water, riprap, and low visibility. Standing water is present just outside of the bridge underpass area and extends into habitat areas that are in the direct path for wildlife toward the dry underpass. The low visibility of the passage area under the bridge is caused by dense vegetation near openings and (possibly) the metal wings extending from the ends of bridge.

East side of Jones Ferry Road bridge over Neville Creek. Pete Schubert.

Replace the existing bridge and raise the road's approach to it to increase the height clearance for the dry passage areas. The bridge span should be long enough, and above flood level, to allow for dry passage on both sides of the creek. Fencing to guide wildlife into the underpass should then be installed.

A temporary solution to consider is to excavate down in the earthen areas on each streambank and leave an earthen "table", to get an additional 2-3 feet of height (with about 4 feet of width). Perform vegetation management in accordance with the NCDOT Vegetation Management Manual and standard practices to ensure visibility of the existing dry opening for wildlife.

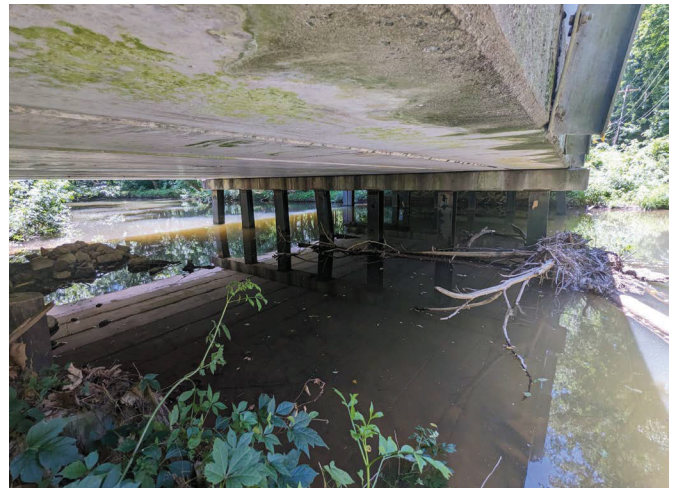
Underneath Jones Ferry Road bridge over Neville Creek, facing Northeast. Pete Schubert.

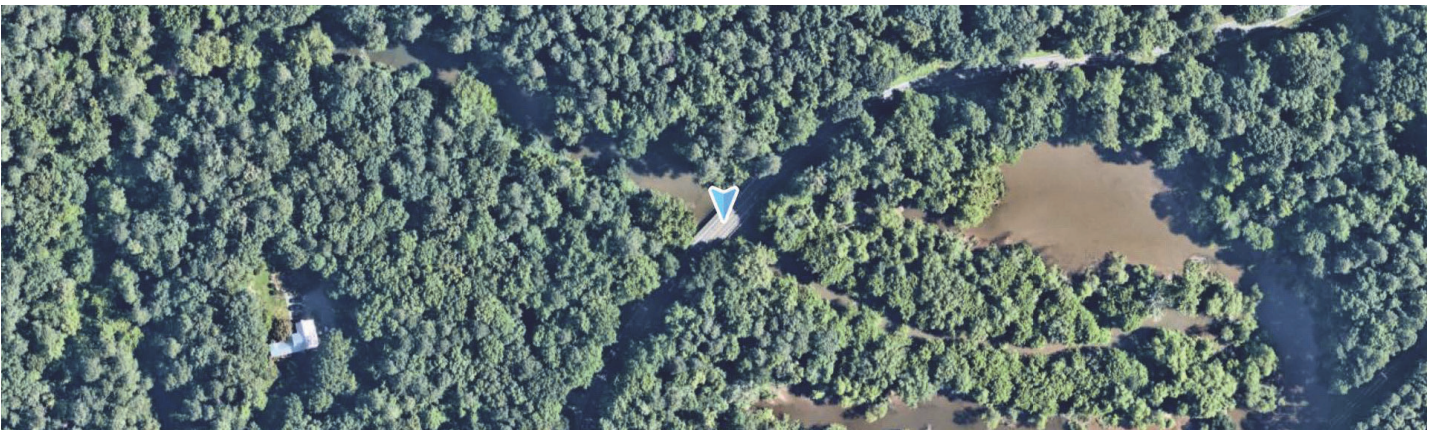
Aerial photograph of Jones Ferry Road bridge over Neville Creek. Nearmap.

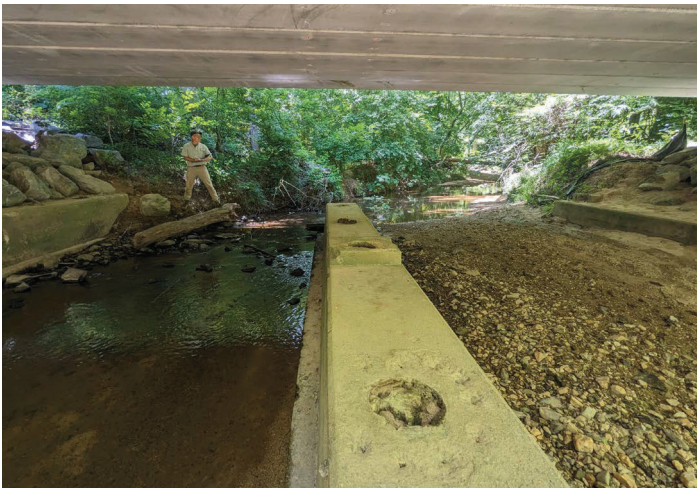
Barriers to wildlife travel along this corridor and under the bridge exist, which encourages wildlife travel on the roadway and results in conflicts with motorists. The bridge at this site was replaced within the past few years. While the footings for the previous bridge were left in place to minimize disturbance to the creek channel, they are constraining the flow and some wildlife access to the creek under the bridge. However, the outer footings stabilize the low-slope abutment embankment toes, providing considerable space for dry wildlife passage. But such passage is not possible due to the placement of exposed, oversize riprap. Given the low slope, the riprap could be removed, but the sheer size of the riprap and the low overhead clearance makes heavy equipment access difficult. If the riprap can be relocated or removed to expose a natural surface, it can be left in place with the voids filled with fine aggregate and alluvial materials to create a natural surface at all points with at least 4-feet of vertical clearance to the deck bottom above. Under the bridge, there is ephemeral dry passage through only the north channel, and only at low flow. At higher flows, both channels have standing water and there is no dry passage due to the riprap slope lining on both sides, except on the narrow (one-foot wide) flat footing tops.

Under Neville Road bridge over Phil's Creek, facing East. Pete Schubert.

Use small stones to choke/fill the voids in all riprap slope protection up to within 4 feet of the underside of the deck to create a low-slope natural surface dry passage for wildlife on both sides of the creek.

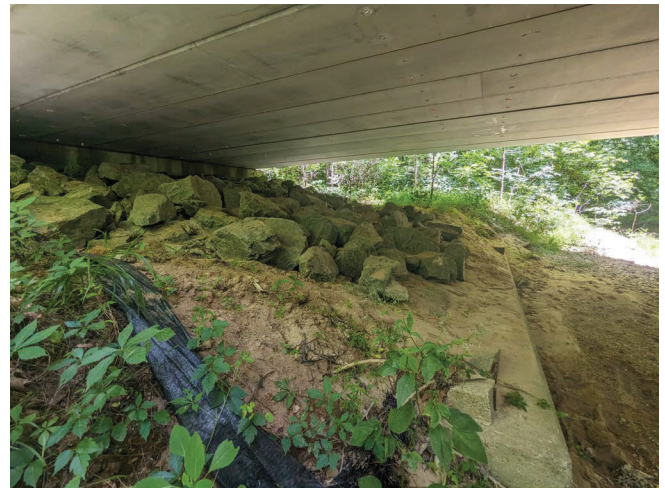
Under Neville Road bridge over Phil's Creek, facing South. Pete Schubert.

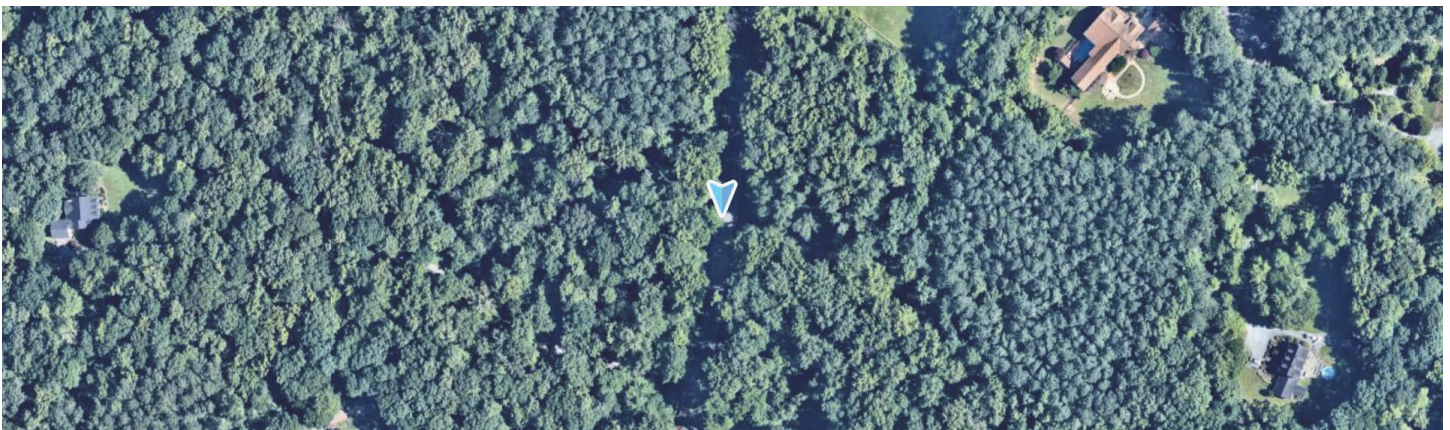
Aerial photograph of Neville Road bridge over Phil's Creek. Nearmap.

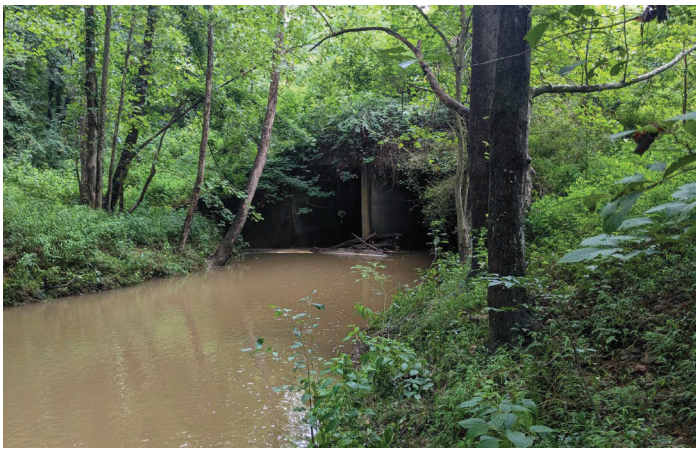
Barriers to wildlife travel along this corridor and through the culvert exist, which encourages wildlife travel on the roadway and results in conflicts with motorists. The two-bay box culvert has standing water in both cells, which provides no dry and safe passage for wildlife. Wildlife that encounters this flooded culvert may move up the slope and onto NC 54 to cross the roadway. Additionally, dense vegetation on the north side of the road (such as dense non-native wisteria extending from the road bank down to the stream on the northeast side) poses an additional barrier and obstacle for wildlife to travel through the natural habitat.

North side of NC 54 culvert, facing South.  
Pete Schubert.

Replace the flooded bottom box culvert with a single span bridge of adequate span length and height to provide dry passage for wildlife on both sides of the creek under the structure. Connect new dry passages to adjacent habitat up and downstream on both sides of the stream. Install fencing along the ROW approaching the bridge to guide wildlife into the dry crossings under the new bridge and deter crossing NC 54. Perform annual vegetation management in accordance with the NCDOT Vegetation Management Manual and standard practices.

Install new higher bottom elevation culverts away from the existing culverts to provide dry passage for wildlife away from the creek entering the flooded culverts. Culverts shall be at a location to provide a minimum height of 8 feet and minimum width of 12 feet, and a bottom elevation that ties into adjacent habitats' elevations up and downstream. Install fencing along the ROW approaching the new dry culverts to guide wildlife into the crossings and deter crossing the busy NC 54. Perform annual vegetation management in accordance with the NCDOT Vegetation Management Manual and standard practices.

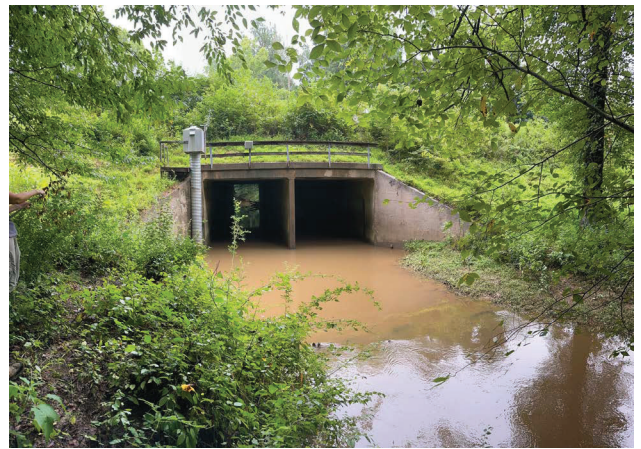
South side of NC 54 culvert, facing North.  
Pete Schubert.

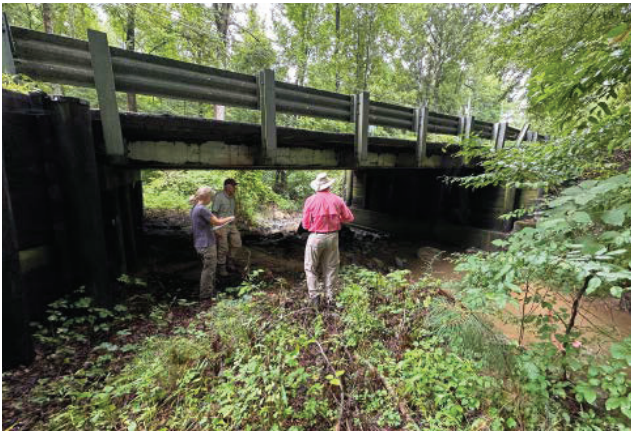
Barriers to wildlife travel along this corridor under the bridge exist, which encourages wildlife travel on the roadway and results in conflicts with motorists. The creek channel has migrated to the south vertical abutment and scoured/exposed the concrete abutment wall footing, leaving no dry passage, and no dry connection to upstream or downstream habitat on that side. Scattered rocks and debris (wooden boards) do not seem to represent significant barriers.

West side of Damascus Church Road bridge over Pritchard Mill Creek, facing east. DCHC MPO.

As part of this bridge replacement, ensure the replacement bridge is high and long enough to allow for dry passage on both sides of the creek, especially during times of high flood. It is recommended that the span be lengthened, especially to the south where there is currently no dry passage, and the creek channel is against the footing of the abutment wall. Connect new natural surface dry passages to up and downstream habitat on both sides of the creek.

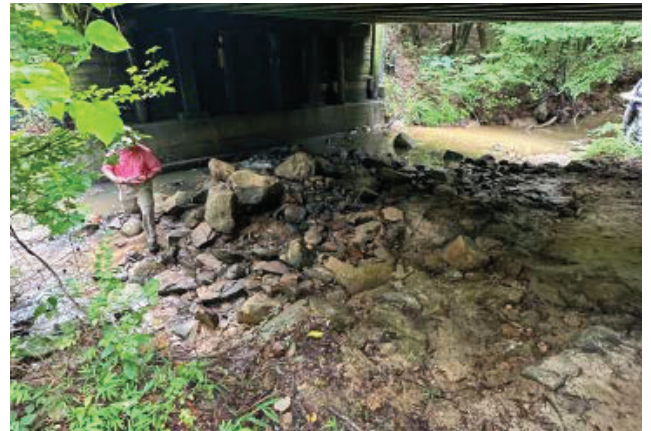
East side of Damascus Church Road bridge over Pritchard Mill Creek, facing west. DCHC MPO.

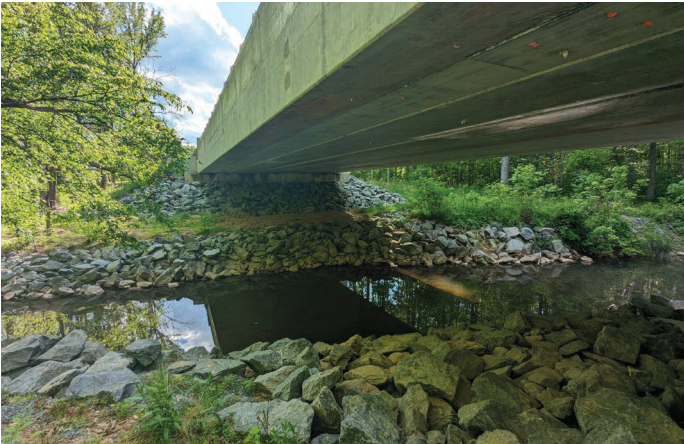
View of west bank, under New Hope Church Road bridge over New Hope Creek. Pete Schubert.

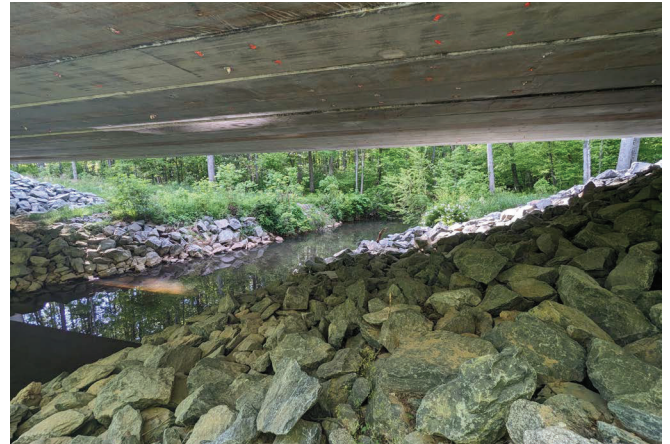
Barriers to wildlife travel along this corridor and under the bridge exist, which encourages wildlife travel on the roadway and results in conflicts with motorists. The east bank slope is completely covered with gently sloping riprap from the abutment 2 feet below the deck to the bottom of the bank, interfering with dry passage on this side only. However, the west bank has a level dry passage, but will not function at high water due to riprap covering the balance of the slope up to the 2 feet abutment under the deck. The bridge span is of adequate distance and has gentle dry slopes underneath to accommodate wildlife passage if the riprap placed above the top of the bank is choked with small stone to provide a natural surface to within 2 feet vertically of the underside of the bridge deck.

East bank, under New Hope Church Road bridge over New Hope Creek. Pete Schubert.

Create a natural, dry surface for wildlife passage by using small stones to choke/fill the voids within the portions of the existing riprap slope that is below 2 feet from the underside of the deck to the top of the creek bank.

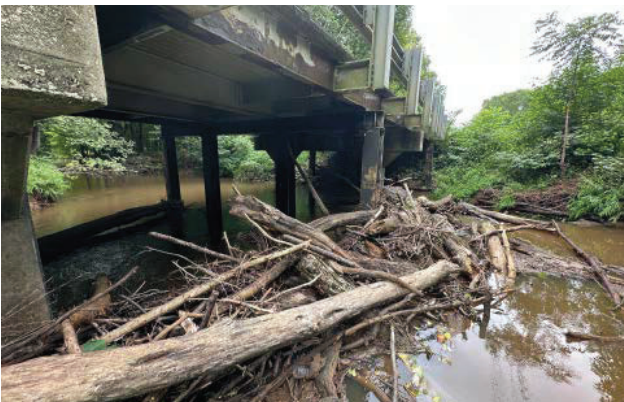
Barriers to wildlife travel along this corridor under the bridge exist, which encourages wildlife travel on the roadway and results in conflicts with motorists. Barriers include riprap on the entire south abutment slope, and old construction debris in the lower portion of the north slope and bank. The existing bridge span is of insufficient length to fully accommodate dry passage on both banks at high creek levels, as evidenced by stranded woody debris and flotsam. The existing bridge is low and narrow and appears to have been structurally repaired and augmented many times over the years, and a replacement bridge provides the opportunity to improve dry wildlife passage along both creek banks. Lengthening the bridge span as part of the replacement is the most critical, combined with replacing the multiple bents with a single span across the entire crossing.

West side of NC 86 bridge over New Hope Creek, facing east. DCHC MPO.

As part of the bridge replacement project, raise the NC 86 causeway profile through the entire New Hope Creek floodplain and install a replacement bridge with a span high and long enough to create a passage bench for wildlife on both sides of the creek, which must remain dry during times of high flood. Avoid placing riprap slope protection on abutment slopes, and provide dry connection to adjacent habitat up and downstream on both banks.

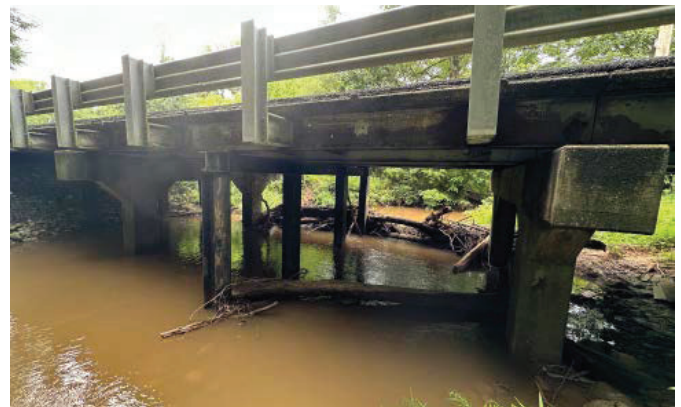
East side of NC 86 bridge over New Hope Creek, facing west. DCHC MPO.

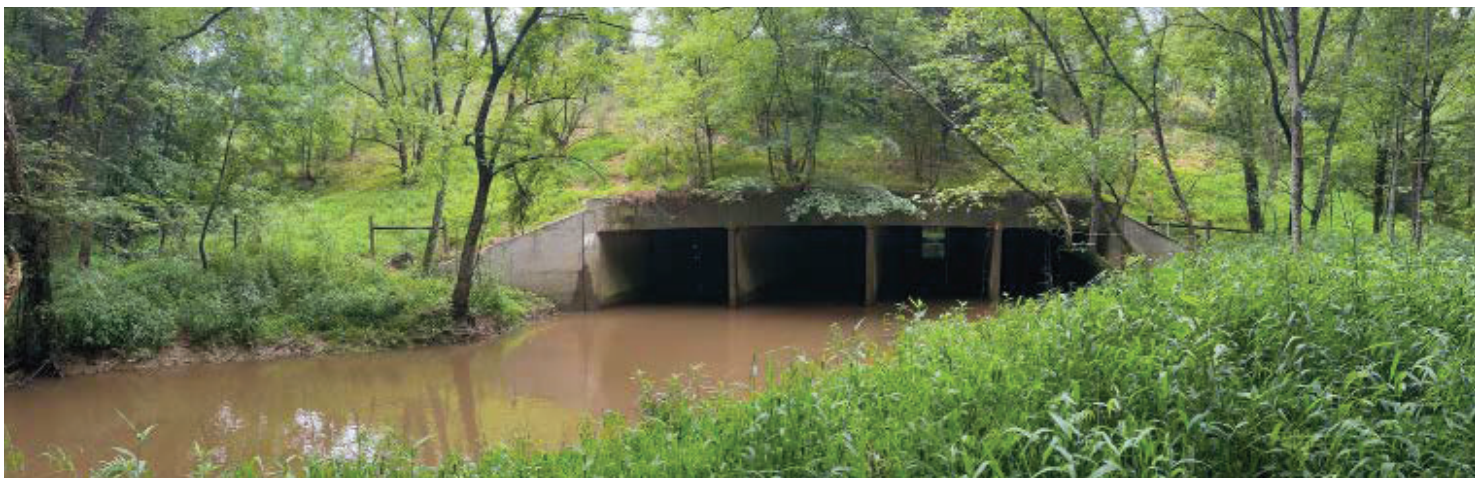
Barriers to wildlife travel along this corridor through the culvert exist. No dry passage for wildlife exists at this site due to continued standing water in the culvert. Combined with ROW fencing that was installed on both sides of the creek, this site creates an ecological dead end for wildlife. However, white-tailed deer have navigated through the existing ROW fence and onto the roadway as indicated by the reported WVCs.

East side of I-40 culvert over New Hope Creek, facing west. DCHC MPO.

Replace the existing 4-cell culvert with a multicell culvert which includes additional outer raised bottom elevation culverts to accommodate dry passage for both creek banks. Construct these new dry passage culverts with natural surface floors. Connect these new dry passages to adjacent habitat up and downstream.

Construct separate, new dry culverts through the I-40 embankment out from the existing flooded culvert to accommodate dry passage for both creek banks. These two new culverts should be at least 8 feet high and 12 feet wide, with a natural surface floor and be straight with no offset or skew. Replace existing ROW fencing with taller fencing to guide wildlife into the dry passes from the adjacent habitat areas and deter wildlife climbing the embankment to attempt to cross I-40.

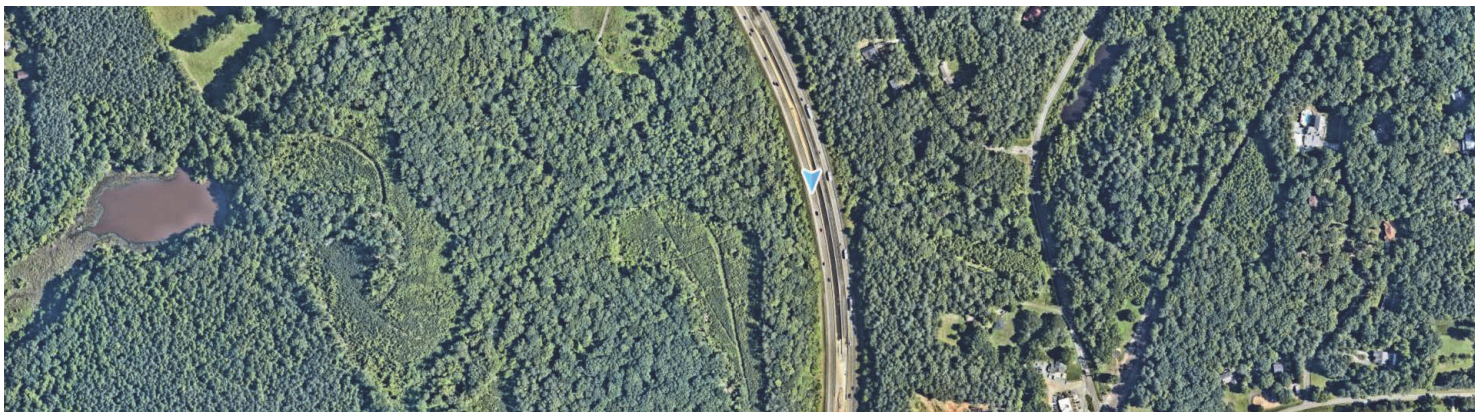
Aerial photograph of I-40 culvert over New Hope Creek. Nearmap.
