Safe Routes to School

Existing Conditions Analysis

Orange County, North Carolina

Prepared by WSP

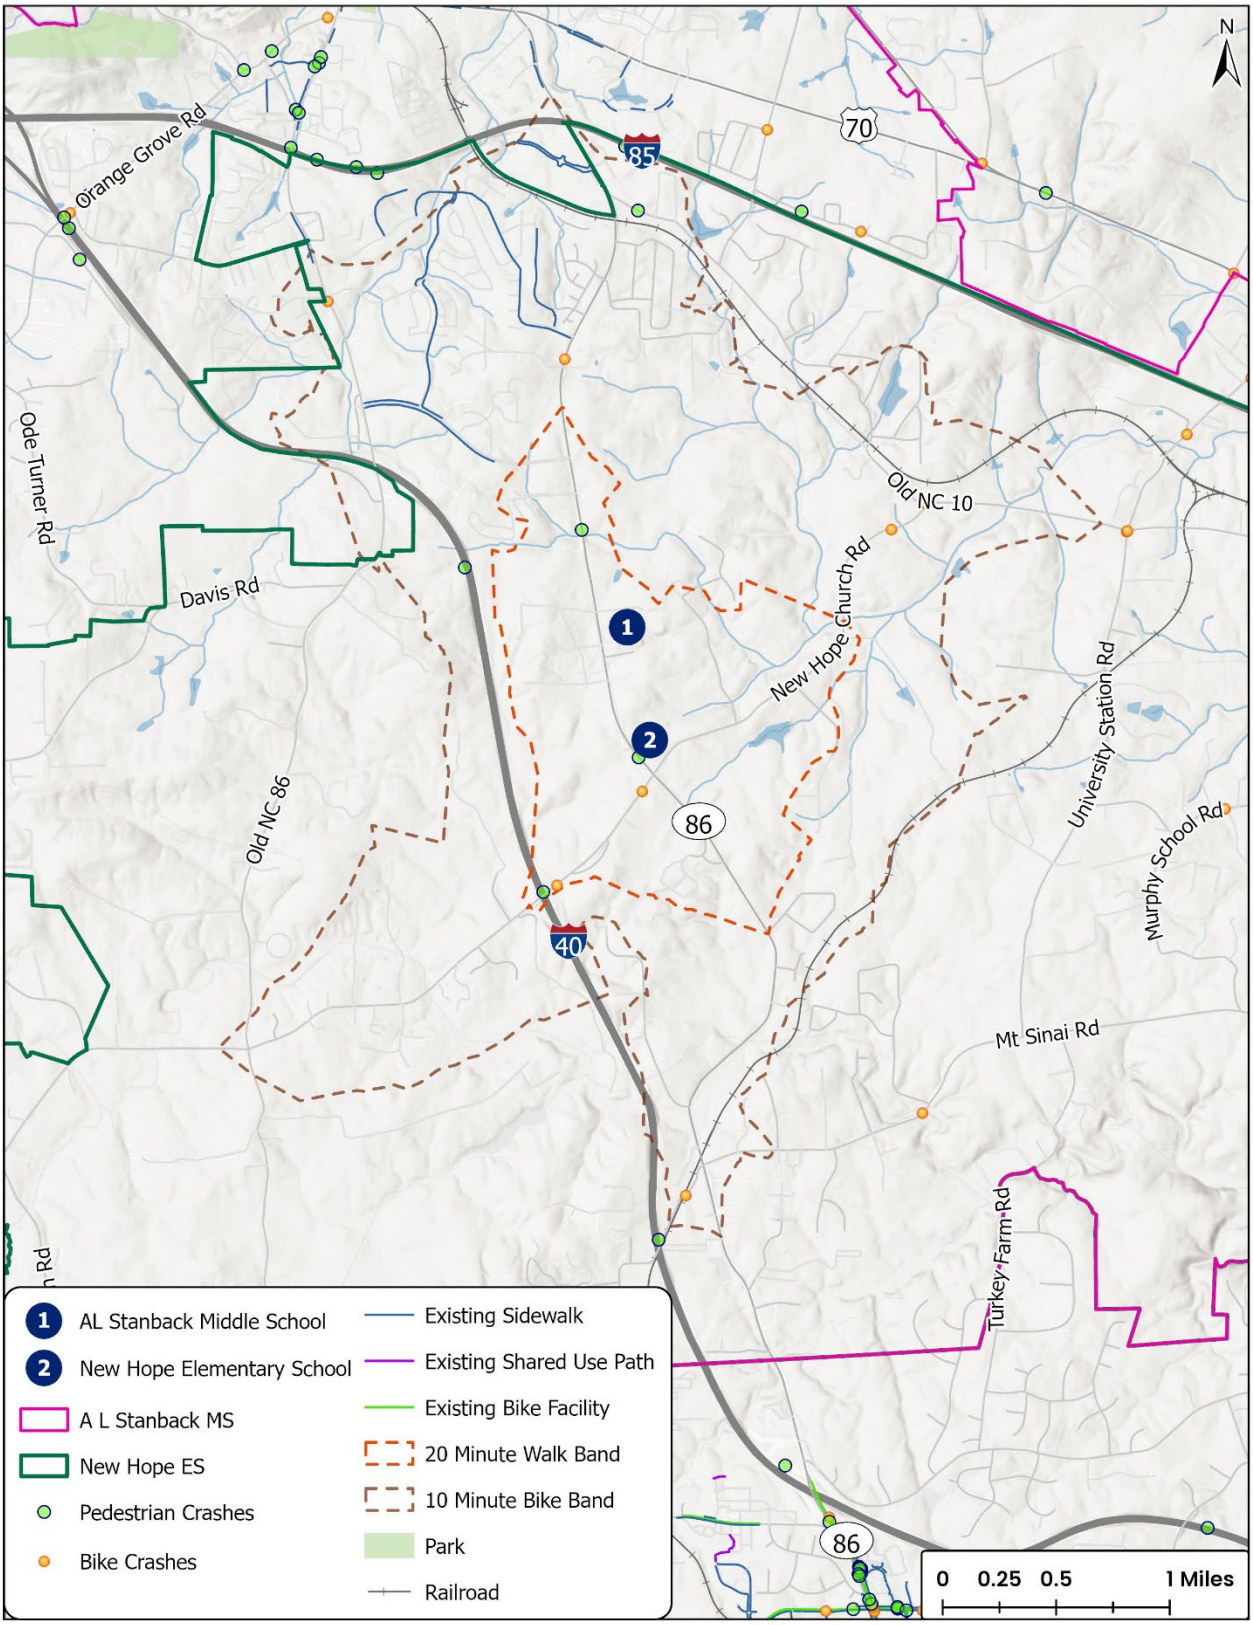
Figure 2.2: AL Stanback Middle and New Hope Elementary Overview

Looking southwest down New Hope Church Road towards the intersection with NC 86

Afternoon pick-up line along New Hope Church Road

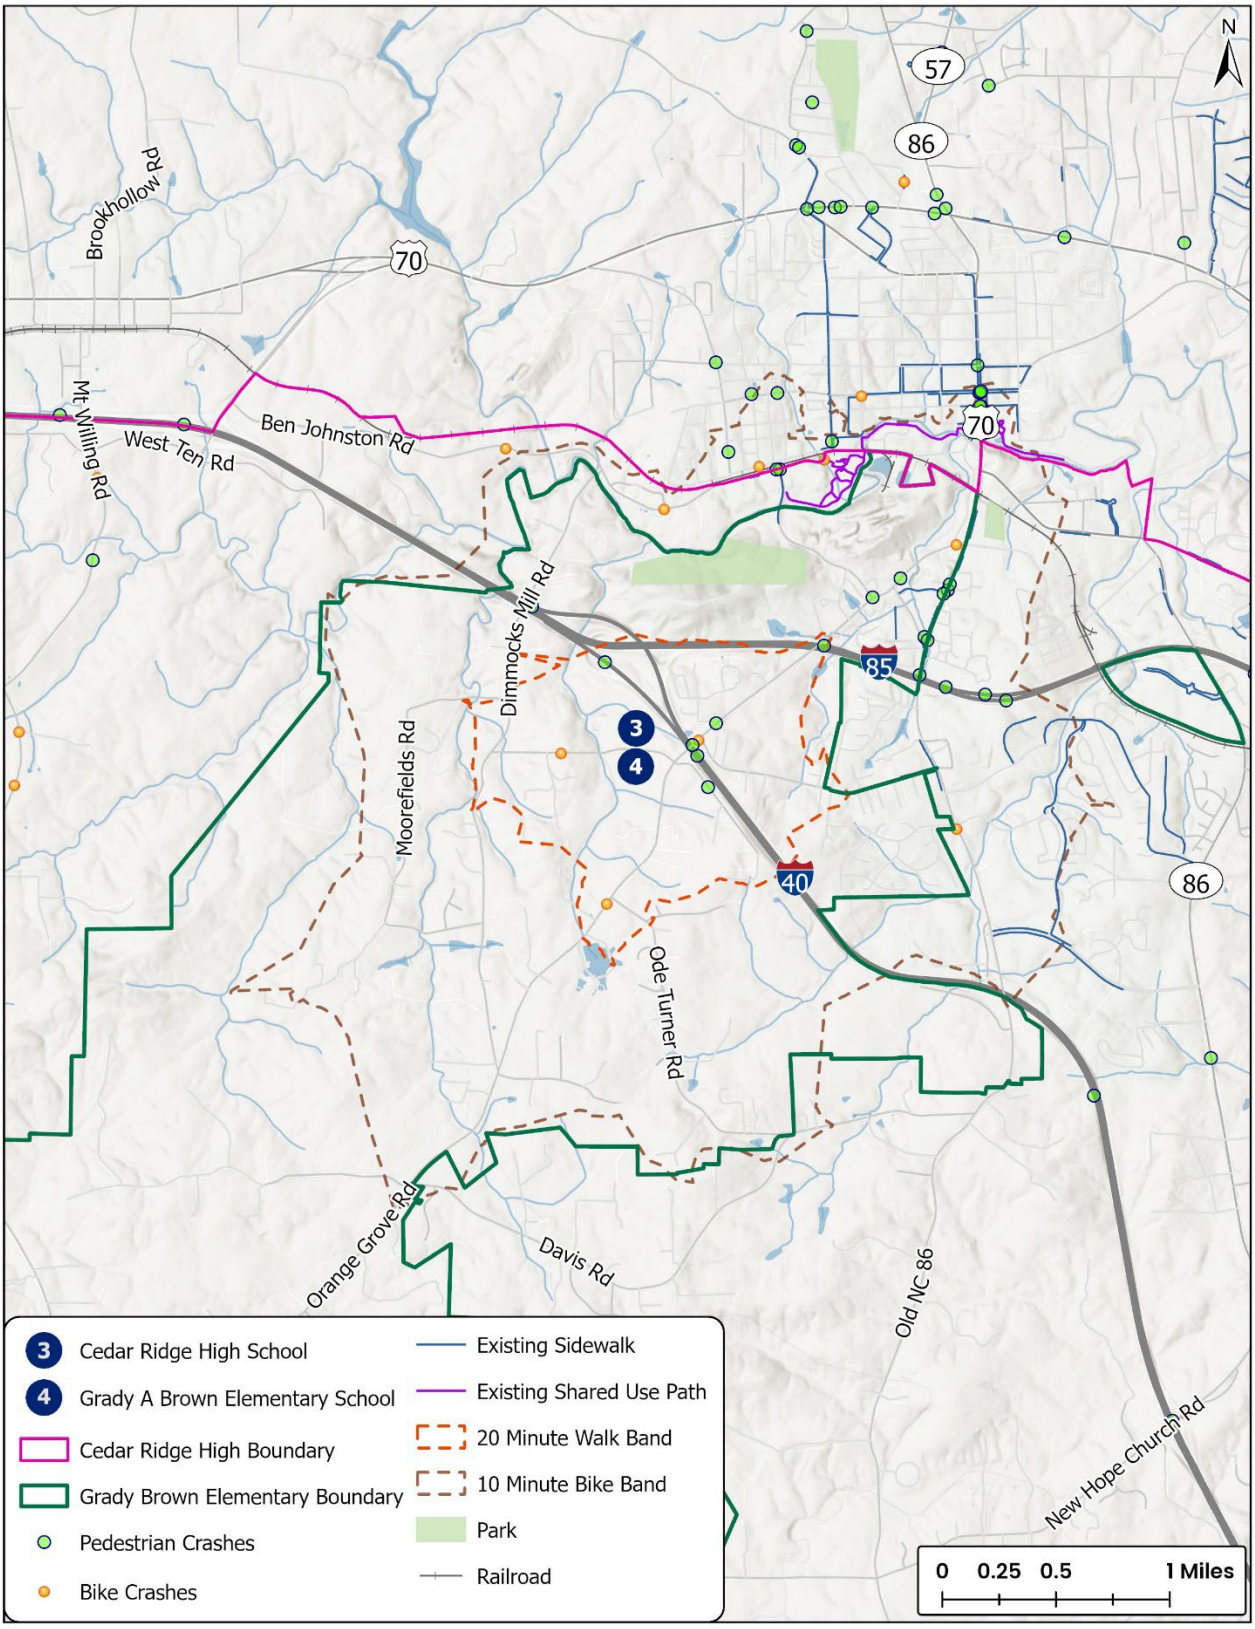
Figure 2.3: Cedar Ridge High School and Grady A Brown Elementary School Overview

Pedestrian signage on New Grady Brown School Road

Sheriff directing traffic exiting out of the school

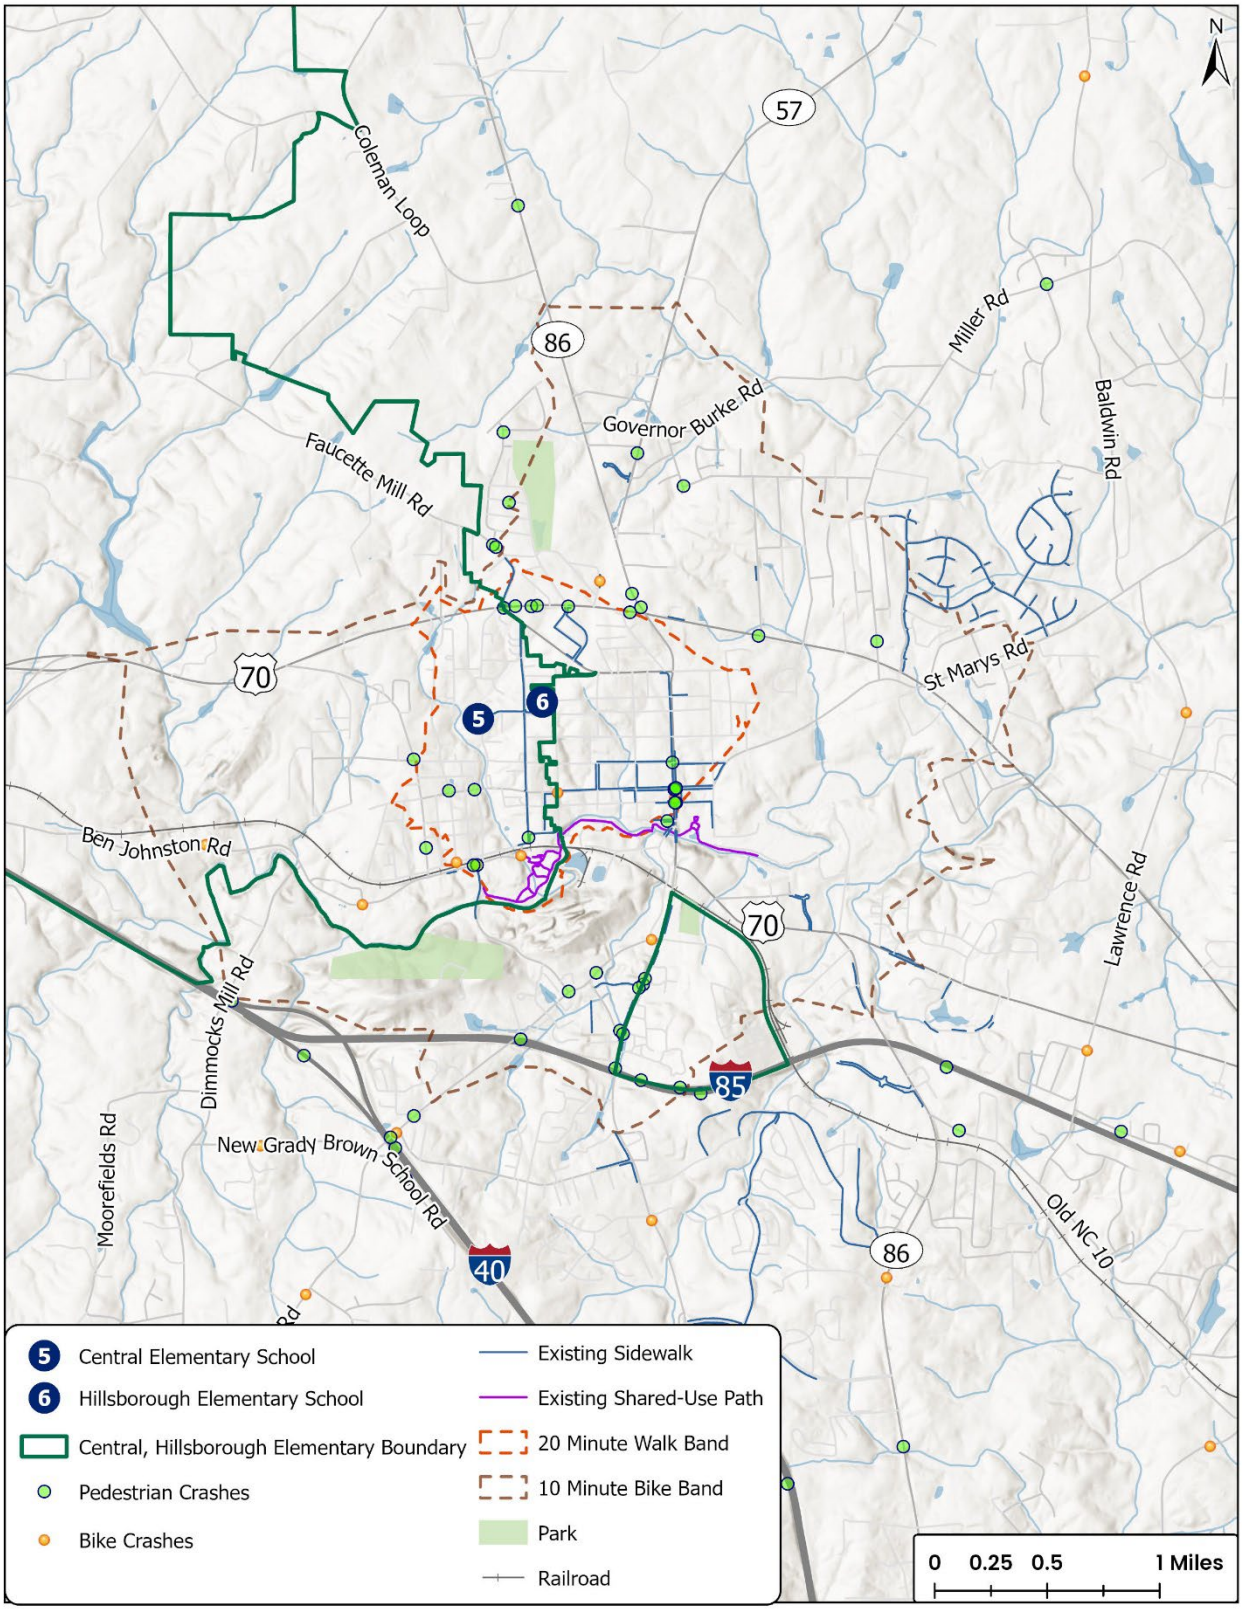
Figure 2.4: Central Elementary School and Hillsborough Elementary School Overview

Standing on W Union Street looking west at the skewed intersection with N Nash Street and Hayes Street.

Crosswalks on W Union Street in front of the school

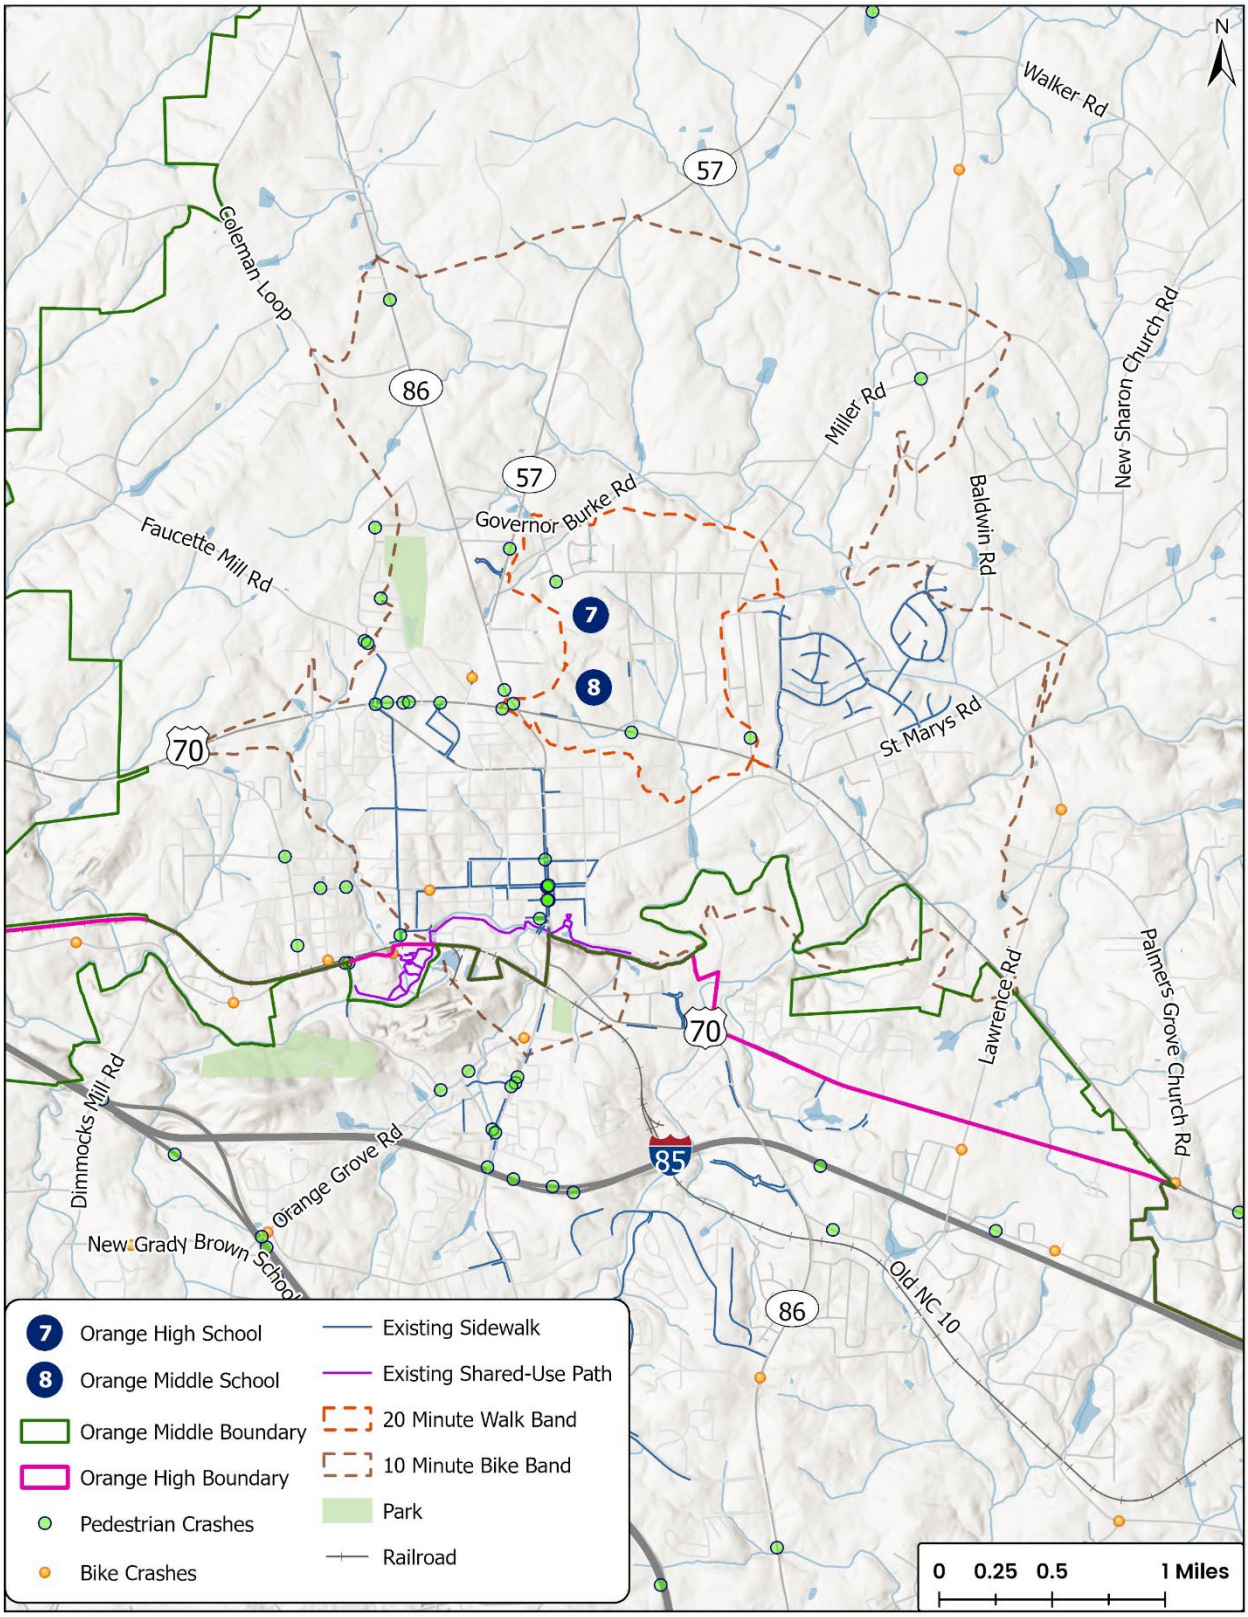
Figure 2.5: Orange Middle School and Orange High School Overview

Traffic passing on both sides while cars are pulled off to the side

Cars pulled off to the side to avoid the car queue. A bus is passing the cars partially in the left lane

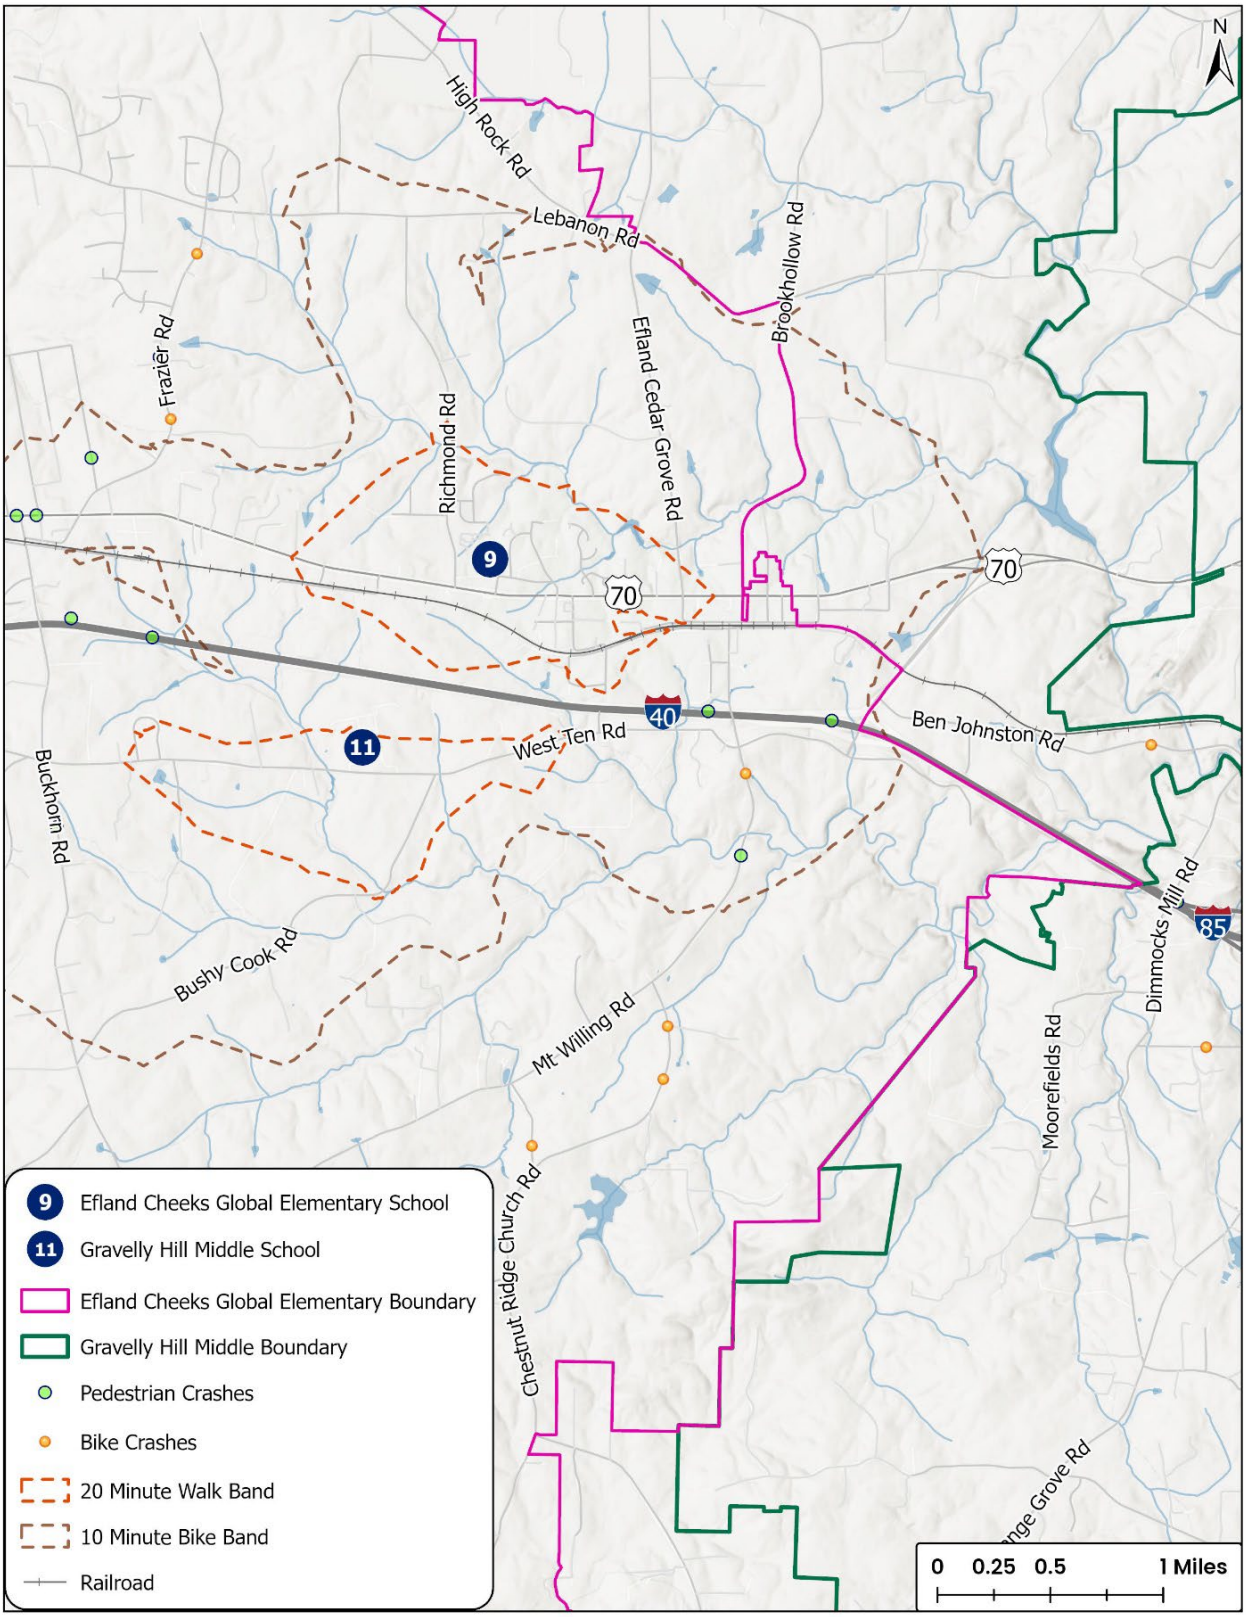
Figure 2.6: Efland Cheeks Global Elementary and Gravelly Hill Middle School Overview

Cars blocking the crosswalk during afternoon pick up

Traffic in the left-turn lane during the afternoon pick up

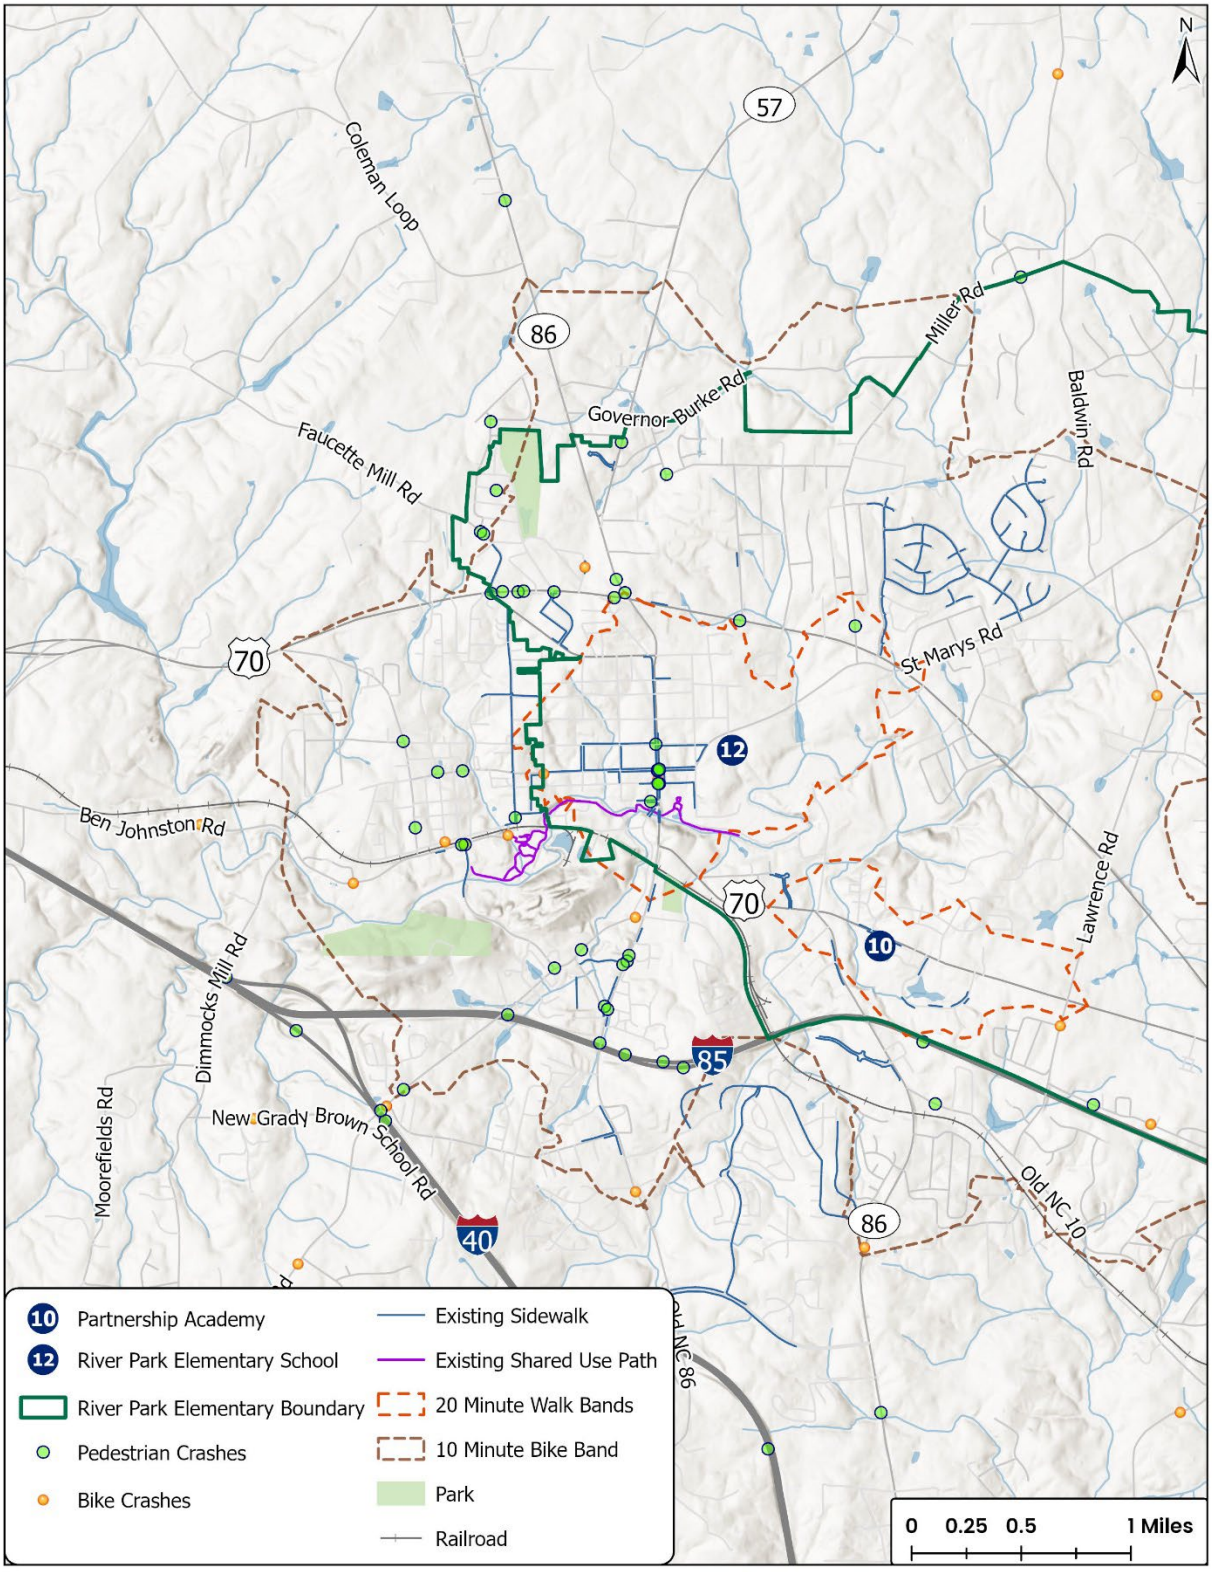
Figure 2.7: Partnership Academy and River Park Elementary Overview

Sidewalk in front of River Park Elementary

Crosswalk on St Marys Road

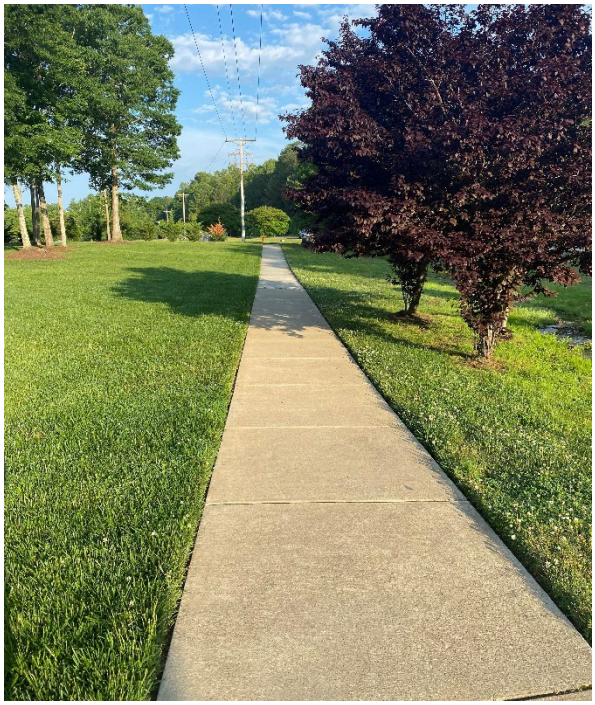
Sidewalk in front of Stroud's Creek neighborhood

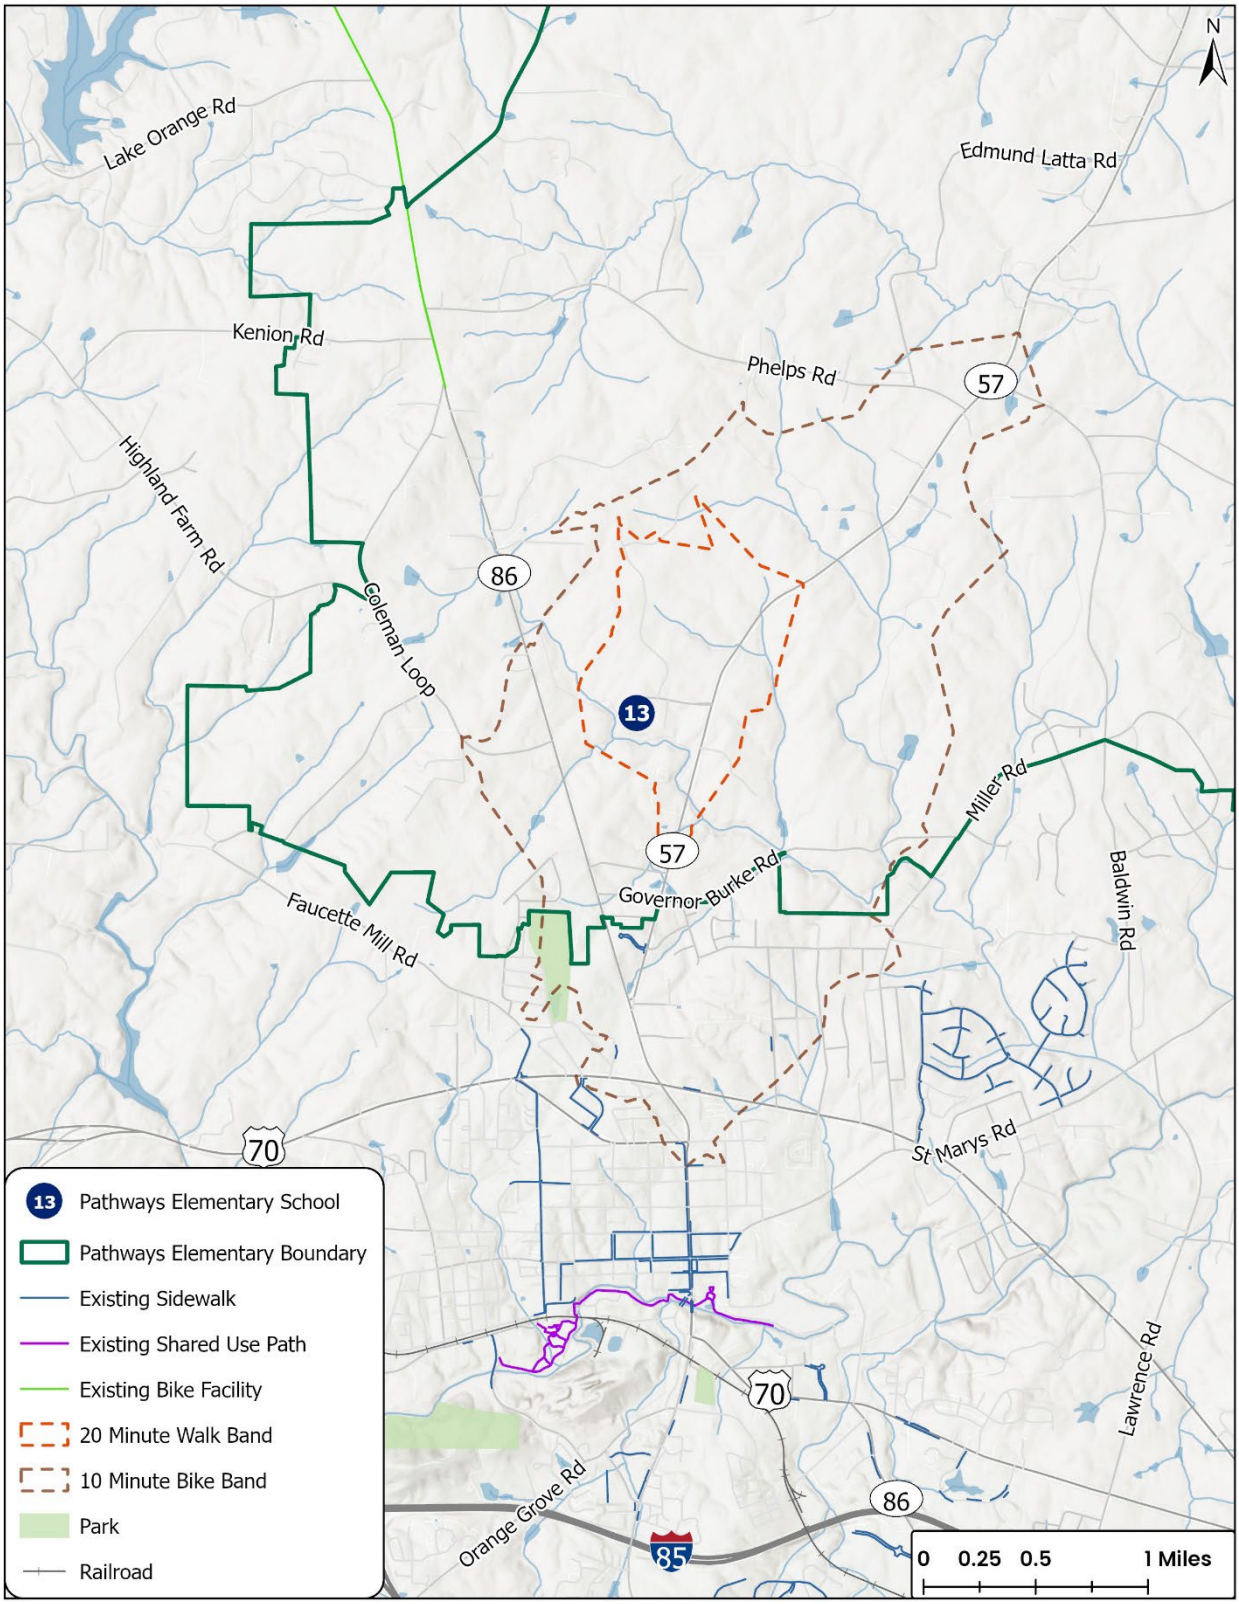
Figure 2.8: Pathways Elementary School Overview

Bus passing in the left lane to get into the bus lot

Afternoon pick-up line
