## Section 3.1

# CHATHAM COUNTY RECOMMENDATIONS

# US 15-501 over Pokeberry Creek

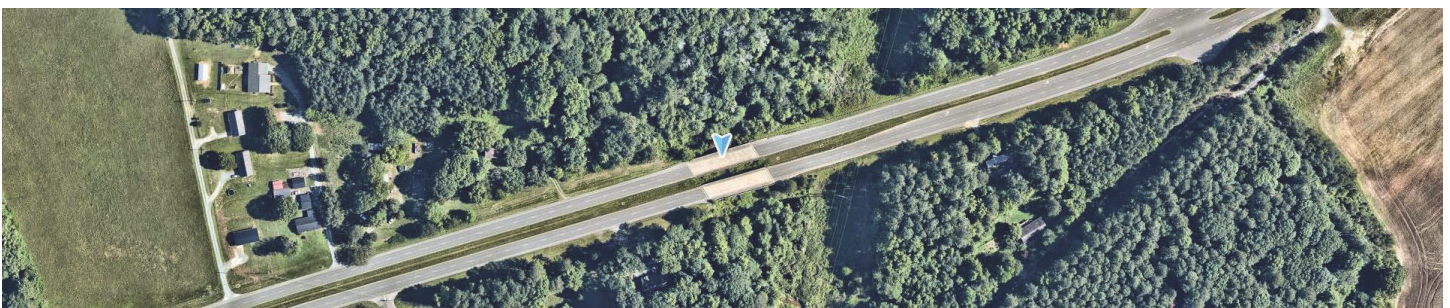
This site has an existing good, dry bench on both sides of the stream when not flooded. The width of the spans and the cross section of the ground surface under the spans already provide adequate space and geometry for wildlife passage on dry banks on both sides of the creek. However, barriers to wildlife travel exist along this corridor and under the bridges, which encourages wildlife travel on the roadway and results in conflicts with motorists. There are areas of exposed riprap with shallow to no sediment/soil (i.e., large voids) that are creating an uneven surface that likely makes it difficult for some wildlife species to traverse. The exposed riprap areas along the streambanks (and possibly in the adjacent toe ditches running parallel to the road) should be filled with material such as fines, soil, screenings, or aggregate to make the surface more even and traversable for wildlife.

Vegetation under the bridge does not appear to be an obstacle, but vegetation downstream along the streambanks is dense, brushy, and thorny. There are also abundant invasive woody species present which should be removed, as they significantly degrade the habitat value of the corridor through the ROW. Vegetation management in at least the downstream riparian area should be explored to determine if it would help guide or attract wildlife to the riparian corridor and the crossing under the bridge. If these aspects are addressed, this crossing site may be a good candidate for fencing, depending on parcel ownership, fencing design factors, etc.

Aerial photograph of US 15-501 over Pokeberry Creek. Nearmap.

Fill voids in the exposed riprap under and adjacent to the spans on both sides of the creek with fine aggregate to provide a smooth natural surface for wildlife passage on the existing benches. Thin vegetation and remove invasives within the ROW immediately downstream of the bridge to increase permeability into the adjacent undisturbed habitat to allow wildlife passage. Install fencing to guide wildlife under the bridge.

Until the riprap surface can be filled/improved, perform the selective vegetation clearing described above at a minimum.

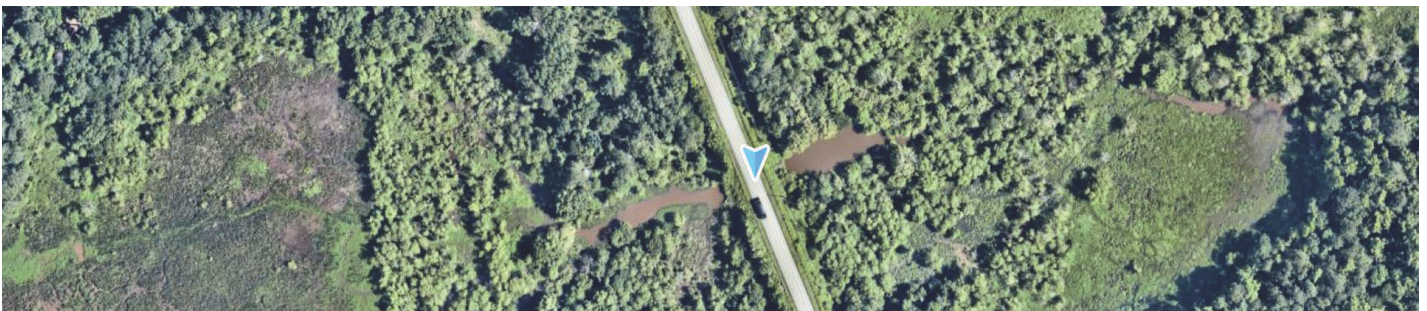
Barriers to wildlife travel exist along this corridor and through the culvert, which encourages wildlife travel on the roadway and results in conflicts with motorists. Barriers include standing water through the double box / two-bay culvert, and the placement of riprap. There are areas of suitable dry habitat approaching the underpass area on both sides of the road, even though there are also flooded wetland areas. However, there is no dry passage because both cells of the culvert are flooded to their full width, and because the riprap slope protection on the roadway embankment (causeway) extends into the standing water both up and downstream of the culvert.

Several elements of the roadway embankment (causeway) and stream culvert construction present challenges for the potential of dry passage through the culvert except potentially in times of extremely low water levels when no standing water is present. First, the culverts are not wide enough to accommodate dry wildlife passage and hydrology. Further, the placement of embankment riprap slope protection to the toe of the embankment at the adjacent floodplain elevation, cuts off dry passage from the floodplain when it is flooded. In addition, the uniform steep slope of the riprap on the embankments and the concrete wingwalls does not include a level bench that could be tied into the culvert if dry passage through them were provided.

Aerial photograph of Big Woods Road over Bush Creek. Nearmap.

Replace the existing culverts and adjacent earthen embankments with a single span bridge of sufficient roadway length to provide both hydrologic function plus a minimum width of 8 feet at and above floodplain elevation on both sides of the creek for dry wildlife passage. Extend these dry passages on both side of the bridge up and downstream into adjacent dry habitat areas. All dry passages must be natural surface, free of open riprap.

Construct new dry culverts through the causeway as wildlife underpasses on both sides of the existing culvert, placed so that wildlife can move from dry habitat areas on either side of the road, through these new dry culverts, to dry habitat areas on the other side of the road. These two new culverts should be at least 8 feet high and 12 feet wide, with a natural surface floor that is not normally flooded and should be straight with no offset or skew. If sufficient causeway height is not present to achieve the required height of the new dry culverts, the profile of the roadway may need to be raised in the section between the new culverts.

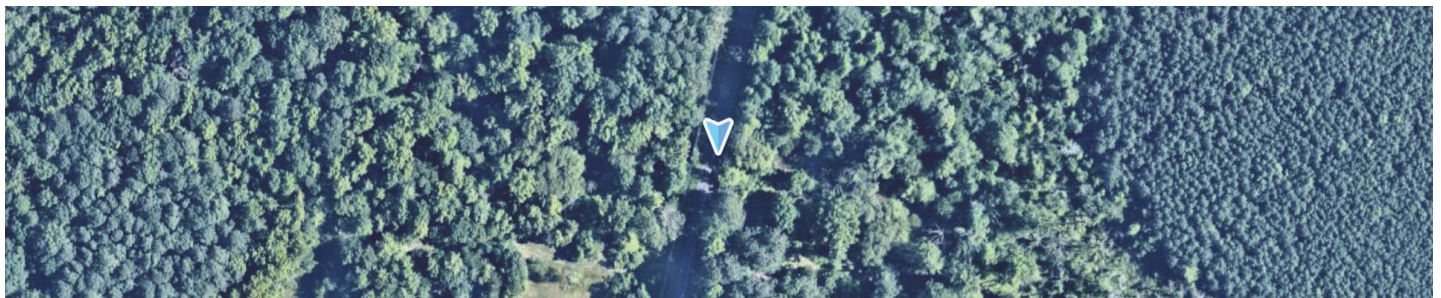
Barriers to wildlife travel exist along this corridor and through the culvert, which encourages wildlife travel on the roadway and results in conflicts with motorists. This site offers no dry passage for wildlife through the existing triple pipe culvert. During the relatively low water conditions on the date of site assessment, all pipe culverts were flooded with water, and debris was blocking the central culvert pipe. The three identical pipe culverts are round corrugated galvanized steel (pipe appears to be bituminous-coated on bottom) and are aging. Given the less than 6 feet of elevation difference between the road profile and the adjacent floodplain, there is no opportunity for any modification to the pipe culverts or installation of dry passage culverts adjacent to the existing culverts away from the stream channel.

Aerial photograph of Manns Chapel Road culvert over Wilkinson Creek. Nearmap.

The triple pipe culverts should be replaced with a single bridge of sufficient span to provide dry passage for wildlife on both sides of the stream at or above floodplain elevation. The road causeway profile should be raised to provide at least 8 feet of vertical clearance between dry passages and the bottom of the bridge structure.

The existing triple pipe culvert could be replaced with a 5-bay box culvert that provides outer cells with higher, dry passage for wildlife on both sides of the stream, with these dry passages connected to habitat up and down stream; or, a relatively short, full open-span bridge wide enough and high enough for dry passage on both sides of stream. The road causeway profile should be raised sufficiently to provide at least 8 feet of vertical clearance between the natural surface bottoms and the box culvert ceilings within dry passage bays.

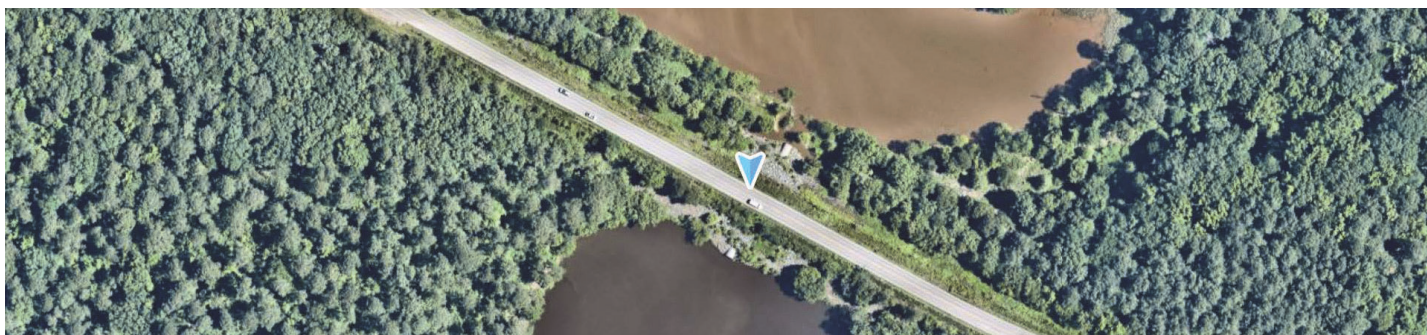
Barriers to wildlife travel exist along this corridor and through the pipe, which encourages wildlife travel on the roadway and results in conflicts with motorists. The road at this site crosses the lake on a raised causeway with steep riprap slopes from the road down to the floodplain and lake. The land around this crossing has existing trails currently used by the public that are conducive to wildlife travel. However, due to the pipe's location in the middle of Overcup Creek, and the wide body of water surrounding it, the structure is not conducive for wildlife passage through a retrofit.

Aerial photograph of Lystra Road pipe over Overcup Creek / Jordan Lake. Nearmap.

Construct dry culverts through the causeway on both sides of the lake to connect the high-quality lakeside habitat on both sides of the road. Dry culverts should be at least 12 feet wide and 8 feet high. The existing approach for wildlife to a potential underpass in these areas (visibility, slopes, etc.) is already good. This solution would also require fencing to guide wildlife to the dry culverts.

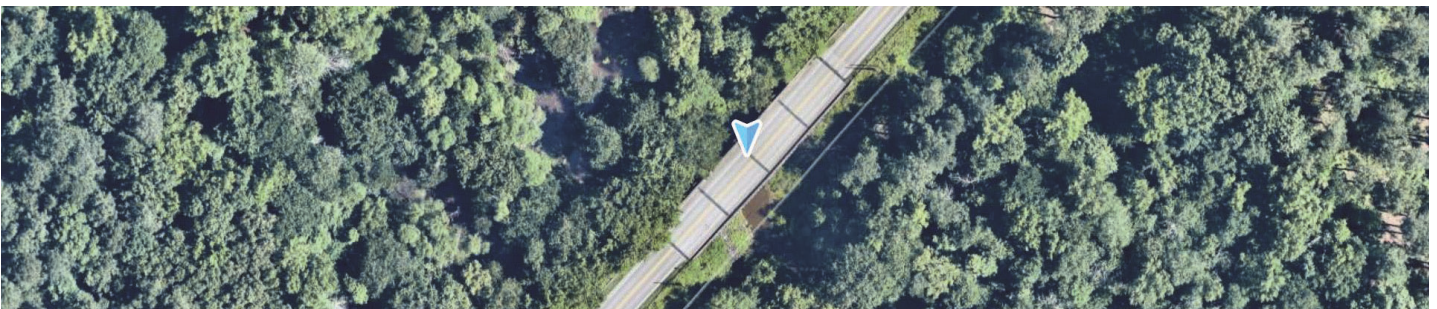
Barriers to wildlife travel exist along this corridor and under the bridge, which encourages wildlife travel on the roadway and results in conflicts with motorists. The continuous riprap slope protection along the causeway/roadway embankments and under the bridge is a major barrier to wildlife passage through the underpass and connection to habitat areas up and downstream. This riprap extends from about 10 feet below shoulder grade down to the toe of the slopes at the floodplain without a bench that could function as dry passage above the floodplain elevation. Though low water dry passage exists on the east side, none exists on the west side, and neither functions at high creek levels. A 30 feet wide partially dry natural surface floodplain exists on the north bank under the bridge, beyond the toe of the riprap slope protection that has good connectivity to adjacent up and downstream habitat, but only at low water levels. No dry passage is present on the south bank as the riprap slope protection extends to the top of the creek bank.

Aerial photograph of Jack Bennett Road bridge over Herndon Creek. Nearmap.

If the length of the bridge span between abutments is sufficient, grade 8 feet wide benches into the embankment/causeway slopes across the entire width of the creek floodplain on both sides of the road to create dry passages for wildlife at high water. Connect the benches under the bridge on each end, and tie them into dry habitat up and downstream. Benches should be natural surface or, if riprap is used, it must have all voids filled to provide a smooth surface.

Construct new dry culverts through the causeway to serve as wildlife underpasses on both sides of the existing bridge span, placed so that wildlife can move from dry habitat areas on either side of the road, through these new dry culverts, to dry habitat areas on the other side of the road. These two new culverts should be at least 8 feet high and 12 feet wide, with a natural surface floor that is not normally flooded, and be straight with no offset or skew. If sufficient causeway height is not present to achieve the required height of the new dry culverts, the profile of the roadway may need to be raised in the section between the new culverts.
